## Katrina: Wood-Frame Damage Assessment

Preliminary Observations By Rakesh Gupta, Oregon State University

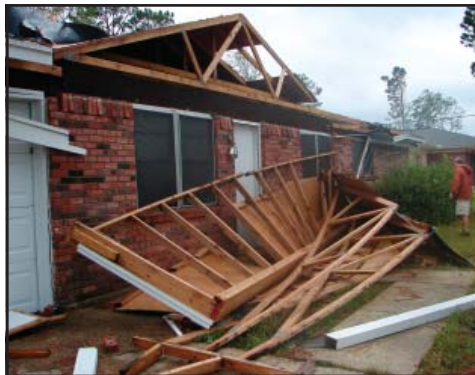
*Figure 1: Porch overhang collapsed due to poor anchorage between columns (white) and foundation*

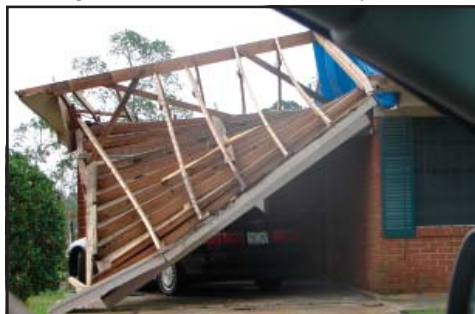
*Figure 2: Carport collapsed and structure breached*

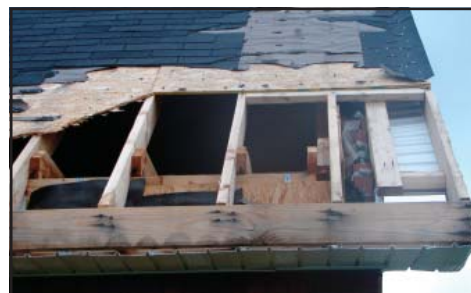
Loss of roof sheathing at corners and edges was observed in several buildings (*Figure 4*). This was probably due to the high suction pressure at discontinuities (edges and corners), which is consistent with the ASCE-7 wind load calculations. In these areas, the nail spacing was more than the minimum-code required. Either the minimum code-required nailing for conventional construction (for areas where wind speed is less than 110mph) or properly designed nail spacing for higher wind speed zones would have prevented this type of failure.

*Figure 4: Roof sheathing damage at the corner of a roof, fastener spacing was in excess of the code minimum*

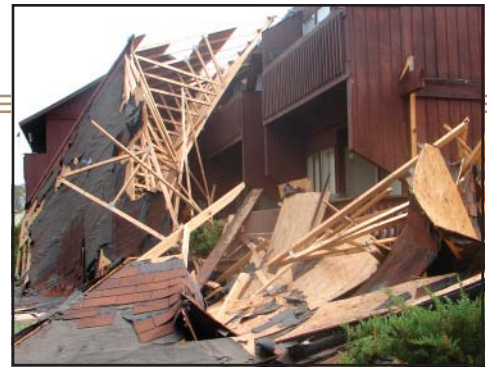
*Figure 3a* shows the loss of a complete roof, mainly due to roof truss to top plate connection failure. Apparently trusses were connected to top plate with hurricane clips but only one or two nails were used to connect to the top plate instead of four (as shown in *Figures 3b* and *3c*, respectively). Fortunately, this gable roof was built later on a flat roof. The flat roof survived, preventing water damage.

*Figure 3a: Multi-family condominium roof collapse*

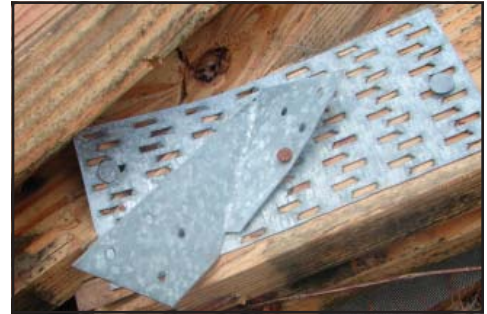
*Figure 3b: Truss to top plate connected using hurricane strap but only one nail instead of four nails*

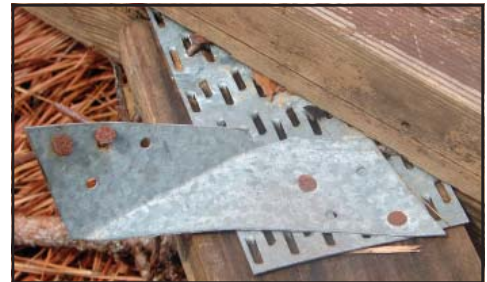
*Figure 3c: Truss to top plate connected using hurricane strap but only two nails instead of four nails*

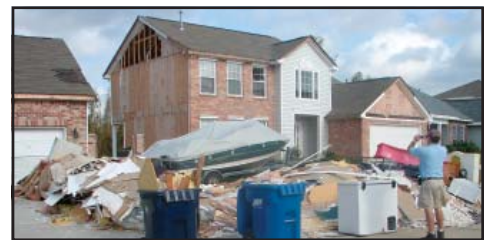
One of the common types of failures was loss of non-structural, foam-substrate, insulation sheathing panels at the gable-end walls (*Figure 5*). This was probably caused by air entering through blown up vents and creating a balloon effect in the attic. This blew out a few foam sheathing panels of the gable end wall (structural wood panels remained intact at these locations). This allowed water to get into the attic, resulting in wet insulation and ceiling drywall. Once attic insulation and ceiling drywalls were saturated, the whole ceiling collapsed due to its weight resulting in significant water damage to the contents of house. This is probably the single most common economic loss (which is non structural) from a hurricane, along with damage due to storm surge. In one subdivision, extensive damage was caused by failure of vinyl siding and foam sheathing panels, resulting in extensive damage to the interior (and contents) of the house. In most of these homes, structural

*Figure 5: Non-structural, foam-substrate, insulating sheathing panels failed at the gable end*

wood panel siding remained intact. It is recommended that the whole house (all walls plus roof) should be sheathed with structural wood panels with code-required nailing requirements, to prevent future losses.
