# The Empire State Building

## Façade Evaluation and Repair of an Engineering Landmark

By Robert J. Nacheman, P.E.

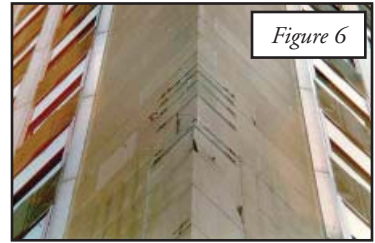
Figure 6

causing corrosion of the iron strap anchors attaching the limestone to the brick back up wall. At these locations, as the iron anchors corroded, the corrosion product expanded, causing a shard of the limestone to pop out, and severely diminishing the limestone anchorage capacity. The parapet walls were severely deteriorated as a result of water infiltration, which caused corrosion of the steel spandrel beams, and also freeze-thaw damage to the masonry. At the building corners, the stone was cracked and many years ago, steel straps had been bolted on to the surface of the limestone in an attempt to confine the limestone cladding in place. (Figure 6)

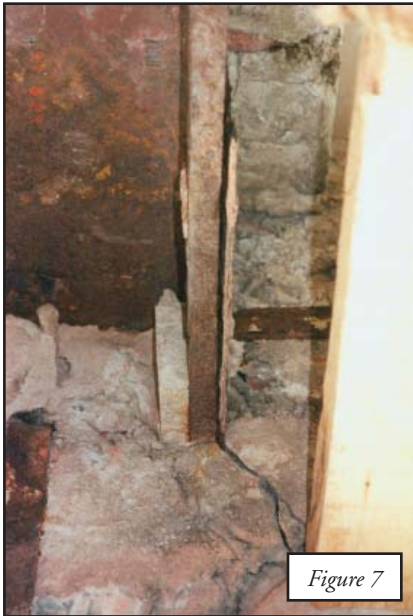
Figure 7

The mostly vertical cracks in the limestone facing and brick masonry back-up at the building corners were probed to confirm that the cracks were directly correlated to conditions of outward expansion resulting from corrosion of the structural steel (Figure 7). However, the amount of section loss at the structural steel framing sections was for the most part structurally insignificant. A detailed survey and invasive probes provided correlation between the degree of limestone cracking at the eight corners of the tower and the severity of corrosion of the structural steel building columns within the corner piers.
