# A Case Study of Early Steel Curtain Wall

By Eric Hammarberg, Assoc. AIA

## The Chrysler Building,

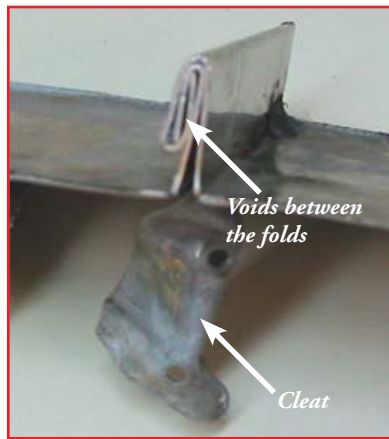
Original sheet metal cladding - voids between the folds were originally filled with white lead paste sealant

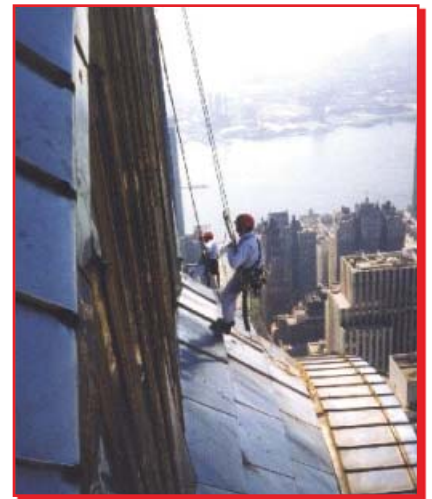
Industrial Rope Access inspection

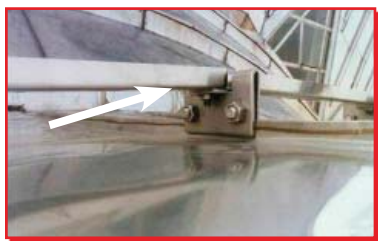
*Snow stop (part of the Replaced Simple Arch Cladding)*

The lowest arch is a simple arch built of standing seams. This arch actually has a slight inward or back pitch toward the building. The valley formed by this back pitched portion and the stepped compound arch creates a slight trough that acts as a gutter to control rainwater and reduce the amount of runoff over the outboard brick façade.

The supplier of the original Nirosta remains one of the world's largest suppliers of stainless steel sheet metal. They also support state-of-the-art "seam welding" technology, including a fully detailed system of cleats and expansion. This system is often used for water storage tanks. The system requires special very low temper 26-gauge (0.50 mm) stainless steel sheet metal which is fusion welded together using a hand-held welder about the size of a wood working router. The seam welder includes self propelled pinch-rollers that deliver controlled high heat and produce a uniform weld (continuous spot weld) without burning through the metal. The result is an air tight seam. All necessary expansion is detailed into the system. Thirty-five linear feet (11 m) of arch, four-feet (1.2 m) wide, was replaced at each of the four elevations.

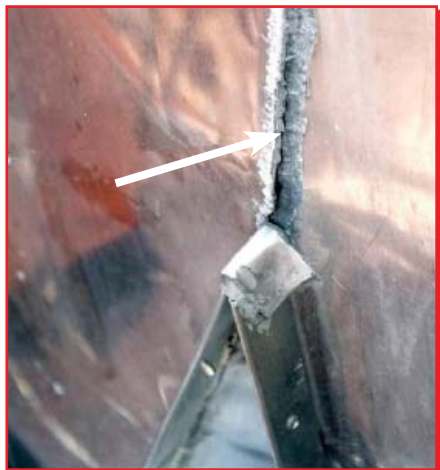
*Cracked solder*

Cracked solder typically occurred at complex intersections, where two panels of sheet metal were not parallel. Cracked solder and pinholes in the metal were repaired with either sealant or liquid applied membrane.

All sealants were Dow Corning Silicone, either 795 or 995 depending on desired modulus of elasticity. These were chosen for superior adhesion to the stainless and long life expectancy. Liquid applied membrane was Mathys Noxide. This was the only acceptably performing membrane available, at the time of this project, which included a color coating that matched the polished stainless steel... an aesthetic requirement.

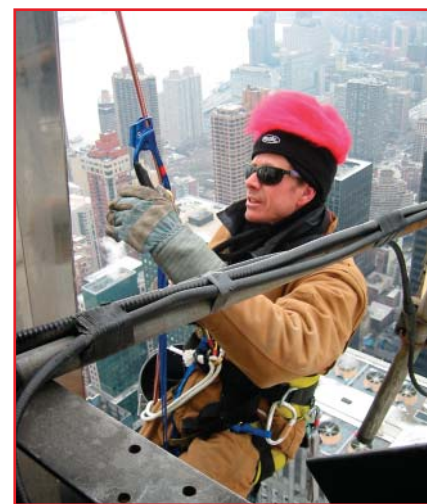
*Sealant repairs*

The selected approach included installation of sealant (same used on sheet metal) on the operable sash — along the sash/frame meeting surfaces. A bond break was applied to the frame so the sealant would not “glue” the window shut. The window was closed and latched, the sealant allowed to cure for one-week, and then the window was opened. This created a cast-in-place gasket seal that closely aligns between the two mating surfaces. The sealant is expected to have at least a 20-year lifespan. In addition, the sashes are generally not operated in order to maintain the “balance” of the building heating, ventilation and air conditioning system so very little wear and tear is anticipated. When the “gaskets” do wear out, repair/replacement would follow the same simple technique. In addition, all window lites were reglazed and cracked glass lites were replaced.

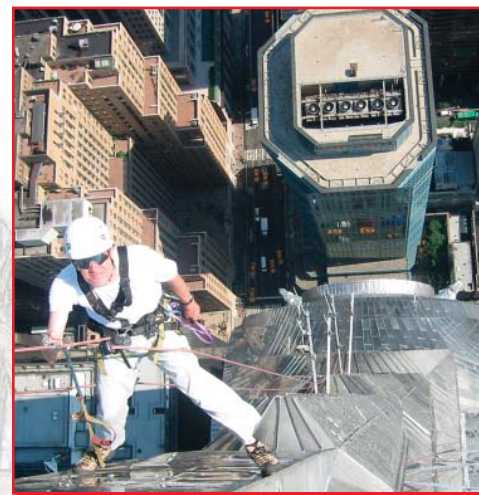
Final inspection

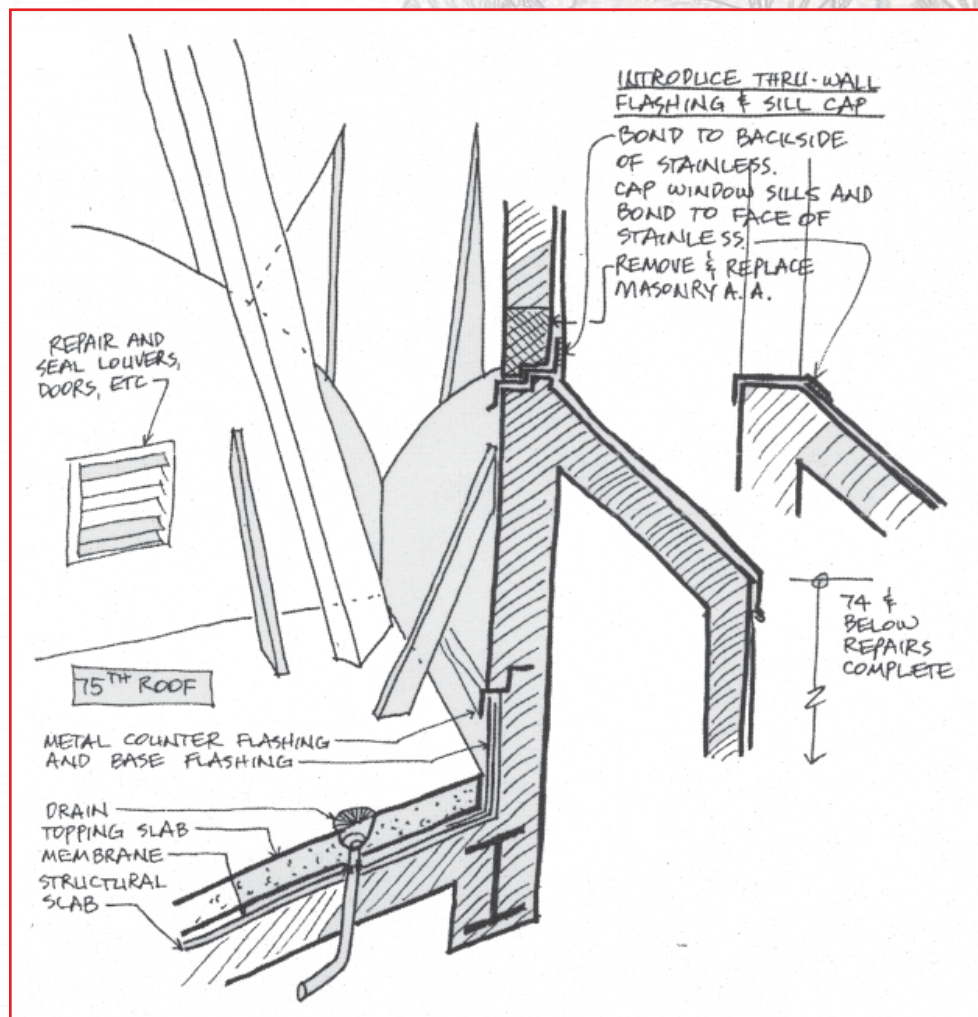
75<sup>th</sup> Floor through-wall flashing

Since there is a roof at the 75<sup>th</sup> floor level and windows punctuate the majority of the wall area, LZA suggested installing through-wall flashing in case any leak occurs in the spire and pinnacle above. A few courses of brick were removed around the window sill level of the 75<sup>th</sup> floor and a layer of membrane through-wall flashing installed. The membrane was terminated onto the backside of the stainless steel sheet metal skin and on all the steel framing within the walls. Then all masonry was replaced. Therefore, if water infiltrates behind the stainless steel skin, it may run down in the narrow space between the skin and the backup masonry and asphalt felt, become captured by the through-wall flashing and be dumped out on to the 75<sup>th</sup> floor roof and drain.
