FRP STRENGTHENING OF A FIRE DAMAGED INDUSTRIAL PLANT

By Peter Milligan, P.E.

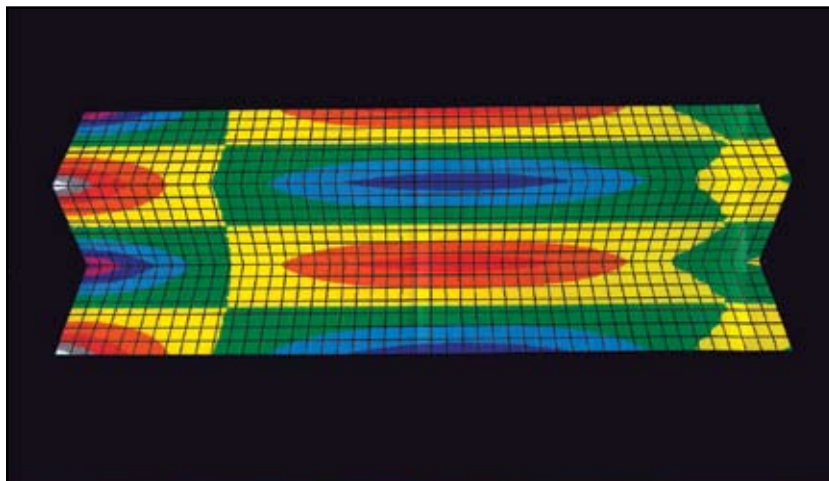
Figure 2: FEM Stress Output Example.

rehabilitation. Figure 2 illustrates the resulting tension deficiencies that became the target design values for the carbon fiber reinforced composite system applied to these areas. The required tension indicated in the finite element analysis was used for the design of the FRP composite strengthening systems. The bulk of the deficiencies were in the East-West direction (parallel to the peak and valleys). Some flexural reinforcing was also completed in the North-South direction perpendicular to the peak and valley axes.

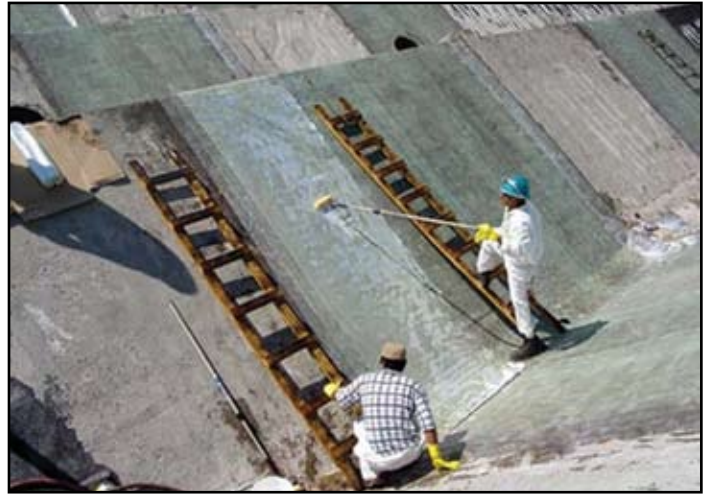
Figure 5: GFRP Bi-directional Shear Strengthening.

In addition to the fire-damaged areas, analysis of the existing structure determined that the areas to each side of interior column line B were deficient in shear strength for current code requirements. During the application of the FRP to the fire damaged areas, the application of bi-directional glass composite to the non-fire damaged areas for the structural upgrade were completed as well. Epoxy injection of existing shear cracks was completed prior to shear strengthening with the glass FRP composite.

To restore the shear strength of both the fire damaged section and the remainder of the folded roof panels at the interior column line B, a bi-directional glass composite system was used. This glass composite was composed of plus and minus 45-degree oriented fibers (Figure 5). Often, the shear strengthening of beams, slabs, and walls can be effectively accomplished with the use of uni-directional composite systems, with the fibers oriented parallel to the applied shear force. The advantage of using uni-directional composite for shear strengthening is the added ductility associated with the retrofit, as well as the additional strength. The advantage of the bi-directional glass composite for this application was to apply the strong fibers at the principal stress axes for the tensile forces in the folded roof panel faces. This added more stiffness and strength to the existing system as opposed to the uni-directional fiber approach, and thus was favorable for this type of repair. Tensile testing was completed to verify FRP to substrate bond strength.
