Quincy Mine Blacksmith Shop

Condition Assessment of Timbers

By Robert J. Ross and Xiping Wang

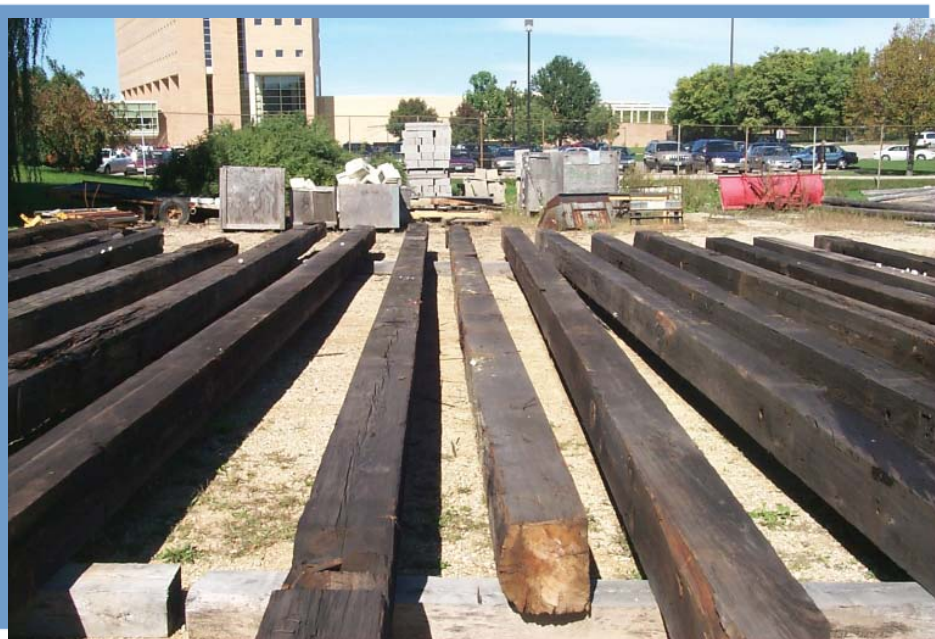
Figure 1: Fifteen 12-by 12-inch white pine timbers removed from the Quincy Mine Blacksmith Shop

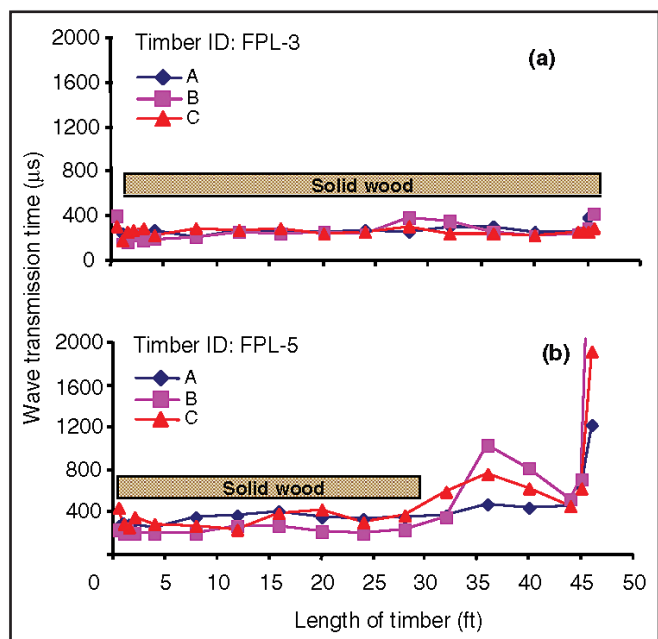
Figure 3: Typical scan results from 12-by 12-inch white pine timbers

As shown in wave transmission-time/length-of-timber graphs, these white pine timbers are in various conditions, from solid, slightly to severely deteriorated, to almost fully deteriorated. As previously mentioned, the deterioration was mainly caused by decay (surface and internal), splits, and mechanical damage. From scans shown in Figure 3, it is possible to distinguish whether deterioration occurs in surface areas or inside of timber as stress wave transmission times obtained from three scan lines (A, B, and C) are plotted on the same graph for each timber.

The solid wood in each timber was determined by comparing scan results with the baseline data of stress wave transmission times for solid wood. The approximate length of solid wood for each timber that could have potential structural uses was also determined and indicated below each scan graph. A summary of potential recovery of the solid wood from all tested white pine timbers is detailed in Table 1.

From the scans and Table 1, it is evident that a substantial amount of solid wood could be recovered from these timbers except for one short timber, FPL-12, which was almost fully deteriorated. The potential recovery rate could be as low as 16 to 17 percent due to severe deterioration found in timbers (such as FPL-4 and FPL-8); it could

also be as high as over 90 percent (such as timber FPL-3 and FPL-10). Overall, an average of 61 percent of total materials (not including FPL-12) could be potentially recovered from these white pine timbers and used in the reconstruction project.

1. Complete stress wave scanning tests on the remaining white pine timbers, including 12- by 12-inch roof truss timbers and 3- by 14-inch floor joists. Use the same procedure as employed in this assessment to determine the location and severity of deterioration that might occur in the rest of the structural members.
2. Cut off deteriorated sections from the timbers and obtain solid material based on scan results.
3. Mechanically proof load all solid wood sections to supply engineering design values for their reuse in the reconstruction project. ■
