# REMEDIATION OF MASSACHUSETTS INSTITUTE OF TECHNOLOGY'S W33 CAGE BUILDING

By Jeff D. Langlois P.E., Milan Vatovec, Ph.D., P.E., Philip L. Westover, P.E., and Randall Preston

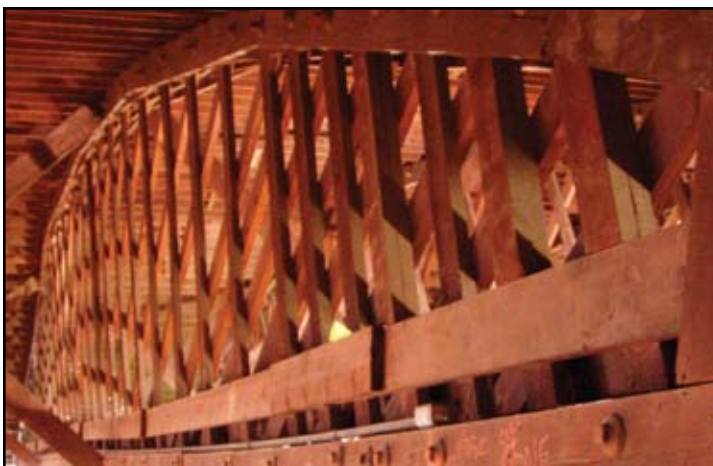
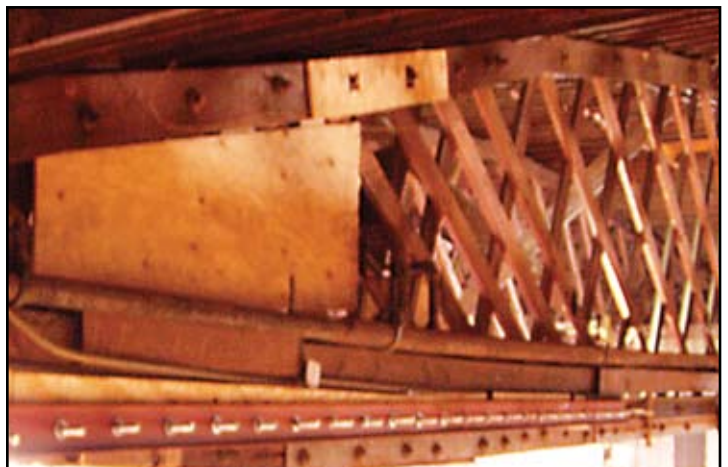
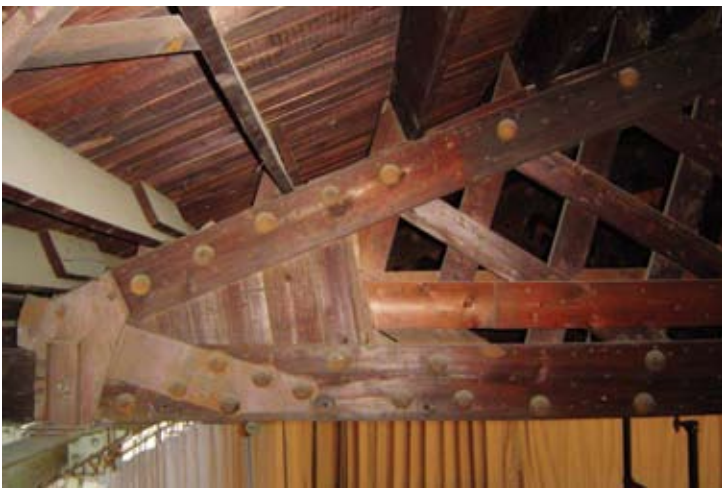
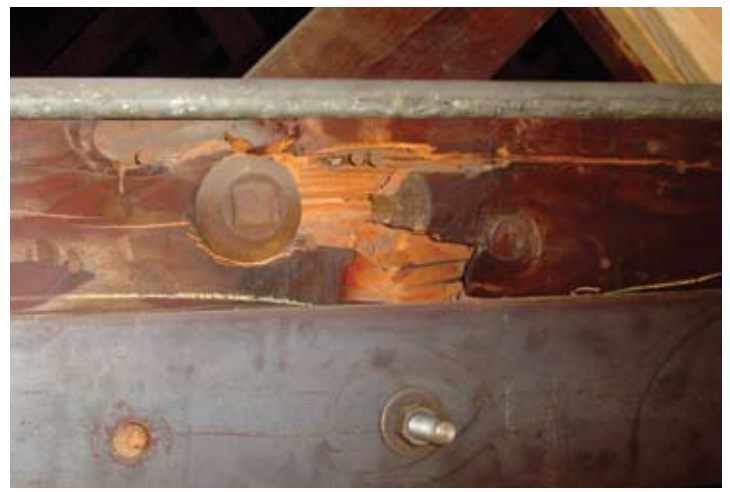
The primary ailment observed was existing repairs at tension fractures along the bottom chord of several trusses. Generally, the existing repairs consisted of through-bolted steel sections sistered to the sides of the bottom chord. Top chords, however, appeared to be in excellent condition, with the exception of one truss, which had sustained damage and was visibly deflected (Figure 2).

Figure 2: Curved-chord wooden lattice trusses support the roof of MIT's W33 Cage Building.

While the observed tension failures can generally be attributed to the presence of knots and to the lack of splice connections in the bottom chord, it is also likely that these trusses were designed with fictitiously high allowable stress values assigned to the lumber. During the na-

As disassembly of existing repairs was deemed too risky, options for chord strengthening were limited. This was the key obstacle in detailing the strengthening scheme and led to recommending the installation of steel tension rods on each side of the bottom chord of the trusses. This an elegant means of avoiding contact with the existing repair; it also allowed for the option to post-tension the rods and remove existing dead load from the bottom chords, such that they were not overstressed during snow loading. Furthermore, since the capacity of existing repairs was unknown, the post-tensioning rods were sized to safely carry the entire lateral thrust of the compression chord under dead and live load combined.

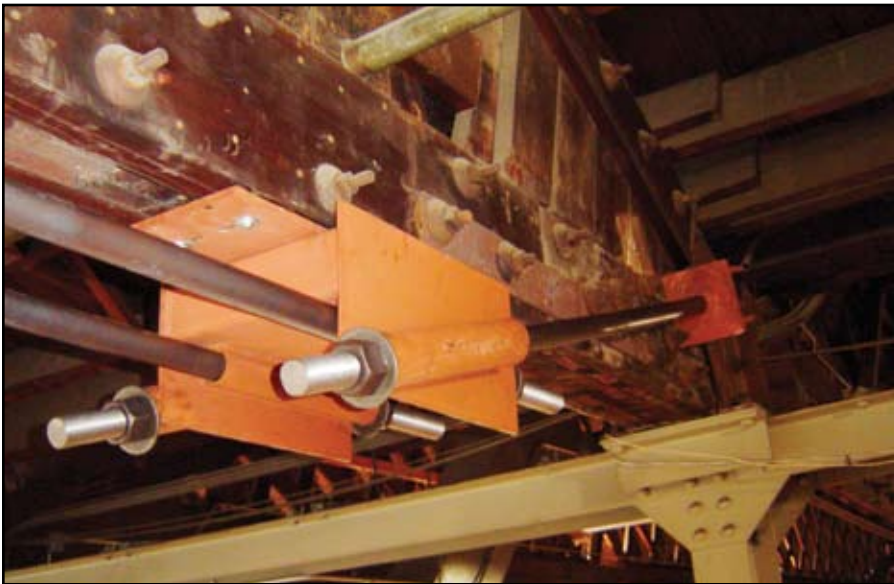
Figure 3: Lower bracket transfers tension from diagonal tie-rods into horizontal tie-rods.

Custom-welded steel brackets were designed to transfer load from the top chord into the new steel tension rods. Three separate assemblies were employed at each support end; 2 upper brackets to transfer load into the steel rods on either side of the truss (oriented diagonally downward), and a single lower bracket, which transferred tension from the diagonal rods into the horizontal rods which run the remaining length of the truss (Figure 3).

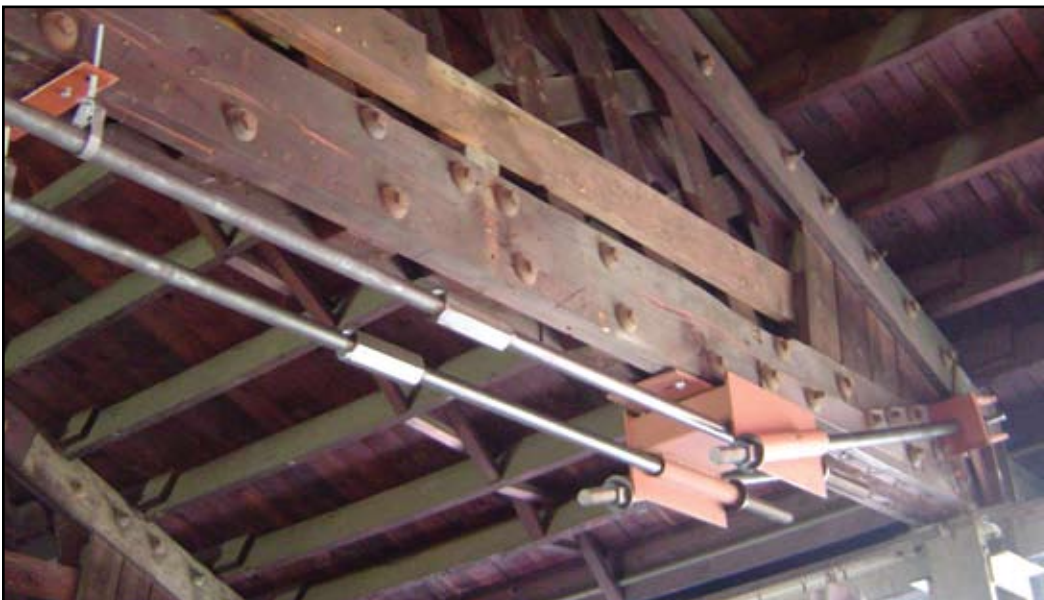
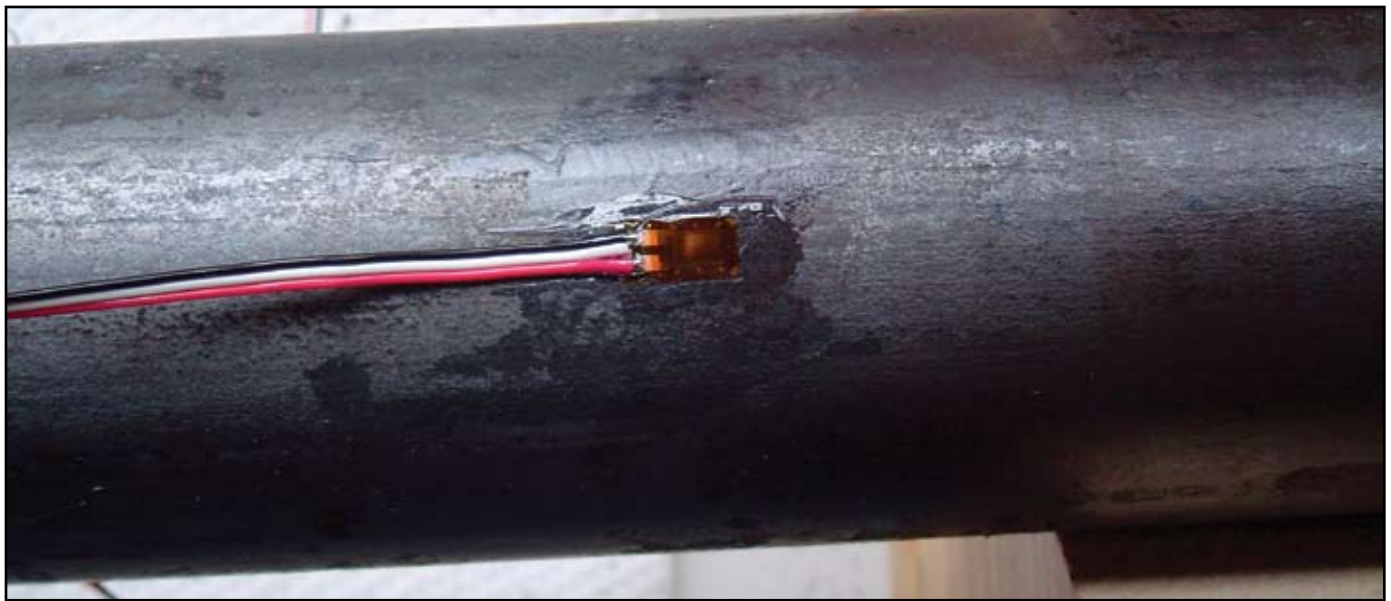
Figure 4: Electronic resistance-type strain gauge used to monitor tensioning of tie-rods.

In order to get the bottom chord stresses within the allowable range under snow loading, the design concept required transferring essentially all of the dead load tension from the existing wood bottom chord to the steel rods. Tensioning of the tie-rods was monitored using electronic resistance-type strain gauges. Two gauges were adhered to opposing sides of each tie-rod. During tensioning, gauges were kept as close to mid-depth of the tie-rods as possible to avoid flexural strain (Figure 4).
