# All Aboard!!

New Life for a Ferry Ramp

By Benny K. Louie, P.E.

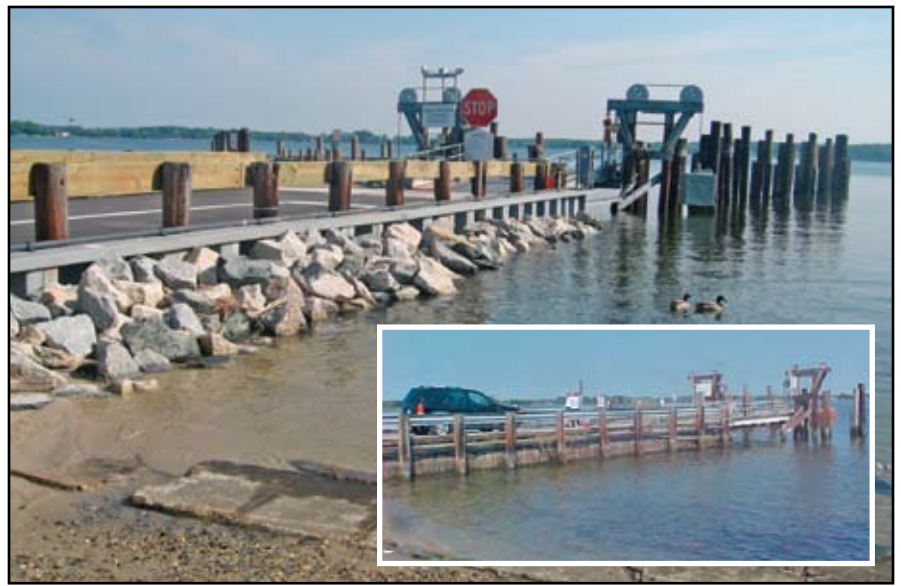
Figure 1: Ramp and approach after reconstruction (May 2006). Inset - Ramp and approach before reconstruction (October 2004)

The 22-foot long by 15-foot wide ferry ramp, composed of steel, exhibited signs of heavy corrosion. The ferry ramp was fairly low to the water, and during

very high tides it would be in the splash zone. Inspection of the mechanical and electrical components of the hoist system revealed that they required replacement.

The existing approach roadway pavement was in good condition, but the back-to-back timber sheet piling was visibly worn and needed rehabilitation. A scuba diver investigated the extent of structural deterioration in the water. The end wall of the approach roadway, which consisted of sheet piling with tiebacks, had experienced moderate movement. The timber bumping dolphins and several other timber dolphins,

In 2004, the Maryland State Highway Administration (MDSHA) slated the ferry ramp and approach roadway on the Oxford side for rehabilitation (Figure 1). MDSHA called upon the engineering consulting firm of Parsons Brinckerhoff Quade & Douglas, Inc. to assist in the effort. Construction took place during the months of November thru March of 2004-2005 and 2005-2006, when the ferry service was closed for the season. A ferry ramp may be considered a movable bridge due to the machinery used to adjust the level of one end of the ramp in order to seat it on an incoming ferryboat or unseat it from an outgoing ferryboat.

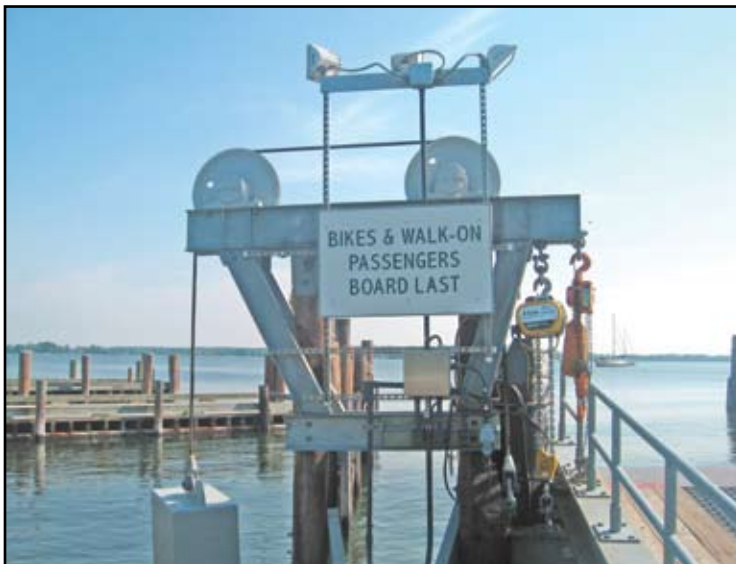
Figure 3: New components on north hoist tower

The project replaced the electrical service and mechanical equipment for the ramp hoist systems with new components in order to better serve the ferry boat (Figures 3 and 4), including counterweight sheave supports, electric chain hoists, manual chain hoists, wire rope and shackles. The new configuration utilizes a safer, more redundant system with two synchronized chain hoists, whereas previously a single electric chain hoist was in service. The wire rope and sheaves, which previously ran under the ferry ramp, are now connected at the top of the W14 through beams, making them more accessible for inspection

The project replaced the existing timber bracing on the hoist towers with galvanized steel members. The only components reused in the hoist towers were the timber piles of the towers and the steel counterweight boxes, which received a new coat of galvanizing.

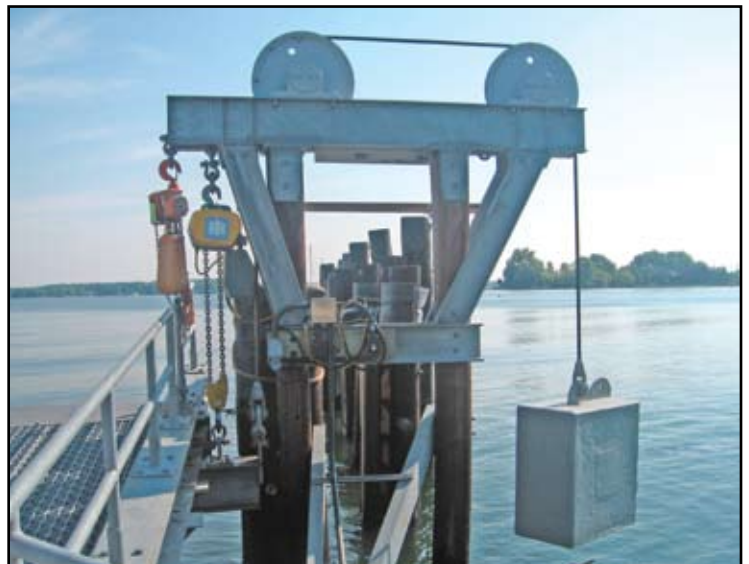
Figure 4: New components on south hoist tower

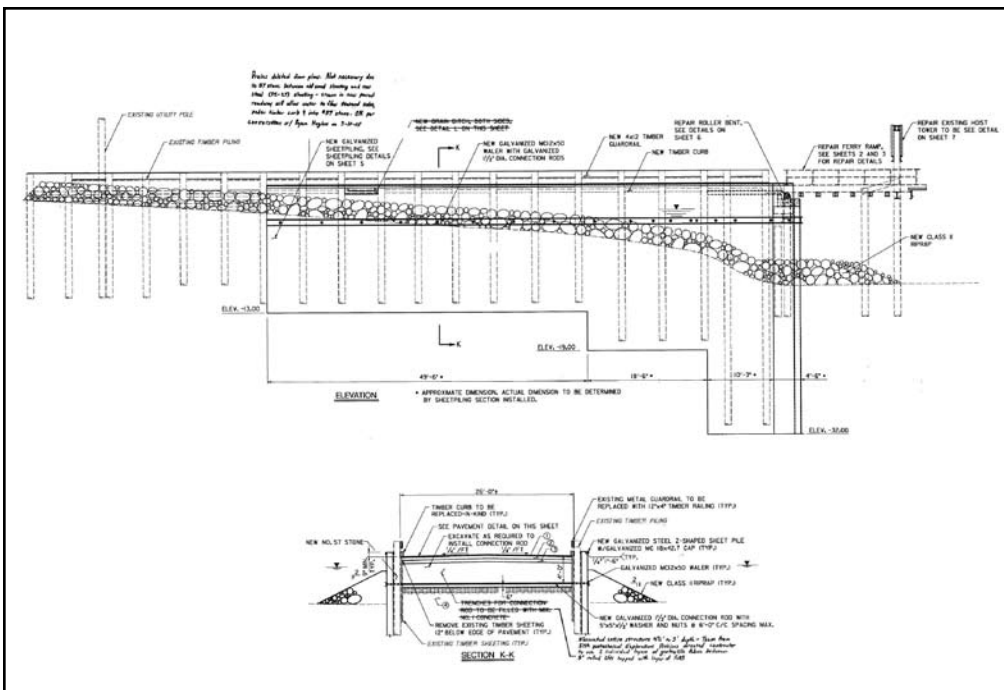
Figure 5: As-Built Elevation and Section of Approach Ramp

Timber sheet piling on the north, south and east sides supported the existing approach roadway. The excavation of the existing roadway revealed that the existing tie rods behind the timber sheet piling were in relatively good condition, considering the constant exposure to local tidal effects. The east side, which was the ferry approach side, had a moderate 5-foot to 7-foot-deep scour hole in front of the sheet-

ing and directly beneath the steel ramp (Figure 5). The scour was due to the wake caused by the propeller of the ferryboat as it backed into the steel ramp to unload passengers and automobiles. The scour hole was the main reason for the observed movement in the pile bent supporting the timber roller.

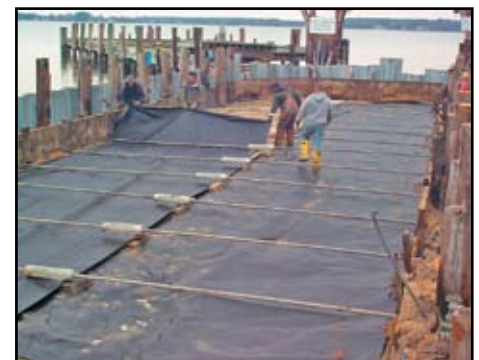
Figure 6: Back-to-back tiebacks for steel sheet piling on approach roadway

The project team performed a geotechnical analysis, considering the scour before deciding to install steel sheet piling with back-to-back tiebacks in front of the timber sheet piling (Figure 6). The back-to-back tiebacks consisted of 1½-inch-diameter rods and turnbuckles connected to MC12x50 walers. In addition,

a team from the MDSA Geotechnical Explorations Divisions provided direction on how to backfill the approach roadway. Large riprap placed in front of the steel sheet piling will prevent future scour or erosion.
