Repair of Duck Creek Culvert

By Terry M. Sullivan, P.E., Peter Kolf, S.E., Michael G. Carfagno, P.E., Steven J. Smith Ph.D., P.E. and Jeremiah R. Nichols, P.E.

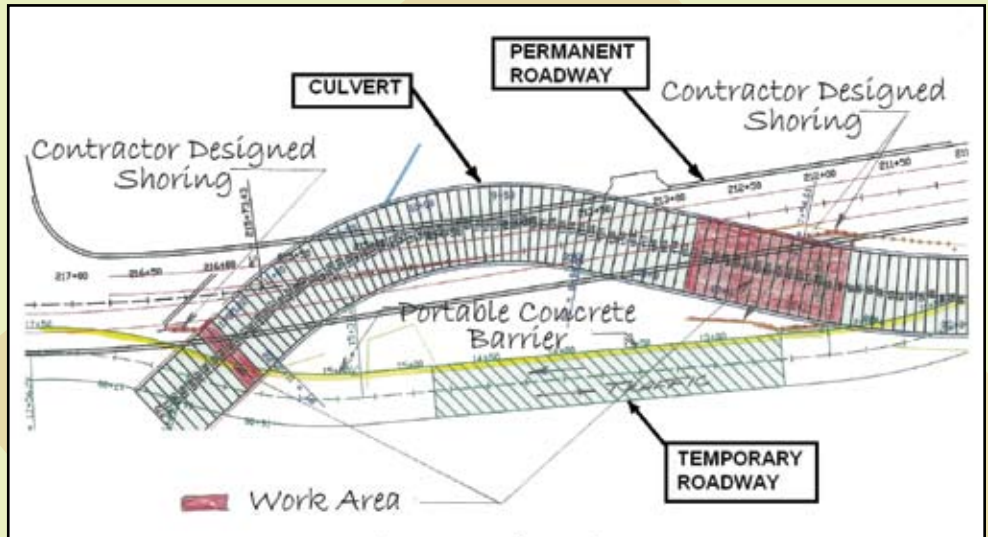
Figure 1: Phase I repair sequencing.

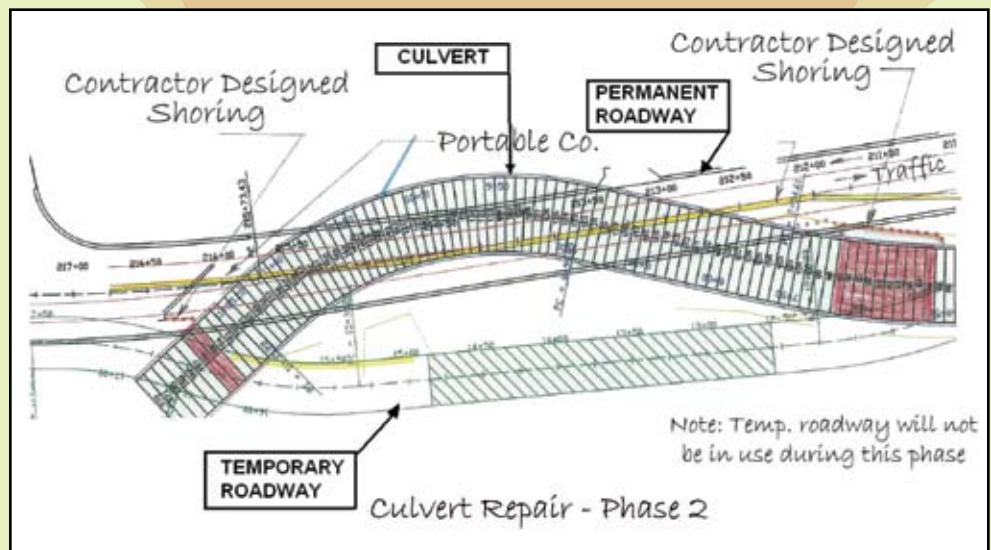
Figure 2: Phase II repair sequencing.

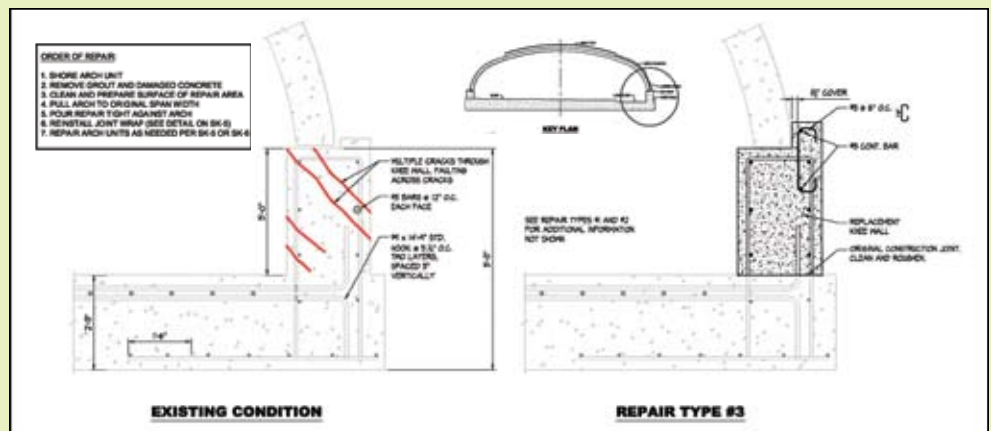
Figure 3: Full section knee wall repair, with reinforced keyway

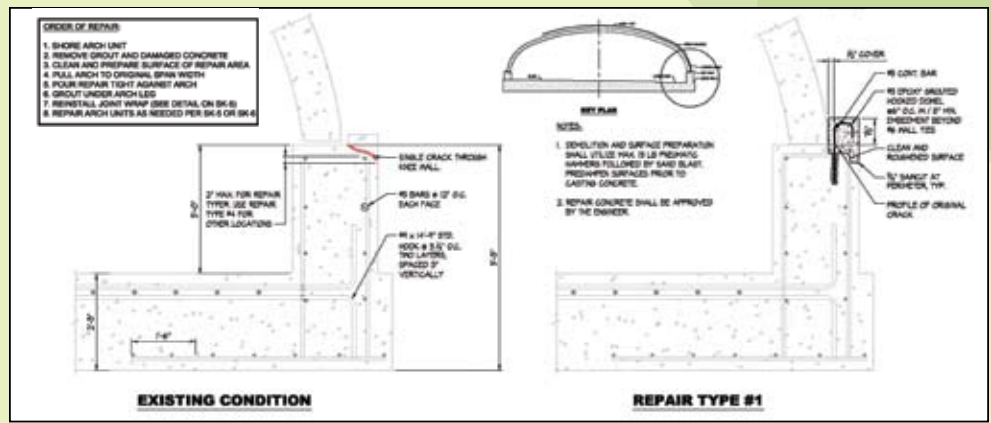
1. Repair of shear failure in the knee wall: some knee walls were distressed as a result of excessive spreading forces generated within arch segments due to the overload (drawings for each type of repair are included in the on-line edition of this paper):

Figure a: Shear failure of the key way

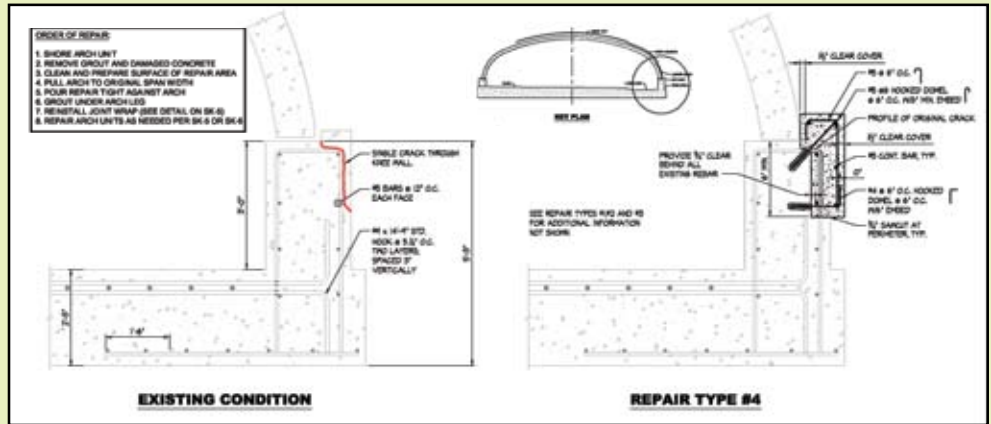
Figure b: Key way failure with partial knee wall spall

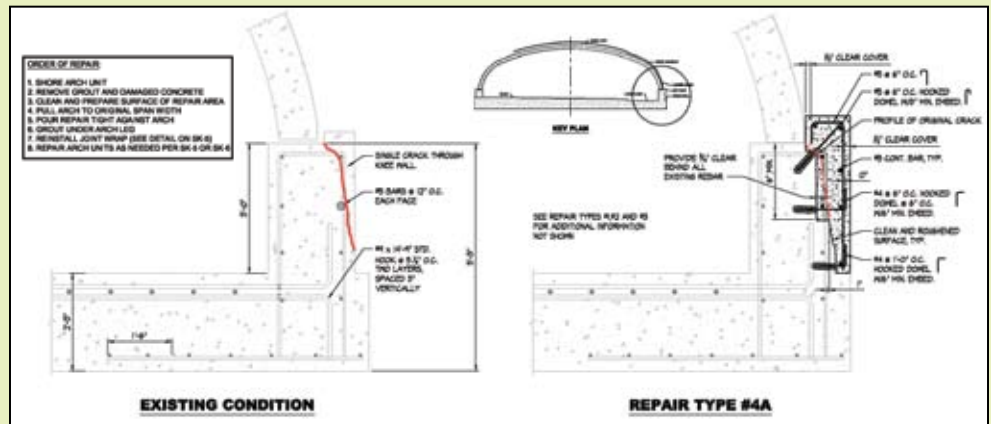
Figure c: Key way failure with extended knee wall spall

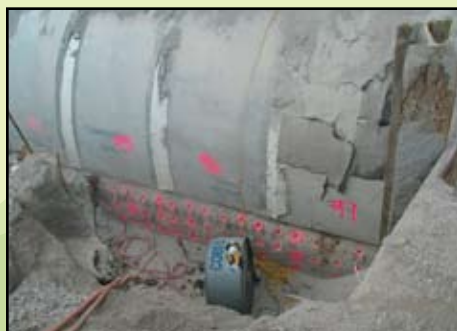
Figure 4: Demolition of damaged knee wall

The arch units were then shored up vertically and cable ties were installed to keep the legs from spreading when the removal of the side fill would no longer provide lateral support. Earth fill was then removed evenly on each side of the precast arch units to minimize any unbalanced loading. Concrete demolition proceeded based on the extent of damage and the required repair. Knee wall sections requiring substantial demolition necessitated the contractor to drill holes and to use hydraulic splitters to break up the damaged concrete (Figure 4,). Care was exercised during demolition to avoid damage to existing reinforcing. The arch unit span was then adjusted by a combination of jacking up the arch units to bring the legs in and by tensioning the cable ties to bring the arch back as close to the original span, 48 feet-10 inches, as possible. The knee wall repairs were then completed with the arch segments in place (Figure 5, see page 33).

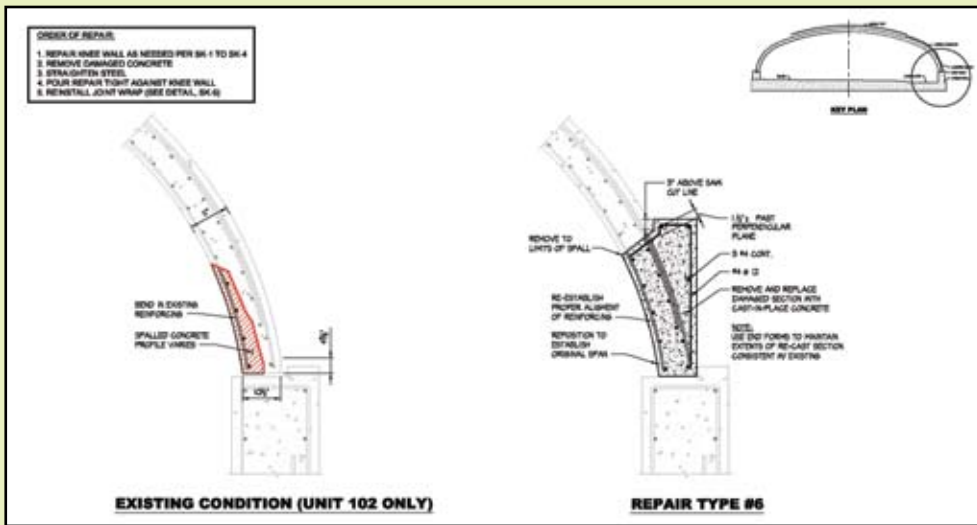
Full arch section repair

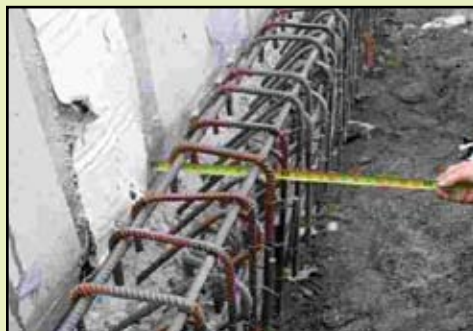
Figure 5: New knee wall reinforcing steel

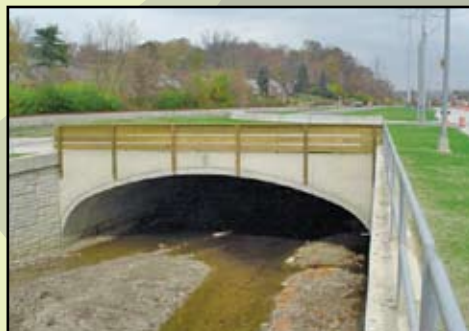
The Completed culvert
