# A Tale of Two Bridges

By F. E. Griggs, Jr. FASCE

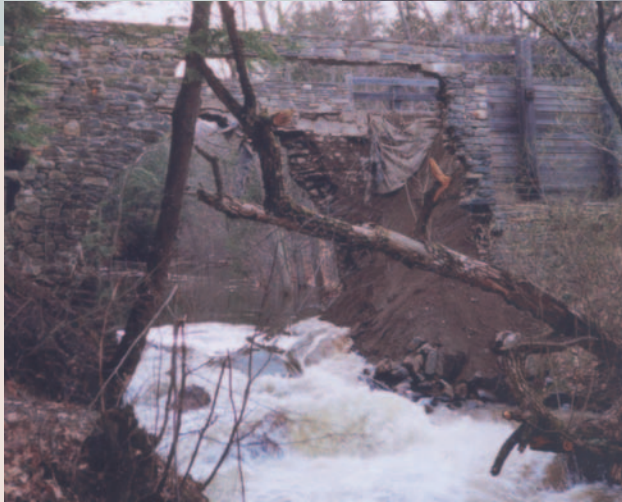
*Malta stone arch, collapsed April 1993*

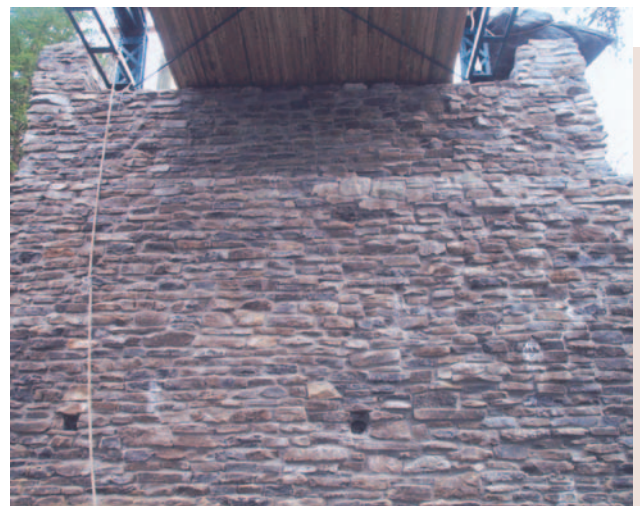
*South abutment using stone from the arch bridge*
