Taking a Closer Look at Masonry and the World Trade Center Disaster

By David T. Biggs, P.E.

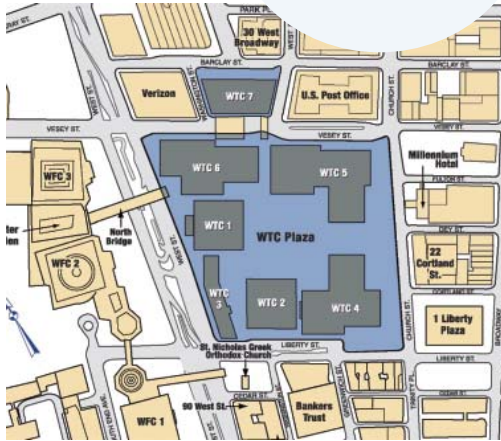
Figure 1 – World Trade Center Plaza and surrounding buildings

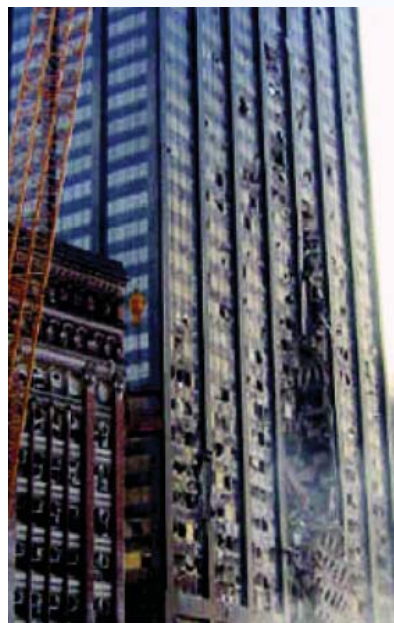
Figure 3 – North elevation of 130 Liberty Street

by impact, the exterior wall and the structure remained intact. In comparison, Figure 3 shows the north elevation of the more modern 130 Liberty Street. A column section from WTC 2 sliced through the curtain wall system and structure from the 15th floor down to the 8th floor. It is not fair to assume both buildings experienced the same loading. However, in general, the masonry elements of buildings that were impacted absorbed the energy and kept the damage to the structural framing more localized.

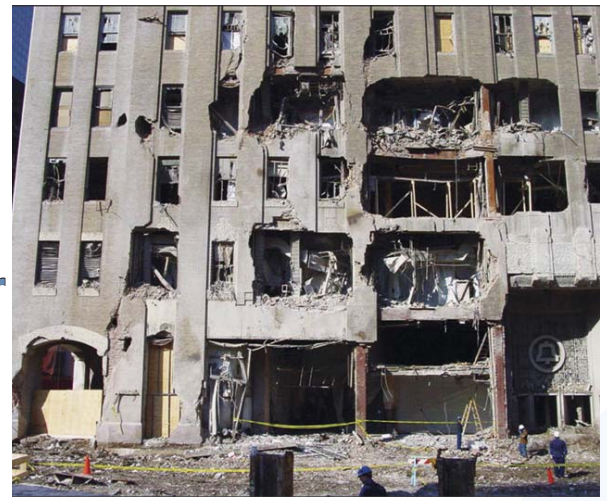
- Older framed buildings with exterior masonry walls generally performed better than the newer buildings with lightweight curtain wall construction. As an example, Figure 2 shows the east wall of 140 West Street that faces WTC 7. Even though large portions of the exterior wall were damaged

Figure 2 – East elevation of 140 West Street

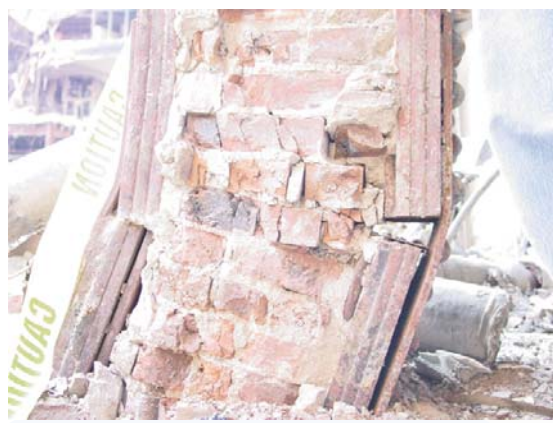
- Masonry infill for walls and beams functioned as fireproofing and provided significant structural redundancy. The infill provided an alternate load path to transfer gravity loads from damaged steel columns, and prevented collapse of portions of several buildings. Figure 4 shows a damaged steel column where the load was taken by the infill and collapse was prevented so shoring could be installed.
- The performance of masonry veneers and panelized masonry systems was dependent upon the type of veneer and the anchorage system used. Figure 5 shows brick veneer damaged by impact and air-borne debris. The brick ties were inadequate, yet damage was limited primarily to areas of impact. Panelized wall systems were removed and rebuilt.
- Interior masonry partition walls provided redundant lateral stiffness and added fire protection in the older buildings.

Figure 4 – Column Infill

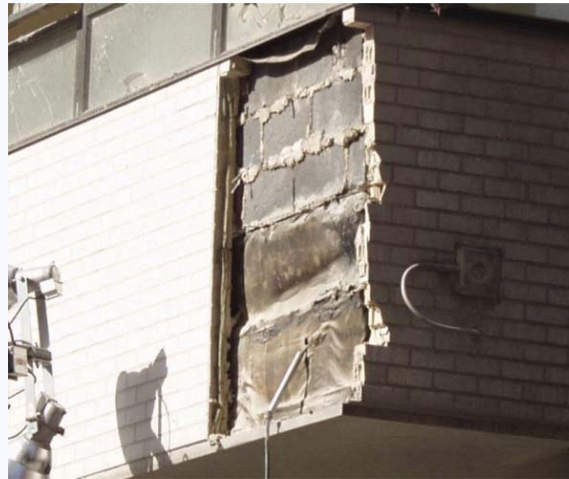
Figure 5 – Southeast corner of 30 West Broadway

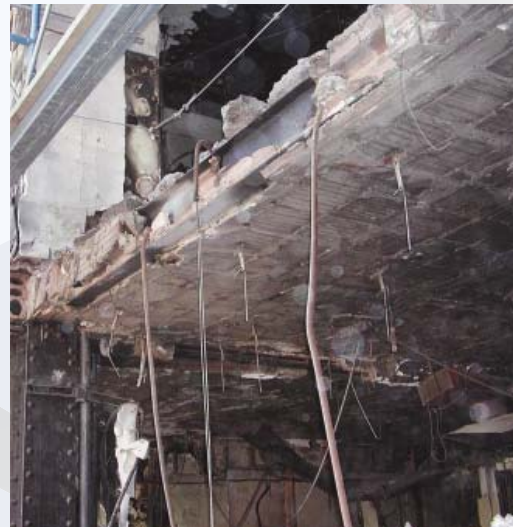
- The masonry flat arches floors of 90 West Street performed better under fire than the newer steel framed plaza buildings. *Figure 6* shows a section of floor in 90 West Street adjacent to an impact area; it was built to 1906 standards and remained intact under the fire. *Figure 7* shows a section of distorted steel framing in WTC 5; it was designed and fireproofed using 1970 standards. Both areas experienced a full fire burn.

Figure 6 – Flat arch tile floors in 90 West Street

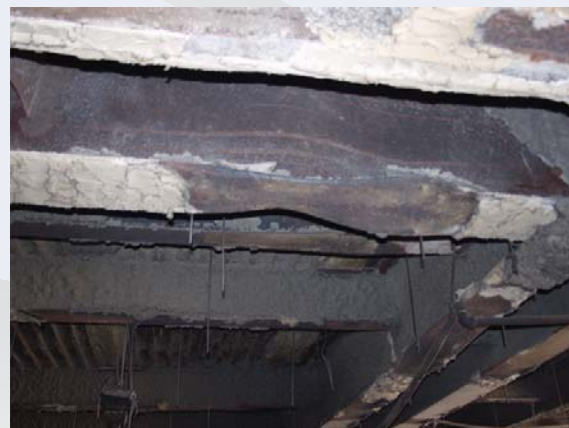
Figure 7 – Floor framing in WTC5
