ADAPTIVE REUSE INVESTIGATION OF ROOF FRAMING

Historic Bush Terminal Complex, Brooklyn, New York
By D. Matthew Stuart, P.E., S.E., FASCE, FSEI, SECB, MgtEng

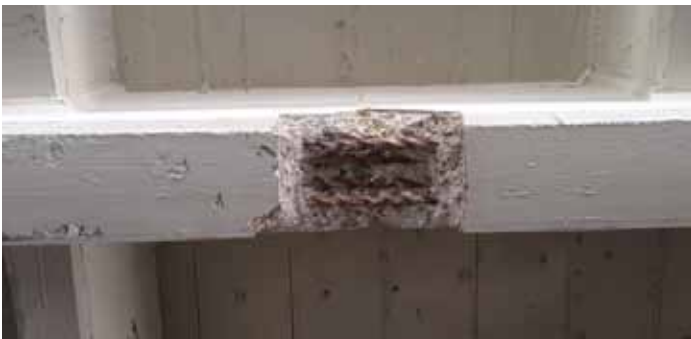
Figure 2.

Due to the lack of original structural drawings, it was necessary to field-determine the internal reinforcement of the concrete system at a typical bay in each building. This involved creating small inspection openings to expose the reinforcement at areas of the framing where removing insignificant amounts of concrete material would not compromise structural integrity (*Figure 2*). This approach, used in conjunction with a Profometer (or Pachometer), enabled the

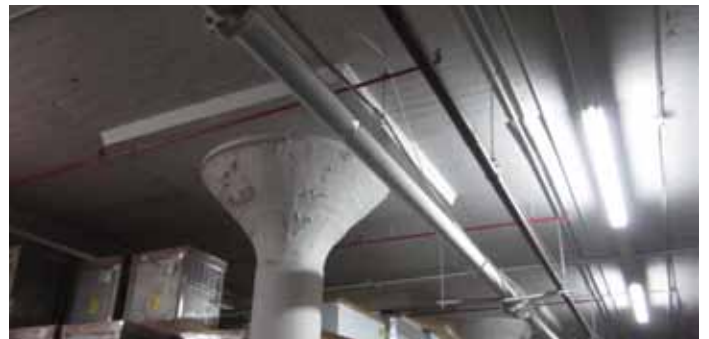
Figure 3.

All of the buildings associated with the investigation were constructed as conventionally reinforced, cast-in-place concrete structures. Building 26 was constructed as a two-way flat slab with drop panels and column capitals, which were all supported by round concrete columns (Figure 3). All of the other buildings were framed as one-way slabs, joists and beams, which were supported by either round or square concrete columns (Figures 4 and 5). The buildings varied in height from six to twelve stories, not including basements.

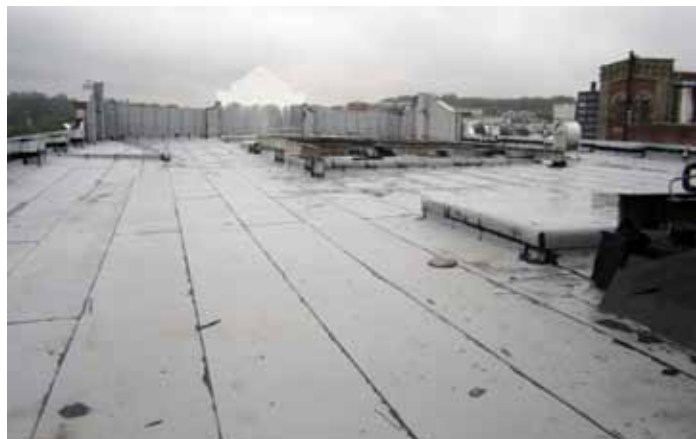
Figure 6.

In general, the existing roof structures were in good condition, with painted soffits, and supported suspended loads such as lighting/electrical, sprinklers and piping, as well as rooftop loads such as steel piping, electrical power lines and small mechanical equipment. The roofs also included skylight openings, most of which had been removed and enclosed with supplemental framing (Figure 6).

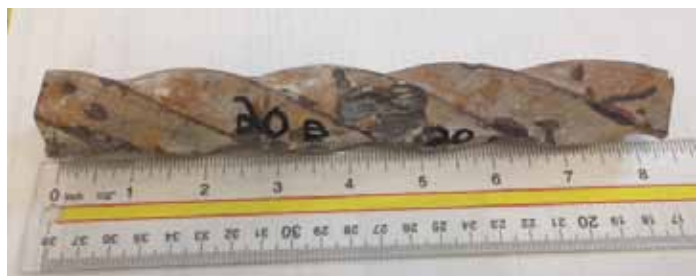
Figure 7.

Samples of the bottom flexural reinforcing of the same roof joists that had previously been subjected to exploratory demolition were obtained at the end of the members immediately adjacent to the supporting beams (Figure 7). An additional similar sample from a beam was also obtained from Building 20 at the end of the member immediately adjacent to the supporting column. The bottom flexural reinforcing sample from the flat slab in Building 26 was removed immediately adjacent to a drop panel. A reinforcing steel sample could not be obtained in Building 9

The samples were exposed using similar exploratory demolition methods with 6- to 8-inch-long samples of the reinforcing steel removed and sent to a laboratory for testing. The damaged area of the remaining reinforcing steel was not repaired, because the samples were obtained from an area of the member in which there was no positive moment, therefore the presence of the bottom flexural reinforcement was redundant. *Table 1* summarizes the test results.
