**RESTORATION OF
HISTORIC FIRE-DAMAGED
MASONRY WALLS**

By Jacob Bice, Ph.D., P.E. and Dilip Choudhuri, P.E.

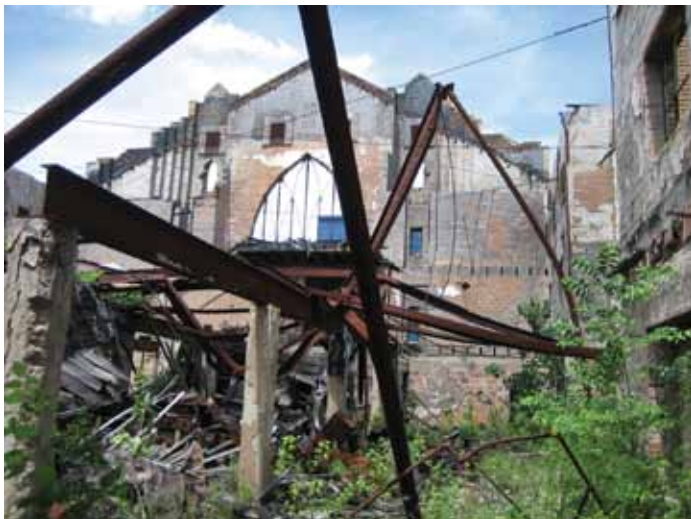
Figure 2.

The first two church buildings were destroyed, and in 1923 a third single story church building was erected. In 1950, second and third stories were added. The sanctuary was designed by James M. Thomas, a prominent architect of African American churches. In January 2005, a fire gutted the interior of the historic structure, collapsing the interior framing and roof, leaving only the exterior masonry walls in place. The structure sat exposed and abandoned until 2009, when the City of Houston purchased the property to convert the former church into a community park (Figure 2).

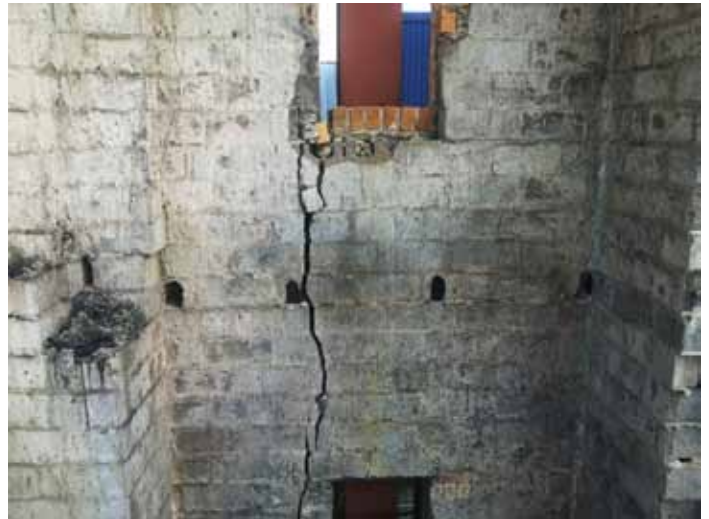
Figure 3.

Walter P Moore of Houston, Texas, was initially retained to provide nondestructive testing services to evaluate the conditions of the existing masonry walls and develop strengthening solutions as necessary. However, once an initial site visit was conducted, the first challenge of the project became evident; access into the site to evaluate the masonry walls was nearly impossible due to the collapsed framing and debris that still remained from the 2005 fire, and a large crack in the 50-foot tall brick veneer running from the base of the wall to the top was visible at the northeast corner of the building (Figure 3). The deteriorating façade immediately adjacent to the pedestrian sidewalk posed a potential risk to public safety. Before any assessment could be performed, the engineering team made recommendations to the City to immediately close the street to traffic and temporarily brace the existing walls. Emergency shoring and bracing was designed and installed within a 24-hour period to protect the public and the structure.

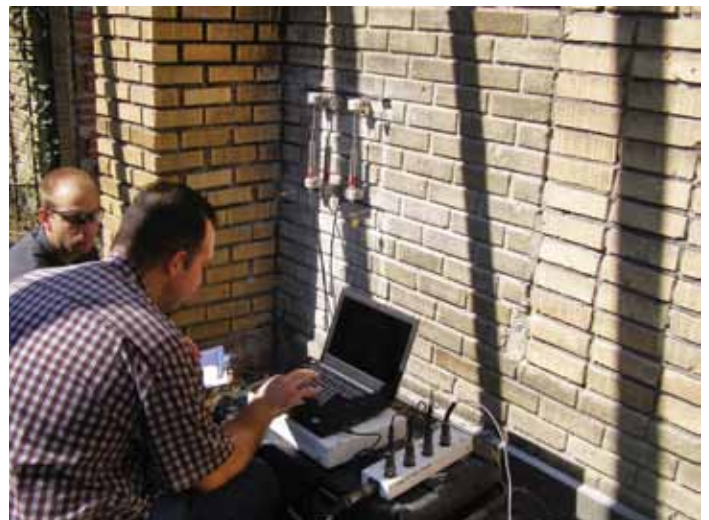
Figure 4.

Flat jack testing is a nondestructive technique where masonry compressive and shear strengths are evaluated in-situ. When measuring compressive strengths, the test consists of routing out a horizontal mortar joint to allow a calibrated steel bladder to be inserted into the joint. For shear strength tests, a vertical joint is tested. Linear variable differential transformers (LVDTs) are mounted to wall surface and the bladder then "inflated" hydraulically (Figure 4). The hydraulic pressure and displacements are measured and a stress-strain relationship is developed.

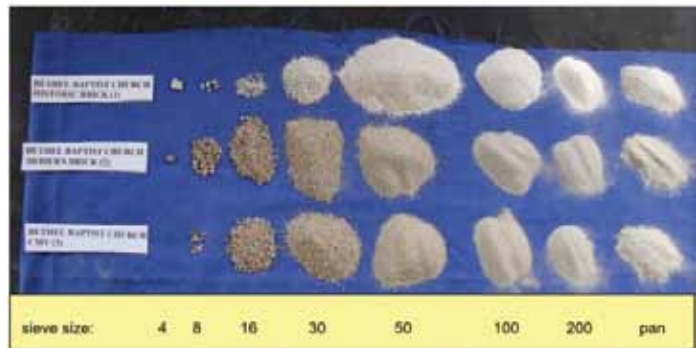
Figure 5.

In historic preservations, the designer always has to specify materials that conform to, or are as close as possible to, those used in the original construction. For this project, it was anticipated that repointing deteriorated mortar joints would be necessary, so a mortar analysis was performed. Three mortar samples were excised from the structure and analyzed by acid digestion of the binder and sieve analysis of the aggregate in accordance with ASTM C136. This analysis determined the starting proportions for the mortar specified in the design documents should be 1: 1¼: 5½ (Portland cement : lime : aggregate). In addition, the color and gradation of the mortar aggregate were determined, which allowed the contractor to closely match the original mortar properties and aesthetics (Figure 5).
