Lessons Learned

Earthquake Damage to Cylindrical Steel Tanks

By Erica C. Fischer, P.E., Judy Liu, Ph.D. and Amit H. Varma, Ph.D.

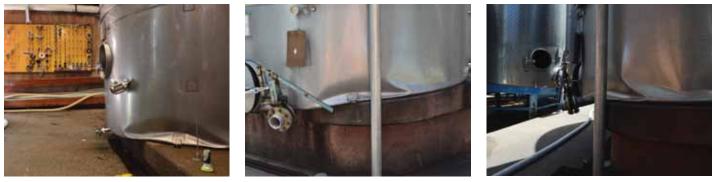
Figure 2. Damage to fermentation tanks. Examples of buckling of steel tank wall at base.

Those tanks that are continuously supported with a flat bottom are typically larger storage and fermentation tanks, and are called flat bottom tanks. The flat bottom tanks are also anchored to concrete slabs. Damage to these tanks observed after the 2010 Maule Earthquake included anchorage failure and buckling of the stainless steel tank wall. Anchorage failures were caused by insufficient edge distance, insufficient number of anchors, corrosion of the anchors, insufficient effective anchorage length, inadequate resistance of the concrete foundation surrounding the anchor, and lack of proper steel reinforcement surrounding the anchor. Anchorage failure typically occurred in conjunction with the diamond buckling shape failure of the steel tank walls. The steel tank walls buckled in two ways: (1) diamond shape buckling, and (2) "elephant foot" failure. The diamond shape buckling failure was more common in tall, slender tanks, whereas the "elephant foot" failure could be observed in the squat tanks that were full of liquid. The damage that was observed during the Napa Valley Earthquake was mainly the diamond shape buckling failure of the stainless steel wall in conjunction with anchorage failure of the tanks to the concrete base and is shown in Figure 2.

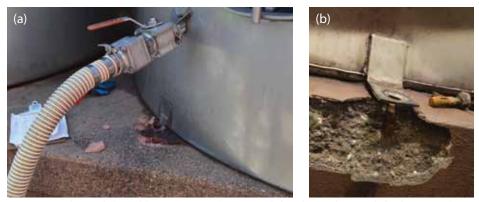
Figure 3. Anchorage failure of fermentation tanks (a) corroded anchor used to attach flat bottom tank to concrete base, (b) anchor failure at edge of concrete base support.

examples of anchorage failures observed after the Napa Valley earthquake. Figure 3a shows a corroded anchor, Figure 3b shows an anchor that failed due to insufficient anchorage length and edge distance.

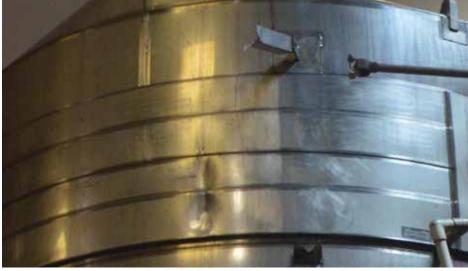
In addition to movement of legged tanks, buckling of the steel tank wall, and anchorage failures after the 2014 Napa Valley earthquake, there was also damage to the top of the steel tanks. This was not due to the suction effect as seen during the 2010 Maule earthquake, rather due to the pounding of catwalk systems against the tank walls. Figure 4 demonstrates an example of this pounding. The catwalk in this portion of the warehouse had been removed because it was damaged; however, the denting of the tank at the top is seen.

Figure 4. Denting of steel tank due to pounding of tank against catwalk.
