Parkway 301

Adaptive Reuse of the Shenandoah Building

By Eric R. Ober, P.E., S.E. and Robert P. Antes

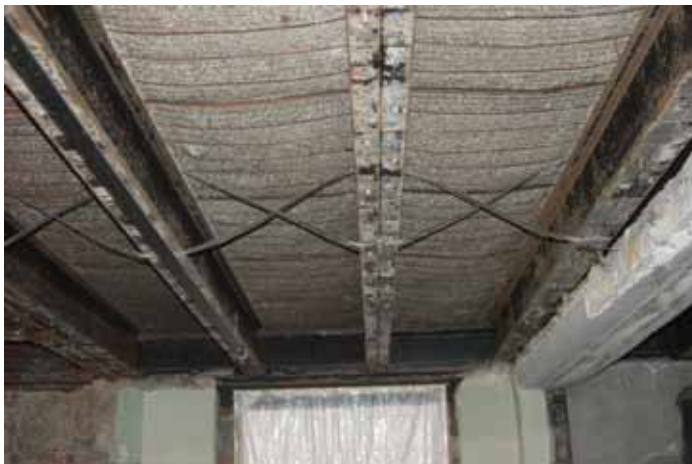
Figure 3. Draped mesh slabs and steel-lumber joists at upper levels.

The presence of some unusual structural assemblies complicated structural analysis of the existing framing. Concrete slabs and beams at the 1910 construction are reinforced with Kahn bars, developed by Julius Khan and patented in 1892. These bars were rolled in various sizes with a diamond-shaped center and horizontal projecting flat plate wings. The projecting plates were cut free from the core in a regular pattern and bent upwards at 45 degrees so that the bars served as both flexural and shear reinforcement. At the 1920s construction, draped mesh concrete slabs are supported by steel-lumber joists at close spacing, which span between structural steel girders. The name is a misnomer as there is no “lumber” in these joists. They are composed of back-to-back cold-bent C-shaped steel sections (similar to modern cold-formed steel studs) and were introduced to be a component of light framed floor systems economical in situations where wood joists were traditionally employed (Figure 3).

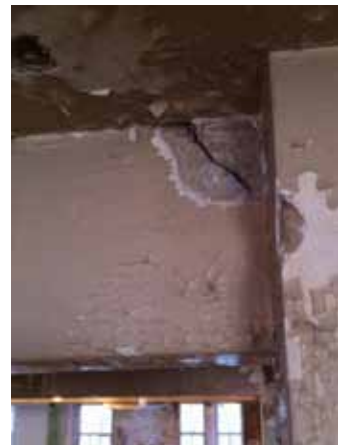
While non-structural demolition was underway, the general contractor uncovered significant hidden structural damage around the perimeter of the light well at the fourth floor. At the north side, two concrete beams, carrying heavy masonry walls and spanning the width of the light well, were found to have wide full width diagonal cracks at their supports (Figure 4). Along the west side, the upturned transfer girders were uncovered and found to be riveted built-up steel sections

Figure 4. Severely cracked concrete beam at north side light well.

installation of new steel beams below both of the damaged concrete beams. The south spandrel beam damage was the result of poor construction quality (inadequate reinforcement cover) but had not resulted in significant steel section loss for the Kahn bars. Conventional concrete repairs were implemented. The most serious structural concerns were with the three steel transfer girders.

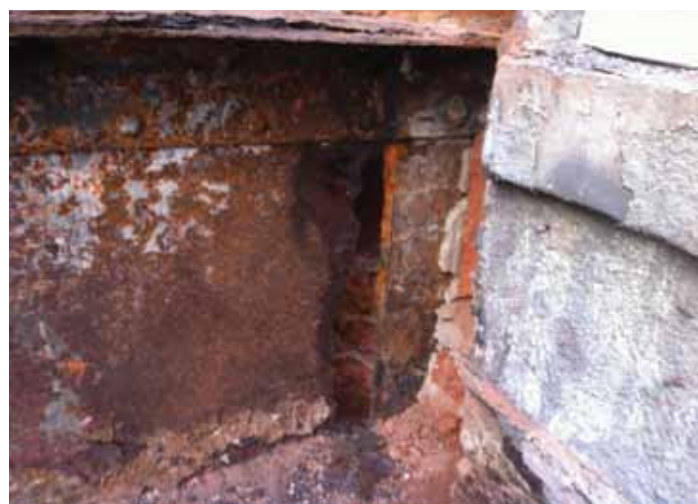
comprised of angles and plates. Where the girders penetrated the building envelope near mid-span, long-term water infiltration substantially corroded the steel resulting in areas of full section loss of the web and partial section loss of flanges (Figure 5). Along the south side, the soffit of each of the concrete spandrel beams across the width of the light well and into the adjacent bays had severe spalling and moderate reinforcement corrosion. Steel lintel angles over the punched window openings in the south wall were severely corroded.

The contractor halted construction while the newly exposed existing conditions were evaluated by the structural engineer. Each of the conditions was determined to require repair intervention. The need for temporary shoring was unclear since there was no visually apparent deflection of the structure; however, the steel girders were believed to be marginally stable based on the extent of corrosion damage.

Figure 5. Severe deterioration of steel transfer girder.

The range of steel girder repair options considered included repair in place, elimination of the transfer by adding new columns to new foundations, and replacement of the transfer girders inside the enclosed portions of the building. Repair in place was eliminated from consideration early. The original ill-conceived design concept of penetrating the building envelope could not be easily made more reliable. Extending new columns to new foundations was technically feasible but architecturally unacceptable in the first floor retail space. Thus the last option, new transfer girders inside the building, was implemented. At Parkway 301, substantial clear headroom was available below the second floor to accommodate the new girders. The final repair design consists of new structural steel transfer girders spanning directly below and parallel to the original transfer girders above, maintaining the original gravity load path to the foundations. Work included the following:

- Erecting a pair of parallel wide flange girders below each transfer girder above.
- Adding steel sections and post-installed anchors around the existing columns to receive the new girders.
- Adding new columns to extend the transferred columns down to the new transfer girders.
- Modifying the existing transfer girders to retain the interior portions (intimately anchored with the existing steel columns above) and eliminate those portions outside the building envelope.

- Partially pre-loading the new girders by hydraulically jacking prior to releasing the shores.
