STRUCTURAL FAILURES

Snow Load Collapse of a Manufacturing Building in Oregon

By Dilip Khatri, Ph.D., S.E.

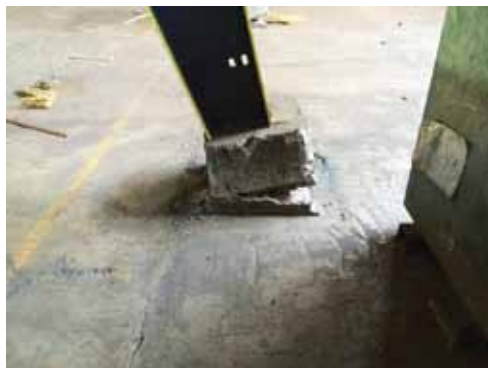
Figure 2.

of this steel moment frame facility to collapse. Fortunately, this failure occurred in the early hours of the morning and no fatalities were experienced. *Figures 1 through 5* show the extent of the damage and loss of inventory. The building was constructed in the 1940s and comprises approximately 400,000 square feet of space, which was designed through successive permits over several decades. In its entirety, the design of this facility ranges from the 1940s-1960s vintage, and remained in operation until the 2014 storm event.

As can be observed from *Figures 1 through 5*, and after doing a collapse load analysis, the reasons for the failure are attributed to several causes:

- 1) Excessive snow/ice loading due the storm event that exceeded the capacity of the steel moment frame system.
- 2) Plastic Hinge Failure at several locations in the steel moment frame system, including compression flange failure of the top chord of the truss.
- 3) Footing failure at the base reaction.

The structural analysis of the steel moment frame system shows the collapse load is approximately 5 to 7 psf of snow/ice load. This varies somewhat based on the assumption of load distribution. If we assume uniform loading, then the answer will be slightly different from unbalanced snow/ice loading because the load distribution changes the stress concentration points. *Figure 6* shows the structural model using RISA 3D and the resultant moment diagram. However, the conclusion from the structural analysis definitively shows that the analytical collapse load agrees reasonably with the estimated ice load at the approximate time of failure during the storm event. The structural analysis also confirms that the collapse load is far below the required design requirement of 20 psf as a minimum snow load capacity, and well below current code requirements, which would exceed 50 psf in certain areas of Northern Oregon.

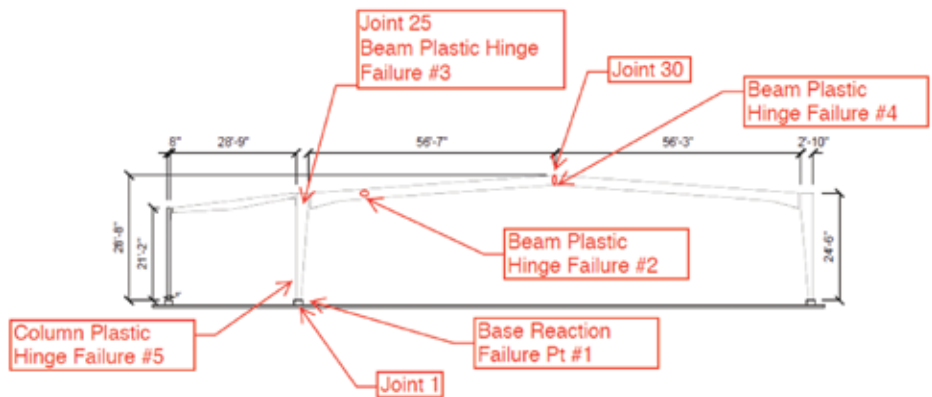
Figure 6.

can move in three translational directions (x,y,z) and this is very difficult to determine with crude measurement devices such as a plumb bob, laser level, or visual means. The alignment survey of this facility showed certain frames had serious misalignment issues that render them potentially unsafe. This was further compounded by the fact that the collapse load analysis showed the failure deflection was less than 2 to 3 inches on certain moment frames. A low collapse load capacity, which translates into a low deflection tolerance, means that these structural frames are a collapse hazard in storm events and must be retrofitted/repared.

The use of Forensic Analysis combines the analytical tools of structural modeling with the physical survey tools of measurement devices that can assist structural engineers to better evaluate such failures and prevent new ones from occurring. In this case, the owners are exploring several retrofit schemes to repair the remainder of their facility to retain their occupancy/use, and maintain the safety of their employees. ■
