# Restoring the FOUNDATION OF JUSTICE

By Thomas E. Forsberg, P.E.

**T**he foundation of Justice in the County of Lancaster, Pennsylvania is once again stable and poised for another century of oversight. Justitia (the Statue of Lady Justice) is re-perched on a new structural framework atop the County courthouse dome.

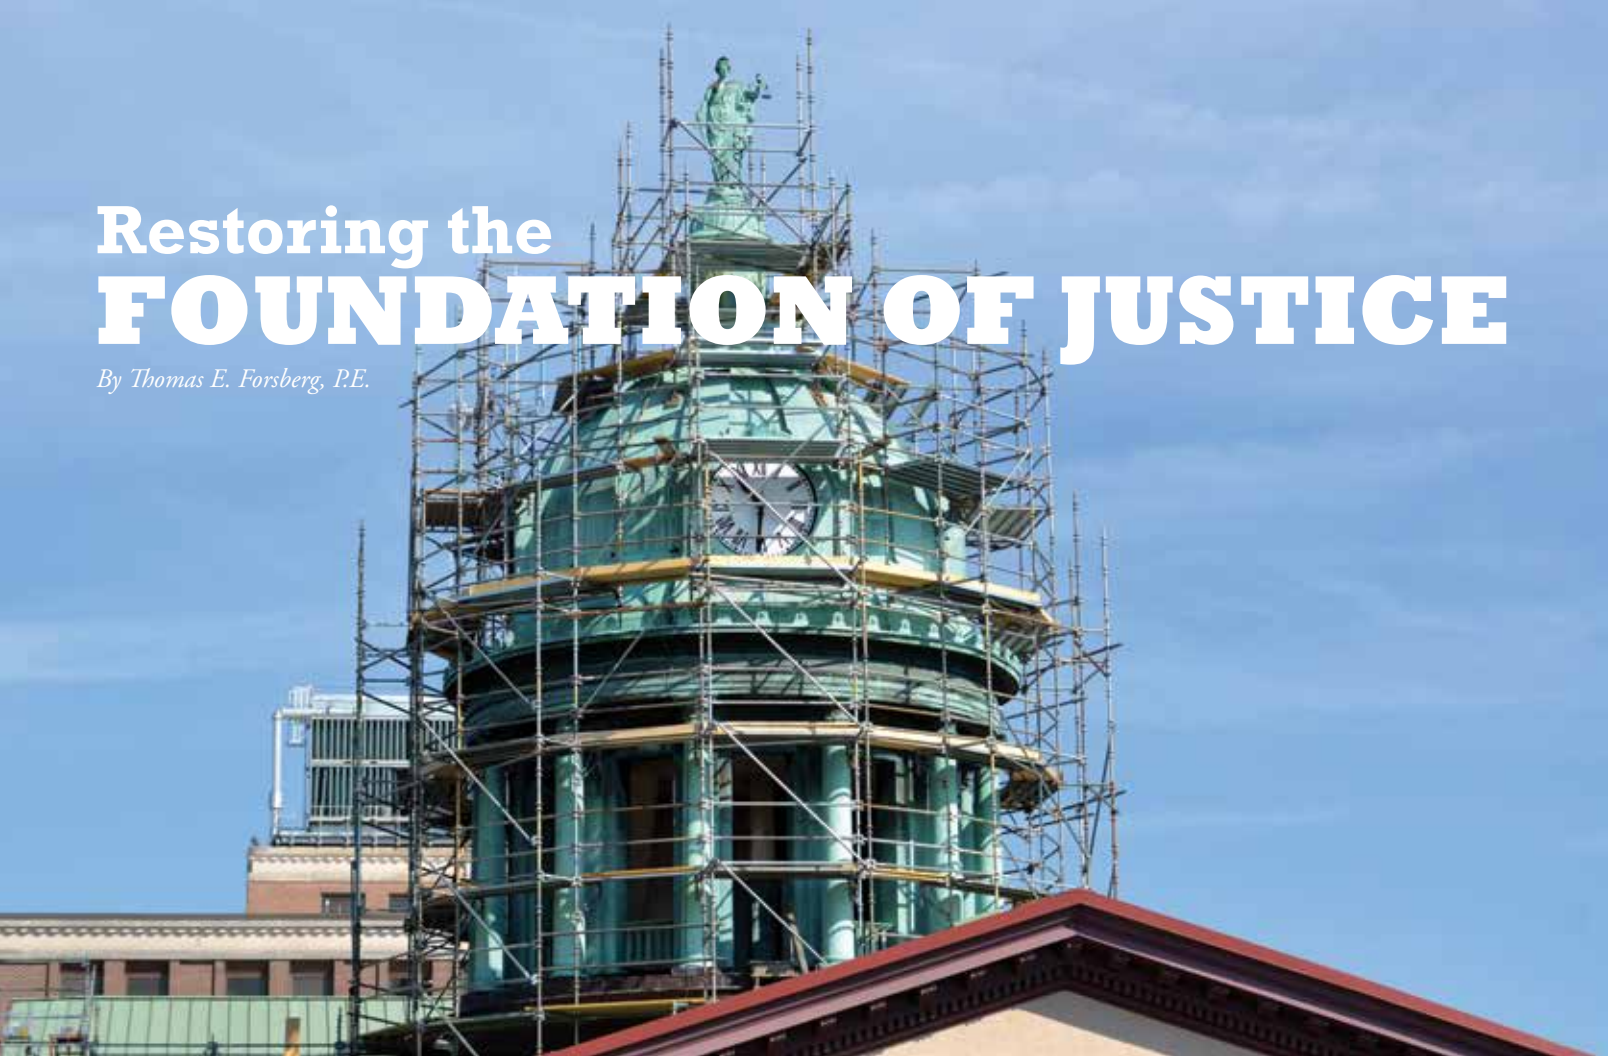
Figure 1. Dome shrouded in a scaffolding tower.

Further, the County decided to remove and restore the Statue. The current copper version, installed in the 1920s, is the second Statue to grace the top of the courthouse dome; the original was made of wood (*Figure 2*). This work required a scaffold tower around the dome reaching nearly 140 feet above the sidewalks and streets below. Fortunately for the team, the scaffold would facilitate the examination and subsequent restoration work (*Figure 1*).

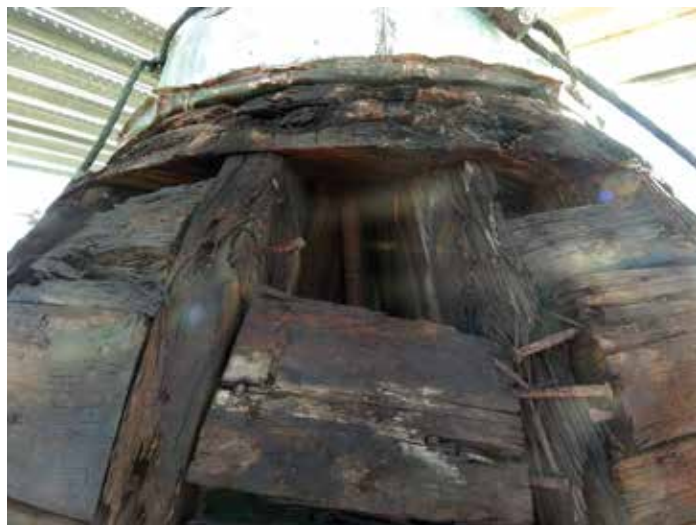
The evidence from several probes overwhelmingly showed that the dome structure had been compromised. Wood decking was rotted so severely that it could not retain the fasteners that held the copper roofing on the dome nor maintain its connection to the structural framework.

Figure 3. Conditions of wood rot at top of dome structure, underneath statue.

Removing the Statue happened concurrently with the examination and evaluation of the dome. In November 2014, the Statue was secured into a steel-framed lifting cage, hoisted from atop the dome, and transported to an off-site studio to begin its makeover. With the Statue out of the way, the upper reaches of the dome structure were exposed and accessible for examination. The final evidence required to conclude the examination was observed, and corrective work was recommended (Figure 3).

Given the conditions of the roofing system and structural deficiencies, there was no choice but to undertake a wholesale restoration: remove all the copper, repair/replace all of the damaged structural framing, replace the wood deck, and install a new roofing system.

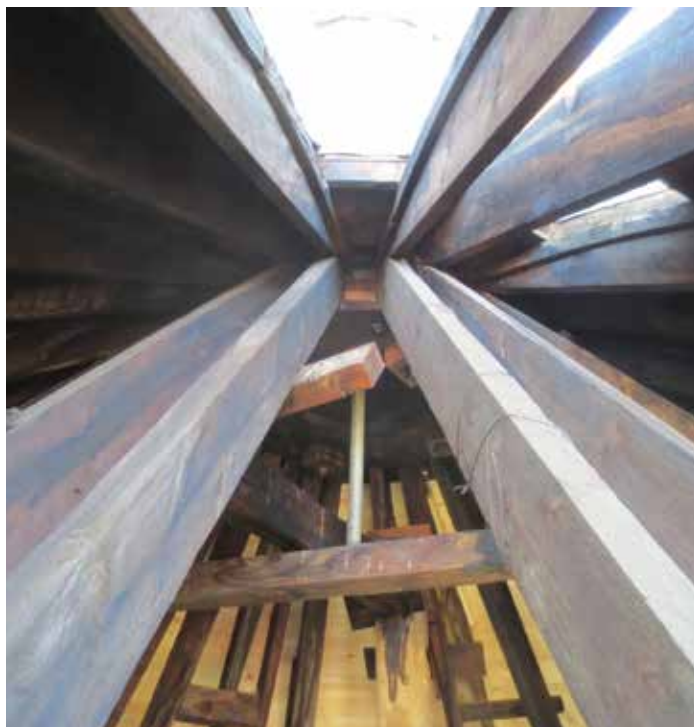
Figure 4. Looking between dome truss bays at the good condition of existing truss framing.

The main dome trusses – there are twenty-four in all – were assembled using several pieces of heavy-timber framing. Despite the poor conditions of the wood decking, the underlying structure was largely unaffected and in very good condition (Figure 4, page 35). There were still a number of repairs to be made on a localized basis, but no primary structural elements needed to be removed and replaced in entirety.

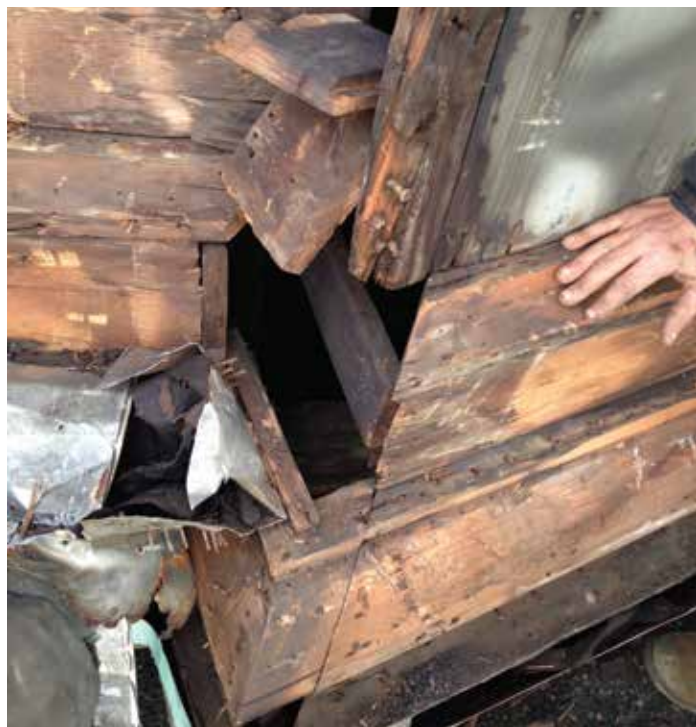
Figure 5. Conditions of wood rot at clock base.

There are four clocks on the main dome, one facing in each of the four cardinal compass directions. Each clock stands proud of the main dome surface and is covered on the top and sides by a dormer-like structure. These elements suffered significant damage from water infiltration, particularly the structural framing under the clocks (Figure 5, page 35) and the main dome compression ring that supports the dome trusses.

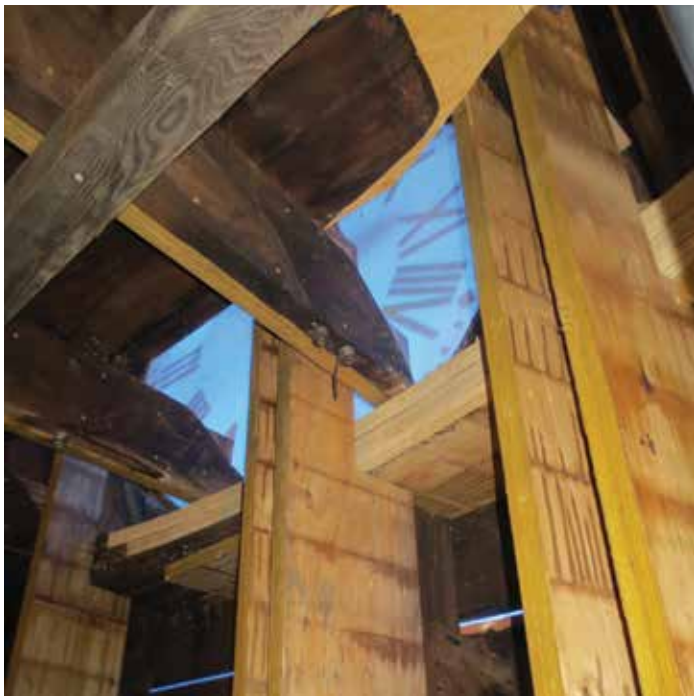
Figure 6. Transfer posts to facilitate removal and replacement of compression ring.

The compression ring, constructed from multiple layers of heavy timber with offset splices and thru-bolted connections, is critical to the structural integrity of the dome. Repairing it meant removing the rotted wood and rebuilding entire segments. Of primary concern was the relief and transfer of dome truss loads around the damaged portions of the ring. This required a series of transfer posts connected to the structural framing above and below the ring. These elements facilitated unfettered access to the ring for corrective work (Figure 6).

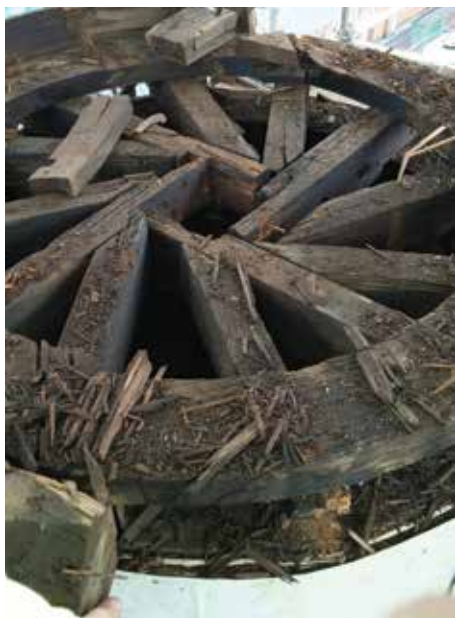
Perhaps the worst conditions occurred at the top of the dome. The compromised condition at the base of the Statue allowed years of water intrusion. The wood framing quite literally crumbled to shards as it was removed. However, enough integrity remained to allow the team to document geometry and element sizes to ensure reconstruction occurred in a like manner. Figure 7 illustrates the condition of the original wagon-wheel

Figure 7. Existing condition of wagon-wheel base framing.

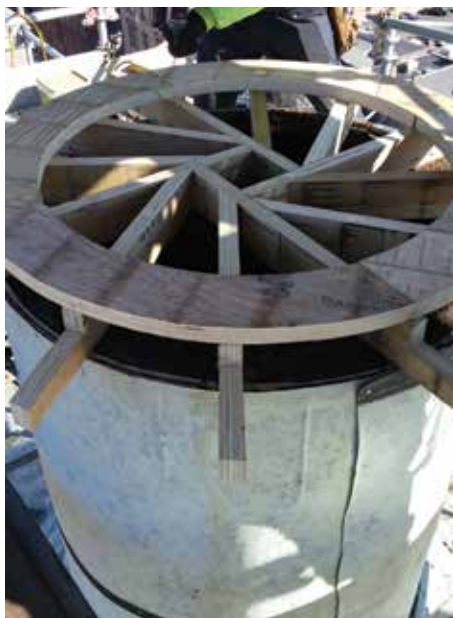
Figure 8. Rebuilding the wagon-wheel base.

frame underneath the dome cap, and Figures 8 and 9 show its reconstruction progress and the new framework to support the Statue.

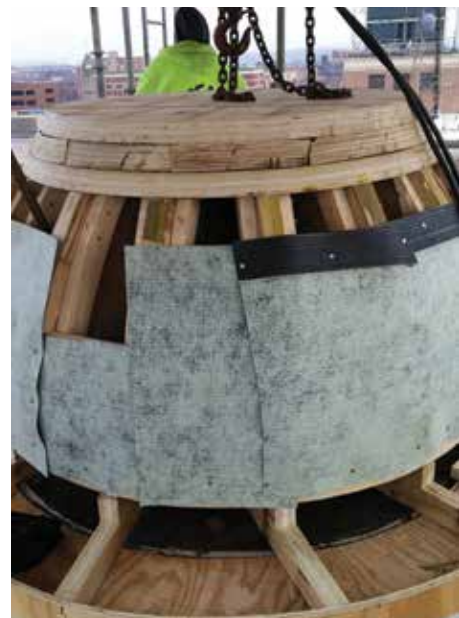
Figure 9. Rebuilding the cap structure which supports Lady Justice.

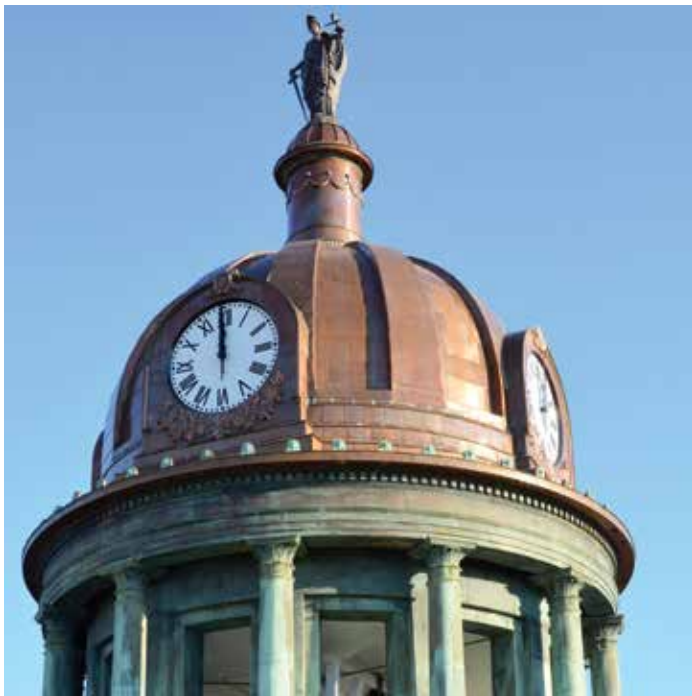
Figure 10. Completed restoration of the Lancaster County Courthouse Dome.

Restoring the dome was accomplished in the manner that every owner desires: ahead of schedule, under budget, and without any change orders. The process of real-time tracking of work and budget allowed the County to perform additional maintenance and repairs on portions of the structure that were not part of the original scope. In the end, this piece of the County's history is ready for another century of service (Figure 10). ■
