# STRUCTURAL TESTING

## Magnetic Flux Leakage for NDE

This article is a follow-up to one of the precast, prestressed thin slab parking garage structures described in *Precast, Prestressed Thin Slabs in Parking Garage Structures*, published in the January 2016 issue of STRUCTURE magazine.

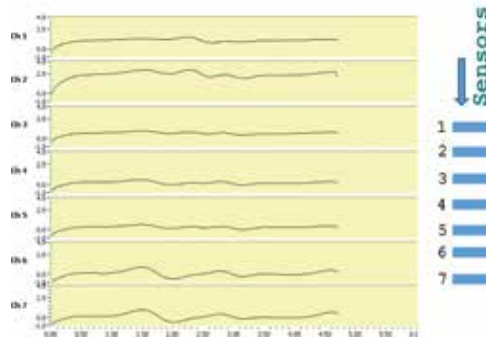
Figure 3 illustrates representative laboratory MFL signatures from multiple side-by-side sensors (sensors 1 to 7 covering a width of 8 inches) for steel rebars and strands with varying cross-sectional area loss. These strands and rebars were located a distance of 5.5 inches from the top surface. Figure 3 indicates the scan length, in feet, and signal amplitude, in

volts, along the horizontal and vertical axes, respectively. Note that the larger amplitude MFL signals from sensors 6 and 7 indicate a complete fracture in the lowest bar shown in Figure 3.

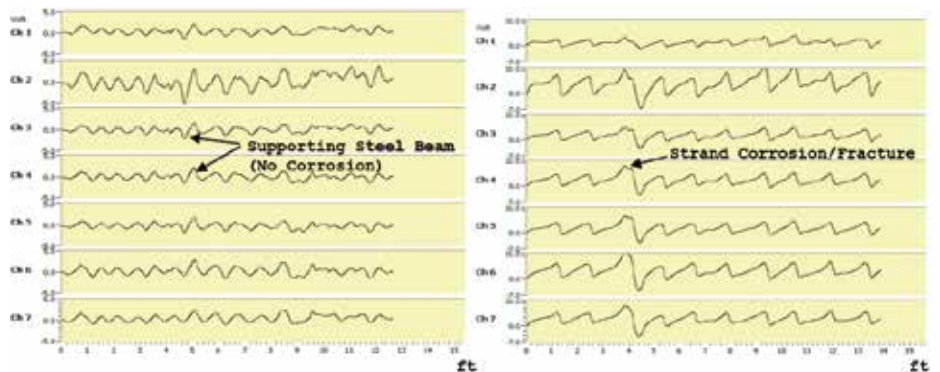
Figure 4.

The field testing was preceded with an additional verification test on strands with known conditions (i.e., with and without corrosion) at the second framed level of the garage structure in which the precast slabs were visible from the level below. Figure 4 shows side-by-side representative graphs of the MFL tests for these strands, with the resulting data (i.e., amplitude vs. scan data position) indicating the strand conditions. The multiple peaks and valleys seen in the graphs are from the responses of the sensors due to the interference effects of crossing rebars in the concrete topping. The higher amplitude signals in the graphs are associated with the location of the steel beams supporting the precast slabs.

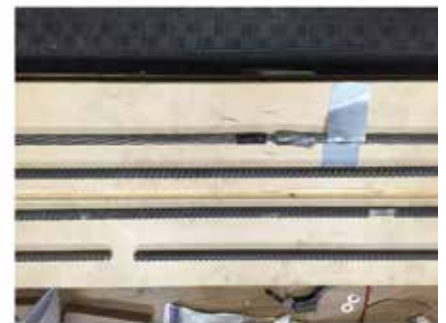
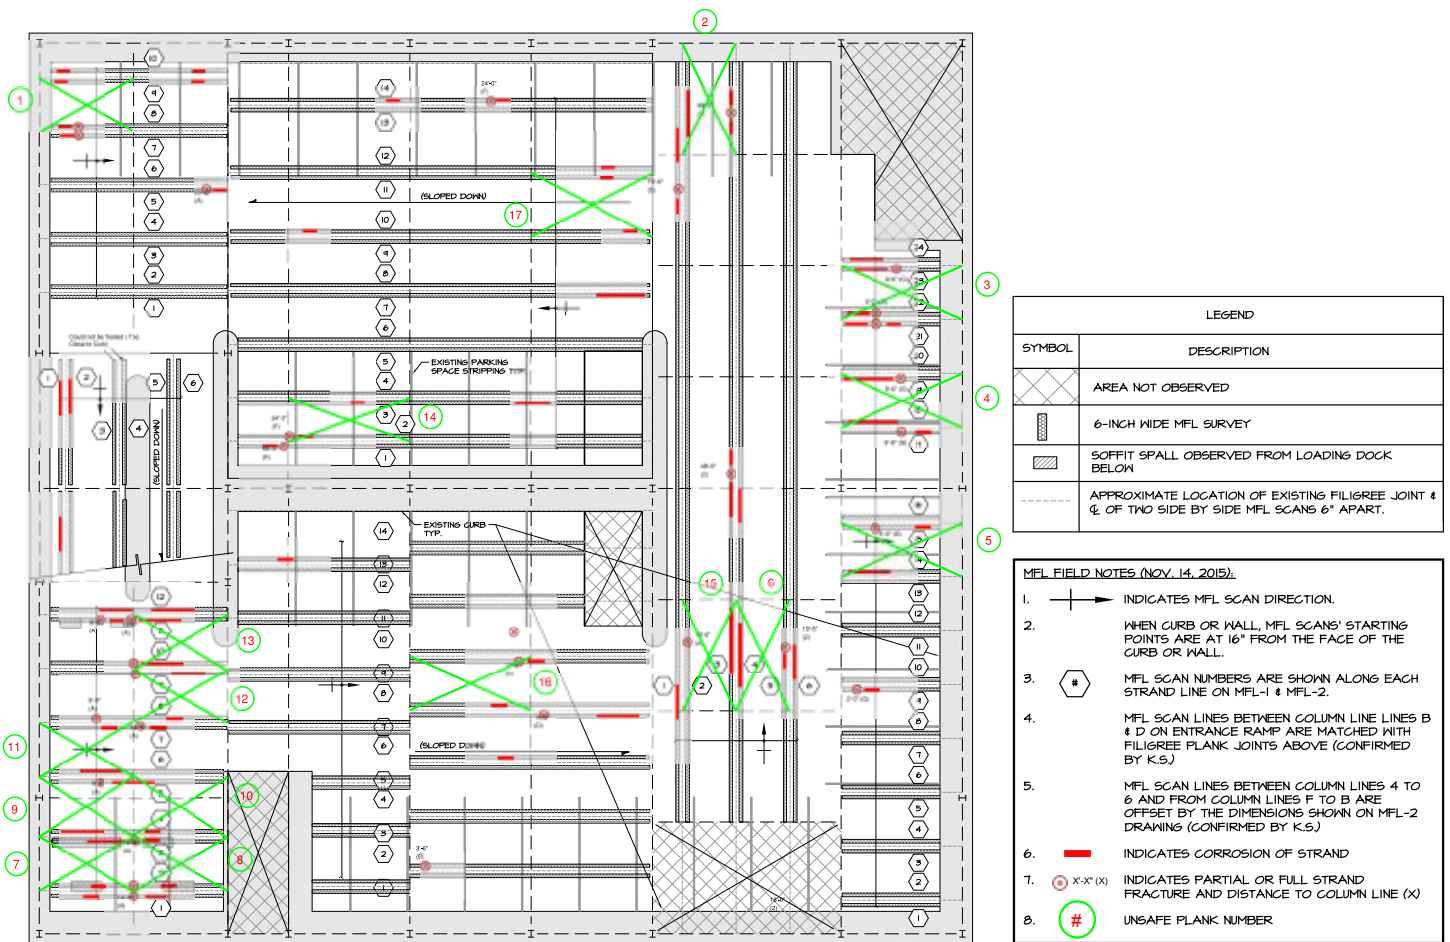
Figure 5.

The MFL test at the first framed level of the parking garage structure included a total of 106 scans along the edges of adjacent precast slabs. These tests were completed over a period of 1.5 days. The use of the MFL system in the garage structure allowed for a successful detection of corrosion in multiple areas. The MFL test scan locations, corroded strand lengths, and strand fracture for each strand were marked on the plan to aid the condition assessment of the garage deck (Figure 5, page 22).

As indicated in *Figure 5*, there is evidence of local and extended corrosion, as well as a partial or full fracture of the strands within the precast slabs for the first framed level of the parking garage structure. In total, the MFL test results indicated 37 partial or full strand fractures and 81 areas of local or extended strand corrosion. Using the results from the MFL tests, appropriate temporary support methods were designed and implemented by Pennoni Associates to extend the service life of the structure.

Fortunately, the majority of the unsafe plank locations identified by the MFL survey were above these same limited-access areas, which made it possible to install shoring beams rather than having to block off the same planks above from further vehicular access. The method of installing the shoring beams followed the previously established criteria used in the upper levels of the garage, which minimized the impact of the repairs on the operation of the facility. Unsafe areas that were not accessible, including parking spaces and a small area of the driving aisle, were permanently blocked off from further vehicular access via barricades that were attached to the concrete topping.

The design of the shoring beams was based on a tributary width of 2 feet, which corresponded to the strand edge distance from the plank joint of 3 inches and one-half of the uniform spacing of the strand within the plank of 18 inches on center, on each side of the plank joints. This allowed for the shoring beams to be located near the
