Repair of Log Cabins

By Paul A. Gossen, P.E., FASCE

The Log Cabin in Roxbury, New York

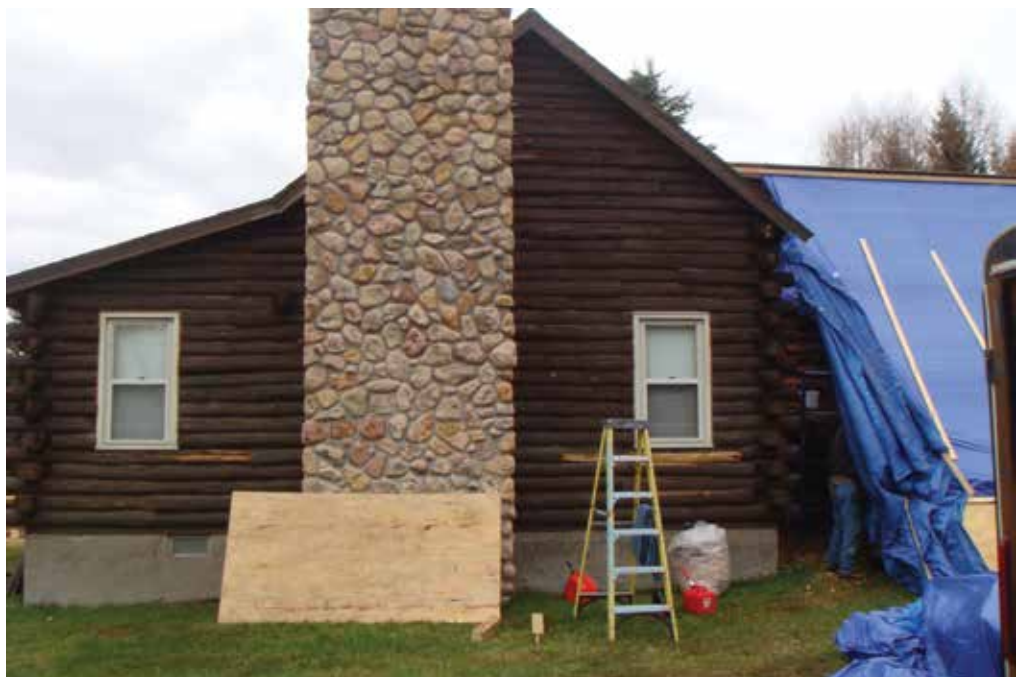
Figure 1. Elevation of deteriorated log wall.

A log cabin in Roxbury had a dry rot problem. The logs on three walls had lost 50% of their section due to dry rot (Figure 1). The decay was on the exterior face of the wall, through half the width of the logs. The logs were seven inches wide and six inches high (Figure 2).

The log surface was highly irregular and had horizontal splits. An attempt had been made to seal the gaps with silicone sealant. The extent of the damage was such that the structural integrity of the building was in question. This structure, located in the Catskill Mountains, must support code loads

The solution consisted of removing the decayed wood and reinforcing the walls, which are 8 feet high, with pressure treated 4x4 posts and then covering the wall with a new exterior facing (Figure 5, page 38).

The posts were designed to carry the roof load. They also served as stiffeners for the remainder of the log wall section, since approximately 50% of the 7-inch log width was rotted, leaving only 3½ inches of sound log material. The remaining 3½ inches stacked log sections formed a slender wall that required bracing. The posts then would be covered with a new exterior sheathing and log siding.

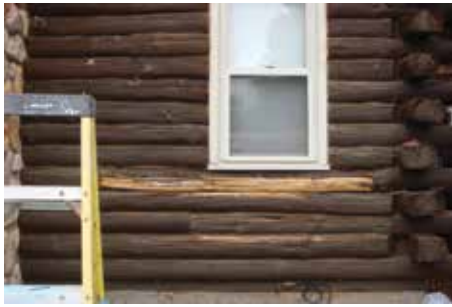
Figure 2. Close-up of rotten logs.

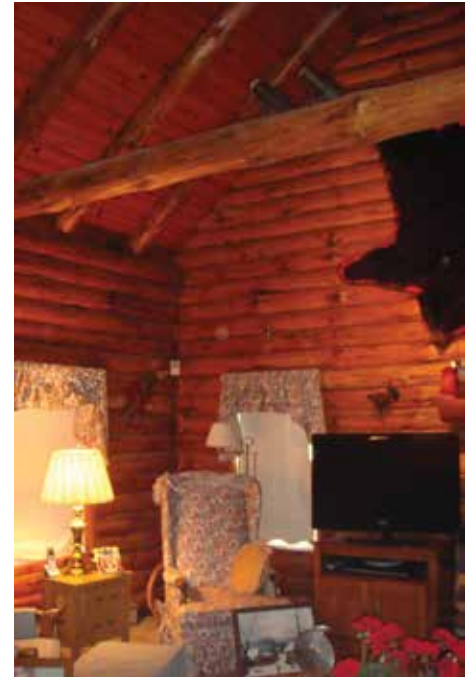
based upon a ground snow load of 70 pounds per square foot (psf). As a result, the roof, as well as the log walls, must support the roof dead load and snow load, a total of 60 psf. The interior was not affected by the decay and exhibited the beautiful texture and wood finish that makes these structures so appealing (Figure 3).

Figure 3. Log cabin interior worth saving.

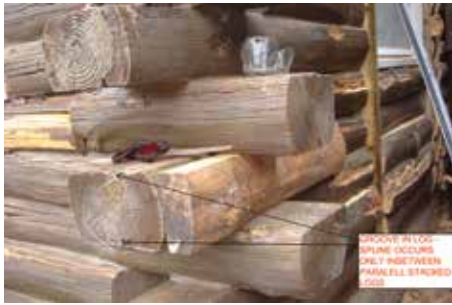
The shaping of sections for a tighter seal in some designs, however, creates some unintended consequences that jeopardize the life of the logs. These horizontal mating surfaces result in a tighter seal but do not drain rainwater that runs down the facade. Water can enter the joint and finds its way into the groove of the spline, causing dry rot of the log.

The logs were shaved flat on the top and bottom with a groove in the center that received a continuous spline (Figure 4, page 38). This spline has no structural significance and is used solely to provide an air seal between the logs. Also, 10-inch vertical spikes placed alongside the groove at approximately 2 feet on center, tied the logs together. A close examination showed that the sill plate, on which the logs rested, and the top plate that supported the rafters, were in good condition.

Figure 4. Log profile; note reveal for the spline.

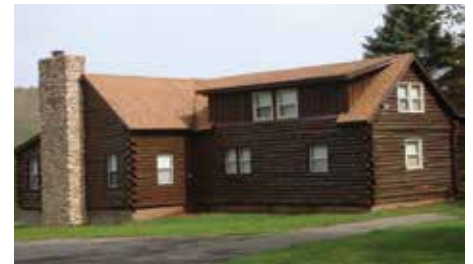
Figure 7. Log cabin after wall repair.

The sheathing was screwed to the stud, and Tyvek protective barrier house wrap was stapled over the sheathing. New log siding was fastened to the wall as an exterior finish. The siding matched the old log appearance and was stained to match its color (Figure 7). The repaired wall ended up being 2½ inches wider than the original, and thus, new windows and doors had to be fitted with extension jams to match this new wall width.
