STRUCTURAL FORENSICS

Lessons Learned from the Bay Bridge Bolt Failure

By Thomas Langill, Ph.D.

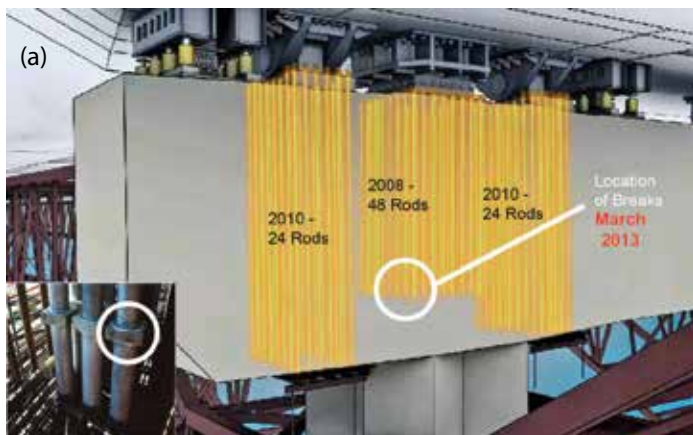
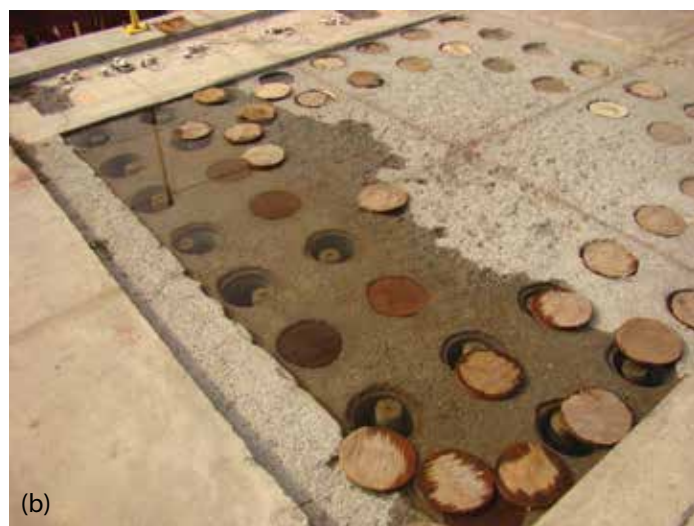
Figures 2a and 2b show the placement of the anchor rods used for the shear keys when the bolts were first put into place in the Pier E2 location. The anchor rods were installed into the shear keys in November 2008, and grouting of the rods began in January 2013. However, these anchor rods were not tensioned until March 2013 because they could not be installed until the superstructure of the bridge was put in place. Because of this, the very bottoms of the anchor rods were purposely damaged to hold the nuts until they could be properly tensioned. The top of the steel pipe sleeve assemblies holding the shear key rods were exposed to the environment

Figure 2 (a and b). Placement of the anchor rods used for the shear keys when the bolts were first put into place in the Pier E2 location.

during the period before the superstructure of the bridge was installed. This left little clearance between the top of the rods and the bottom of the bridge.

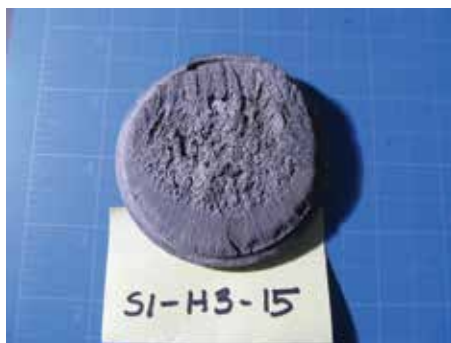
Although these anchor rods were no longer in service, their failure raised major concerns about the long-term performance of the remaining A354BD rods throughout the bridge. The fracturing (Figure 3) resulted in three investigations focused on metallurgical testing and failure analysis on two of the fractured rods from the shear keys. It was determined the failure of the rods was a result of hydrogen embrittlement. As a result, the California Department of Transportation undertook a second testing program to further examine the cause of failure and to evaluate the remaining A354BD rods throughout the bridge.

Figure 3. Fracture surface of 2008 shear key rod.

The investigation continued with a visual inspection of two failed rods and showed the presence of Denso paste, which is part of the Denso Tape System on the rods that provide extra corrosion protection. The threads and fractured surfaces had remnants of this paste as well as the grout used during installation. This visual inspection revealed that the surface was brittle, and that cracks had developed, grown, and spread throughout the rods progressively. This process exceeded the rod's structural capacity, ultimately resulting in the final failure.

After the visual inspection was complete, the investigation moved forward by using a scanning electron microscopy (SEM) examination of the surfaces across the rod diameter. The results showed intergranular fracture morphology near the threaded roots. As the crack progressed, the morphology became more mixed, causing a sudden fast fracture when the crack reached a critical size, meaning the rod could no longer carry the applied load.

The conclusion of this study stated that the cause of this failure was hydrogen embrittlement combined with the applied load exceeding the susceptibility of the rod material. The steel rods complied with the proper specification, A354BD, but the microstructure

was not uniform. The microstructure inhomogeneity resulted in low toughness and marginal ductility, causing the rods to be susceptible to hydrogen embrittlement.

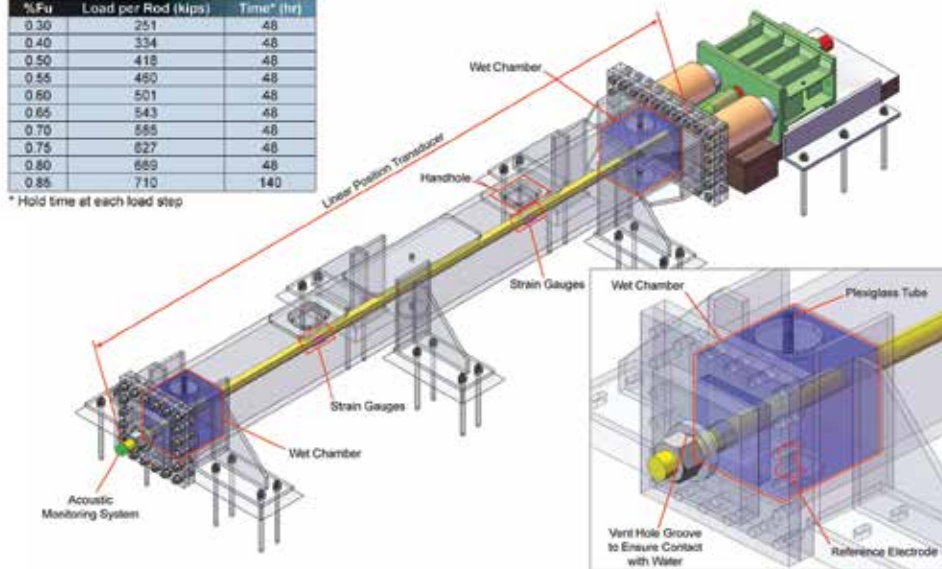
Figure 4. Townsend test schematic.

After these tests resulted in normal readings, the Townsend Test for Stress Corrosion Cracking (SCC) was performed on the full-diameter rods obtained from the various groups of previously selected rods. In this test, the tensile load was increased very slowly (in steps) until a threshold load level was established for the onset of cracking due to hydrogen embrittlement (Figure 4). This slow increase was essential because of the required time it takes for diffusion in detecting the

- The 2008 rods failed because of hydrogen embrittlement at the same load (0.70 F_u) that led to failure on the bridge with similar fracture characteristic. (This confirms the Townsend Test duplicates the actual performance of the rods.)
- The fracture surface on the rods showed where the initiation of the crack occurred. As the cracks progressed, the fractures changed from intergranular to cleavage and finally to ductile fractures that took place on the opposite end of the initial cracks. (These fractures were evident in all the 2008 bolts examined.)
- After testing the remaining rods, it was determined that all had threshold loads greater than their design loads, indicating they were not susceptible to hydrogen embrittlement.
