# LESSONS LEARNED

## Condensation Related Failure of Wood Roof Sheathing

By Zeno Martin, P.E., S.E. and  
Wade Vorley, AIA, RRC

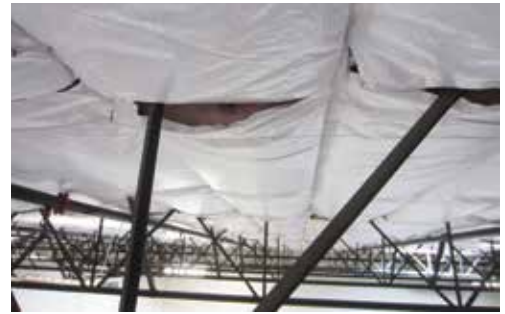
The roof is insulated with R19 fiberglass batt insulation placed below the OSB and between the 2×6 purlins, with a white vinyl vapor retarder stapled to the purlins below the insulation (Figures 1 and 2). The vapor retarder was not continuous and was not sealed around penetrations. The authors have studied similar warehouse buildings in Washington, Oregon, and California where the buildings are only provided with minimal heating systems due to their more temperate climates. Reno, however, can become frigid in the winter and more heating is required for interior comfort. This building is heated with eight direct-fired

Figure 1. Typical wood roof assembly.

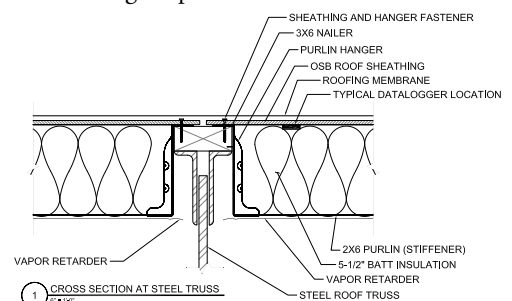
Figure 2. Typical vapor barrier discontinuity at the plane of steel truss web members.

In this particular building, the discontinuous vapor barrier allowed the relatively warm, moist air to contact the cold OSB surface, leading to condensation. In theory, a vapor barrier with low permeability that is sealed at all penetrations can act as an air barrier, preventing air movement to the underside of the wood deck. However, in practice, with the vapor barrier intersected by thousands of steel angle truss web members, there are too many discontinuities and penetrations to create an effective seal. The moisture added to the air by the direct-fired heating units, which increased the dew point temperature of the air and increased the severity and duration of condensation conditions, made condensation worse. Once the OSB is wet, the fiberglass batts adjacent to the OSB, as well as the vapor barrier, serve to trap the moisture and inhibit drying.

The methods of reducing condensation considered were: 1) reducing the amount of moisture in the interior air that is directly adjacent to the wood deck and 2) increasing the temperature of the wood deck. Reducing moisture in the air at the deck can be achieved by sealing or reinstalling the vapor retarder (which was impractical) or by making changes to the heating and ventilation system. Increasing the temperature of the OSB sheathing requires the installation of rigid insulation above it. Installation of rigid foam insulation on top of the wood roof sheathing was recommended by the authors but was ruled out due to cost.

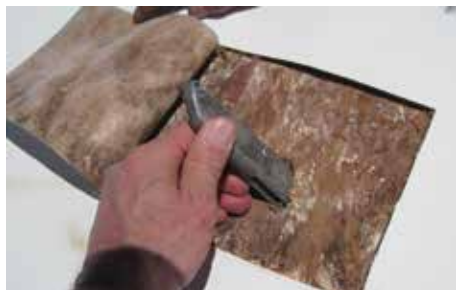
In 2012, during a tenant improvement, wet and decayed OSB roof sheathing was discovered. A subsequent investigation by others found that vast areas of the OSB had high moisture content and specific locations had advanced wood decay, causing localized loss of structural capacity (Figure 3).

*Figure 3. TPO roofing cut open. Decayed OSB roof sheathing cannot resist penetration. Courtesy of Ray Wetherholt.*

A repair was implemented to restore the vertical and lateral load carrying capacity lost due to the decay of the wood roof sheathing. New plywood was placed over the existing OSB. The existing OSB was retained in place and allowed to dry. A new roofing membrane was then placed over the plywood. This was the preferred construction approach by the owner to minimize disruption to the tenant spaces below. An evaluation of the existing structural elements found that they had reserve capacity to accommodate the weight of the added 1½-inch thick plywood roof sheathing and its fasteners. Screws, No. 8 x 2½-inch long (WSNTL from Simpson Strong-Tie), attached the new plywood to the existing framing and were designed to maintain diaphragm capacity. In this repair method, the plywood overlay only treated the symptom, so changes were also made to address the cause of the condensation.

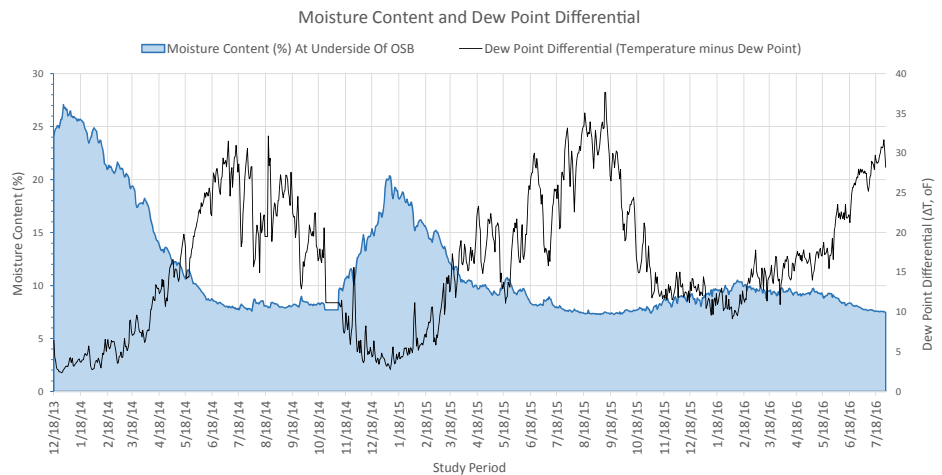
The graph in Figure 4 shows a summary of overall trends over the three years. Data in Figure 4 shows an average value from the six sensors located on the underside of the OSB. The moisture content of sheathing in specific locations reached over 35

percent and lasted for a longer duration than indicated by the average. *Figure 4* also shows a line defined as the “dew point differential,” which is the air temperature at the underside of the OSB roof deck minus the *dew point* temperature of the air at the same location. The dew point is the theoretical temperature at which moisture in the air condenses into liquid water. Condensation occurs when dew point differentials approach zero. The graphs illustrate that the incidence of higher moisture content in the OSB correlated with low dew point differentials. The growth of decay fungi in wood products can be prevented by maintaining a moisture content of 20 percent or less. Monitoring data shows periods of time in the winter months where moisture contents of the OSB exceed 20 percent.

*Figure 4. Approximate 3-year summary of moisture content and dew point differential conditions at the underside of the OSB roof deck.*

summer of 2015, the direct-fired heating units were removed and replaced with indirect-fired heating units. The new heating units use a heat exchanger and exhaust the natural gas combustion byproducts, including water vapor, to the exterior of the building to maintain a dryer interior environment. As shown in *Figure 4*, this change significantly reduced the condensation and moisture build up in the wood roof deck during the winter months.
