## Straight-Line Wind Damage Analysis

By Karyn Beebe, P.E.

A straight-line wind event took place in Rockwall, Texas, March 29, 2017, producing significant structural damage resulting in four red- and five yellow-tagged homes. The National Weather Service in Fort Worth estimated the storm's wind speed to be 100 to 110 mph. Before demolition of the most impacted home (Figure 1), APA – The Engineered Wood Association (APA) field staff followed through with an opportunity to survey the damage.

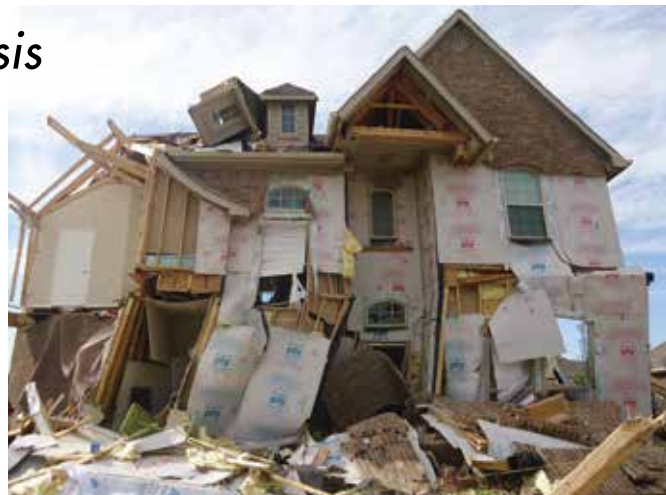
Figure 1. The March 2017 straight-line wind event took place in Rockwall, Texas, produced significant structural damage.

staples. The non-structural grade sheathing installed over the rim board made it impossible to determine the amount of load transfer available. The wall sheathing was punctured and missing as shown in Figure 1, which created an opportunity for moisture damage on the interior contents and possible internal pressurization of the home leading to more structural damage.

The houses observed were intermittently braced with structurally graded flexible laminated-fiber sheathing, infilled with non-structural flexible laminated-fiber sheathing panels (Figure 1). Homes fully sheathed with WSP enrich the structural performance of a building. APA Report T2007-73, *Full-Scale 3D Wall Bracing Tests*, found continuous wood sheathing resists about 80 percent more load than intermittent WSP wall bracing.

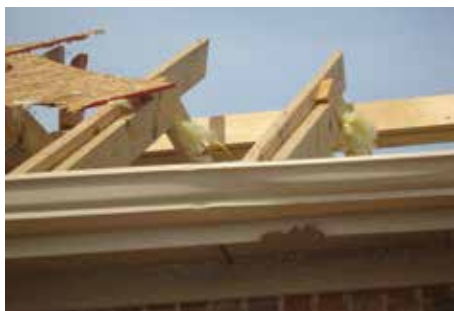
WSP roof sheathing was stapled to the roof rafters and, while code allows for staples, proper installation is critical. The roof in Figure 2 had many staples oriented perpendicular to the rafter, and several staples had only one leg in the rafter, which combined to reduce the capacity of the connection by at least 50 percent. The staple crown should be parallel to the rafter to assure both legs are embedded into the supporting member. The staples also appeared to be fastened in an inconsistent pattern.

Figure 2. This roof had many staples oriented perpendicular to the rafter, and several staples had only one leg in the rafter.

For these wind speeds, APA recommends using 8d ring shank or screw shank nails (0.131-inch x 2½-inch) fastened at 4 inches on-center along the WSP perimeter and 6 inches on-center in the WSP interior. This nailing pattern is closer than the minimum 6- and 12-inch-on-center spacing pattern to provide additional uplift resistance in high-wind events.

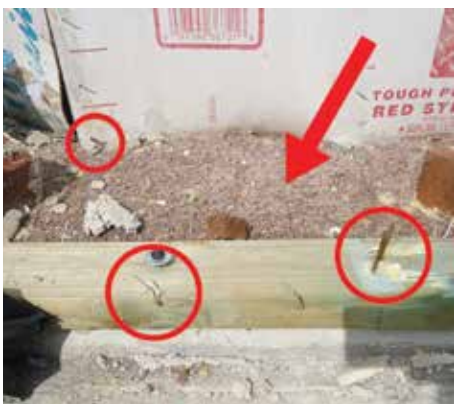
In the observed homes, there was a lack of load path continuity. The wall sheathing panels were not attached to the top plates, had no lateral load transfer at the floor line, and the attachment to the walls studs failed (Figure 3).

Figure 3. The flexible sheathing tore away from the bottom plate where staples were only partially embedded, allowing the balance of the wall to move inside (note that the arrow is pointing at the carpet).

The flexible sheathing tore away from the bottom plate (Figure 3) where staples were only partially embedded, allowing the balance of the wall to move inside (note that

that moisture may have played a role in weakening this assembly.

the arrow is pointing at the carpet). The circles on the left of the photo highlight the staples in the wall sheathing and bottom plate. The circle to the right shows the nails that had held the stud to the plate. The nails were rusted and the wall sheathing had water stains, indicating

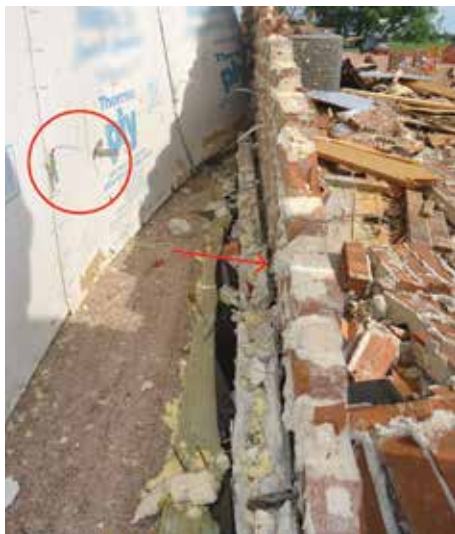
Figure 6. Damage consistent with previous tornado assessments – circle shows brick façade failure, arrow points to mortar buildup between bottom plate and brick veneer.

Another observation consistent with previous tornado damage assessments was brick façade failure. Many homes in North Texas have a brick or stone veneer around the exterior of the home. In Figure 6, the brick ties failed; some stayed in the brick veneer and others attached to the wood studs. Installation of continuous WSP sheathing would allow the brick ties to be attached directly to the panels, ensuring a secure hold and reduced failures. From an engineering perspective, it is important to educate clients so that they understand that brick veneer is merely serving an aesthetic purpose – it is the sheathing attached to the studs that provides the lateral resistance and high-wind protection to the building.

Figure 5 and 6, APA's recommended drainage assembly with one of the walls observed. In Figure 5, the wall sheathing is protected by a code-required water-resistive barrier, flashing, and an air gap to separate the brick veneer from the wood wall. The arrow in Figure 6 points to mortar buildup which occurred between the bottom plate and the brick veneer. This could trap water behind the wall which could infiltrate the wood wall assembly.

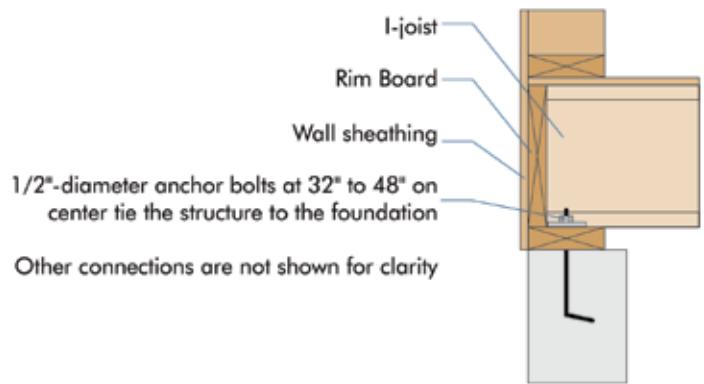
Figure 7. Use larger washers to tie the structure to the foundation better.

The last takeaway from the straight-line wind event relates to the attachment of the anchor bolts. For high wind areas, APA recommends using an oversized, 0.229-inch x 3-inch x 3-inch slotted square plate washer, four feet on-center or less, to reinforce this connection (Figure 7). Wood is weaker when loaded perpendicular to grain and an uplift force on the bottom plate creates such a load in cross-grain bending. The larger washers are a better way to tie the structure to the foundation.
