# HIBERNIA BANK BUILDING

## *Historic Renovation and Seismic Retrofit*

*By Kelly Cobeen, S.E., Terrence Paret, and Owen Rosenboom, Ph.D., P.E., S.E.*

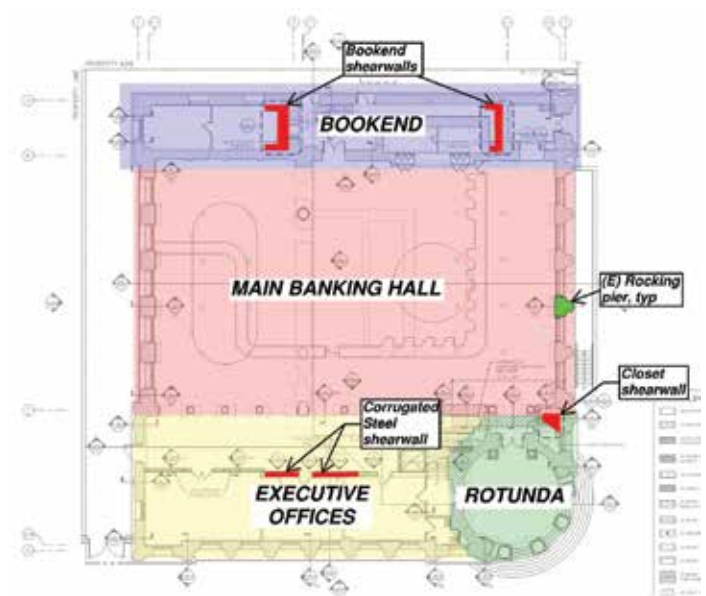
The building is generally rectangular in plan, with dimensions of approximately 130 feet by 120 feet (*Figure 3*). The primary vertical elements of the structure include four massive perimeter unreinforced brick and granite masonry bearing walls and massive interior brick walls. The roof system uses long-span steel trusses, steel purlins, and a concrete slab. The floor system uses cast concrete topped brick arches supported on steel beams.

ran analytical studies that corroborated the observed good behavior. Key to this behavior was the existing massive masonry walls that served to limit drift to modest levels in spite of the tendency towards torsional response (Figure 3). These indications of good seismic performance, combined with the adopted historic preservation objectives, were the primary justification for a focused, surgical seismic retrofit approach.

Figure 3. Hibernia Bank Building floor plan with shaded masonry walls. Diagonal hatched walls are of combined granite and brick masonry.

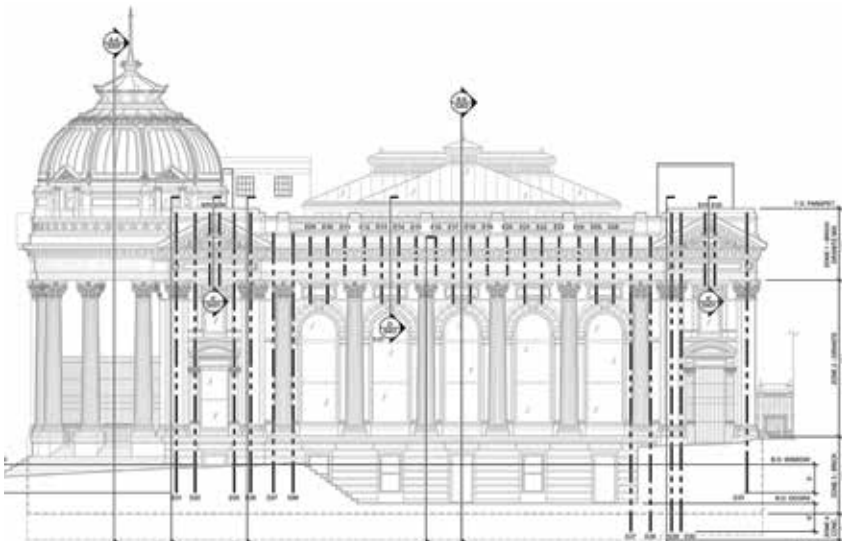
Figure 4. Center coring at Jones Street elevation. Heavy dashed lines indicate center core location and extent.

for this project was more difficult than usual due to the unpredictable mix of brick masonry and much harder granite masonry over the height of each core. Figure 4 shows center cores on one of the exterior wall elevations.

Center coring of the granite and brick masonry walls and piers was included to provide general connectivity and limit slip in masonry joints. The retrofit involved the coring of holes, installation of high strength steel rods as reinforcing, and grouting with a high-strength, low modulus polyester resin-based grout custom designed to reduce shrinkage and heat build-up during curing. The center coring of walls
