structural REPAIR

Metal Plate Connected Wood Roof Trusses

Evaluation and Repair of Fire Damaged

By John Stewart, P.E.

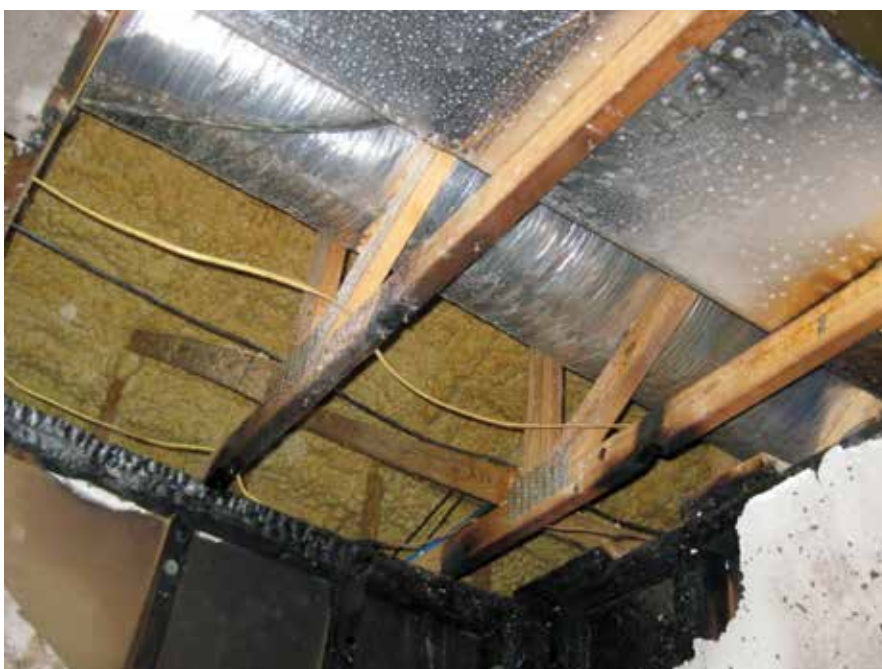
Figure 1. Charred bottom chord truss members.

There was minimal damage to the bottom chord of three trusses due to a fire from below.

Because the damage to the three bottom chords only included minor charring of the 2x4 bottom chord member at two locations and the nearby metal plate connectors were not damaged, isolated repair of the damaged chord members was selected (*Figure 1, page 16*). This eliminated the need for the full replacement of the trusses, finishes, insulation, and utility lines.

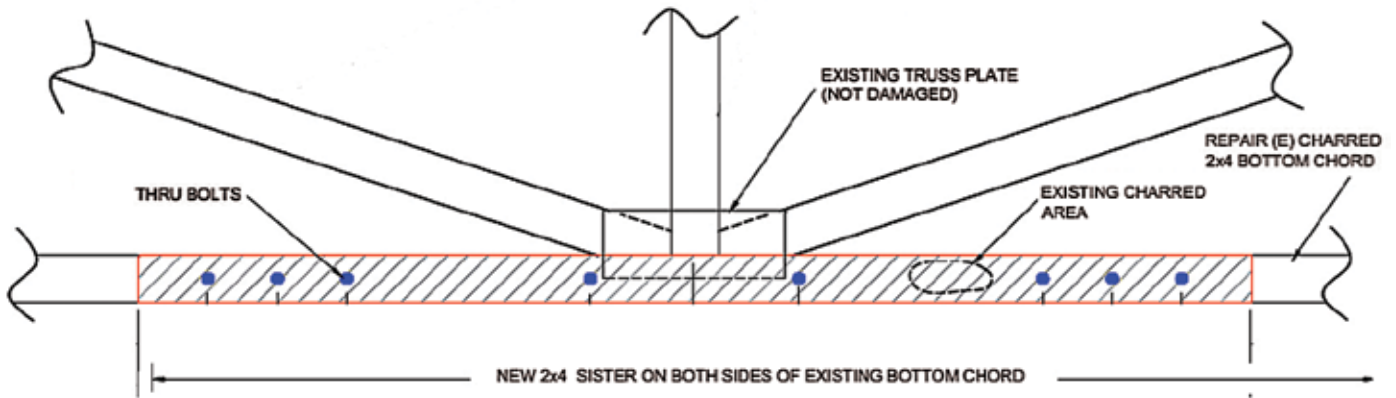
Figure 2. Repair detail for bolted sister members.

The force in the damaged bottom chord was 3,240 pounds tension. It was conservatively decided to sister the bottom chord with an eight-foot-long 2x4 on both sides to provide an additional allowance for fit-up. Because of the relatively high member force, the use of 5/8-inch diameter through-bolts was selected for the fasteners. Three bolts at each end of the sisters were sufficient, but a fourth bolt was added near the panel point to provide additional capacity and stability (*Figure 2, page 17*).

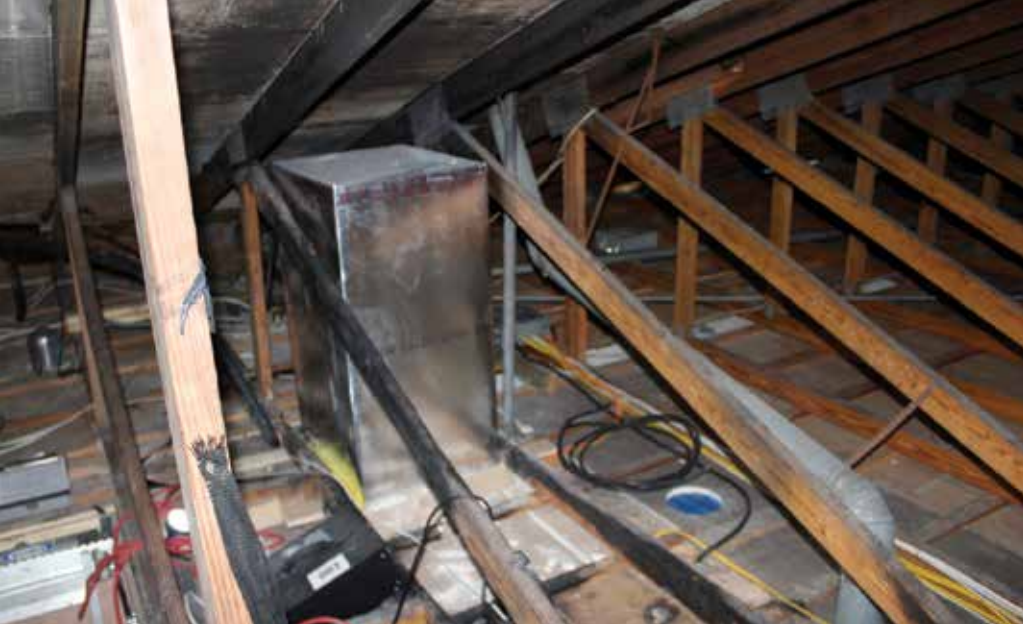
Figure 3. Damaged truss members and the HVAC plenum.

Portions of the top chord, bottom chord, and a web member were partially consumed by a fire from below (*Figure 3*). The metal plate connectors at the ends of the damaged members were warped from the heat of the fire. The Howe trusses spanned 45 feet and were composed of 2x4 web and bottom chord members with 2x6 top chord members. The damaged trusses sandwiched a plenum above an HVAC unit below. Large horizontal ducts came out of the plenum and were routed between the web members of the truss. The underside of the roof sheathing above was covered with smoke residue but was not structurally damaged. Isolated replacement of the damaged truss members was deemed to be

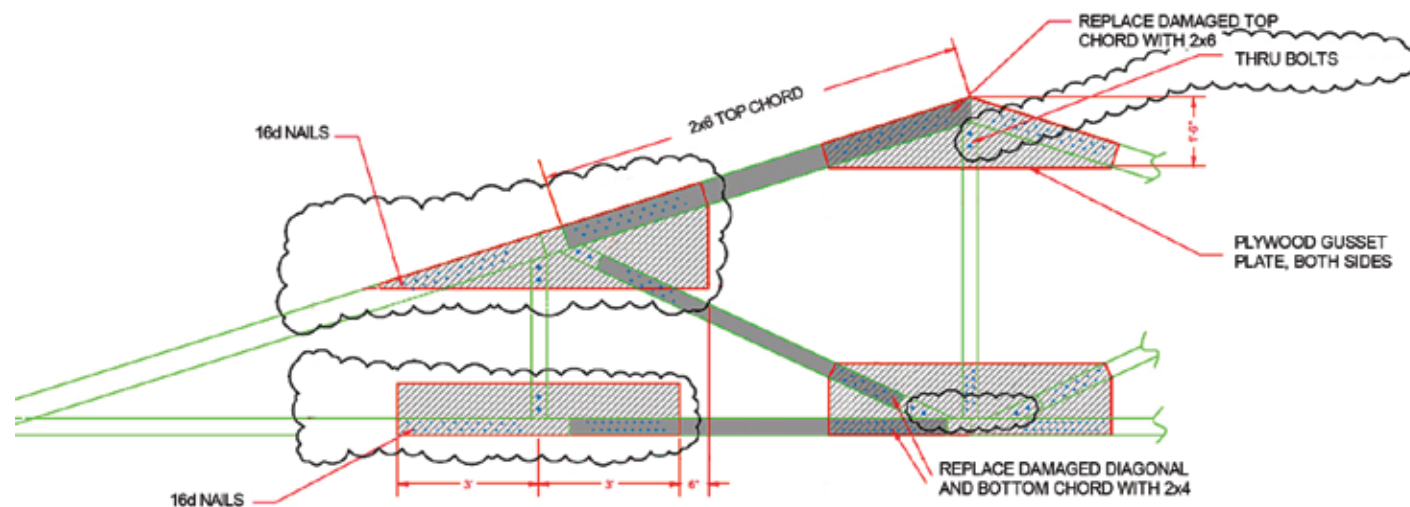
Figure 4. Repair detail using bolts for select connections.

The force in the damaged top and bottom chord members was 4,500 pounds. The maximum force in the damaged web members was 1,300 pounds. Plywood/OSB gusset plates were used to connect the new members at the panel points. Because of the relatively high member forces in the top and bottom chords and interferences with the ducts, 3/8-inch diameter through-bolts were used to minimize the size of the gusset plates (*Figure 4*).

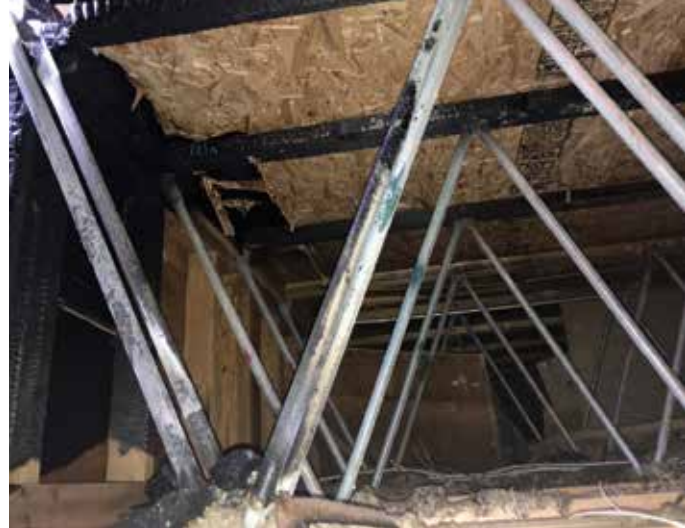
Portions of the top chord, bottom chord, and web members at the ends of four 60-foot-long hybrid Warren trusses were partially consumed by fire (*Figure 5*). The trusses were a parallel wood chord truss 4 feet deep with 1-inch diameter hollow steel pipes for the web members. The top and bottom chords were 2x4 stress rated wood members laid flatwise. The web members were connected to the top and bottom chords with a single 1/2-inch diameter through-bolt at each panel point. Approximately 8 linear feet of the four subject trusses were damaged at one end. Total replacement of the trusses would have required removing and replacing numerous ducts, pipes, and electrical conduits that were threaded through the trusses. Also, there was a long lead time to fabricate the trusses, and a small crane would have been required to set the new trusses. Even though the construction of the trusses was unique and the member forces were very high, it was decided to temporarily shore the trusses and perform isolated repairs.

Figure 5. Damaged top chords of the hybrid truss.

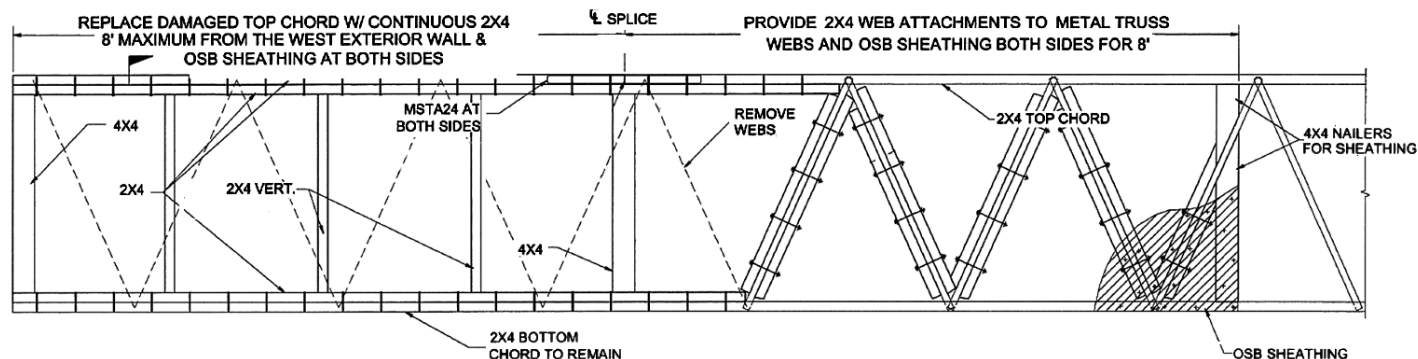
Figure 6. Repair detail at the end of the hybrid truss.

pounds. Trying to pass this force through nailed gusset plates was not workable. Using through-bolts in the flatwise chords similar to the existing connections was also not workable. Hence, it was decided to make a box beam at the end of the truss using full height plywood/OSB side plates. The box beam concept extended the 8-foot damaged length of the truss and then another 8 feet to create a two-panel point transition zone (*Figure 6*). A finite element model was run to investigate the stresses. Because the plywood/OSB side plates are stiffer than the discrete web members and chords, there was a localized area of high shear stress in the side plates that only extended about 8 inches from the ends of side plates. This was deemed acceptable because minor slippage of the nails would redistribute the high localized shear stresses over a large area.
