Structural Engineers in Fire Investigations

By Dan Eschenasy, P.E., F.SEI, SECB

Bronx Fire and Floor Collapse

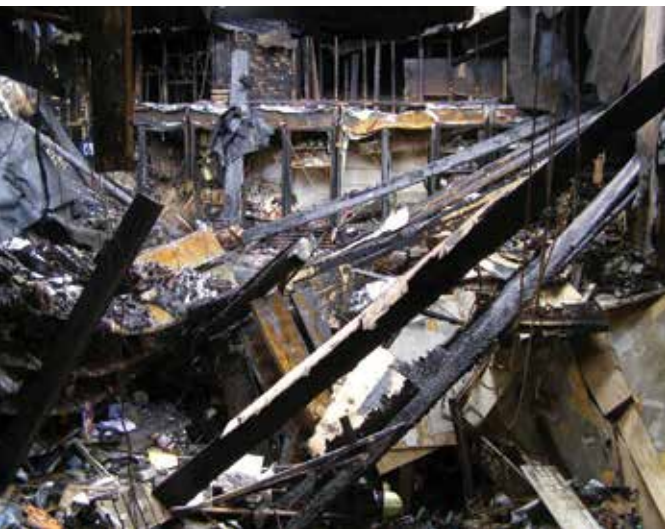
The author was called to participate in the New York City Fire Department’s (FDNY) investigation of a fire incident that occurred at a “99 Cents” store in the Bronx. The fire completely destroyed the wood roof framing of this one-story plus basement structure (Figure 1). During the firefighting operations, the ground floor collapsed, taking the life of two firemen that were fighting in the basement. Several years prior, the store had suffered another roof fire. Subsequently, the roof had been rebuilt. The ground floor, including the supporting wood columns, were built as mill construction (slow-burning construction) using sturdy elements. Along the perimeter, the ground floor was supported by masonry bearing basement walls. Typical of mill construction, the center-heavy timber girders were supported by bolsters set on top of 8-inch by 8-inch timber posts. Almost all the roof joists burned and were lying on top of the collapsed first floor.

Figure 1. Debris field – roof charred joists cover collapsed first floor.

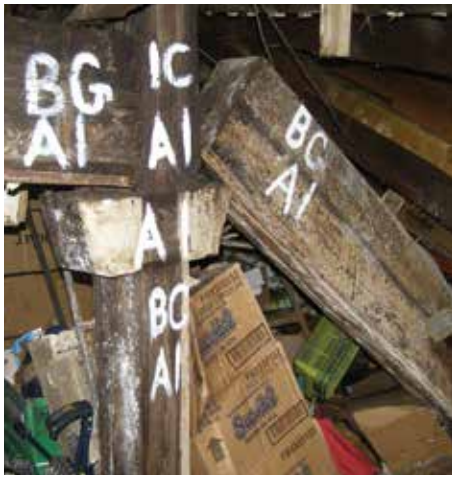
Figure 2. Failure of connection and collapse of timber girder supporting first floor.

The debris field indicated that the collapse had occurred by means of the failure of connections of some timber girders to posts (Figure 2). There was evidence of prior and repeated tinkering with the support of the ground floor.

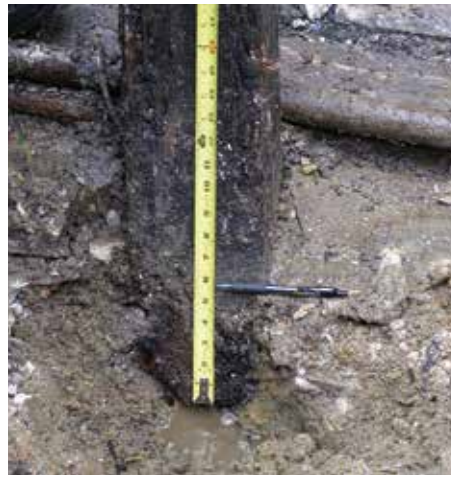
Ultimately, the cause of the collapse was deemed to be rot existing at the base of the timber columns (Figure 3). When erected, these posts had their bottoms extended about 12 inches into the ground where they rested on natural marble outcrops. Over the years, the rot had led to a slowly progressing settlement of the center columns (the perimeter masonry bearing brick walls had not settled). The center columns had lost much of their bearing function. As the settlement had progressed slowly, the owner was able to use shims, wood cribbing, and other types of shoring to mitigate the settlement's effect. These "fixes" did not include the repair of broken beam-to-post connections. During the fire, the sudden additional load of water (from fire hoses) and firefighting personnel led to the abrupt settlement of one of the supporting columns. The conclusion was that the floor failure was due to the disturbance imposed on the system by the large, sudden movement caused by the abrupt shortening of the column. Only the collaboration between fire and structural engineering professionals made possible the determination that the fire was the event that started a chain, but the underlying cause of the collapse was the presence of significant rot at the base of the column.

Figure 3. Rotten base of timber post.

warning about the dangers of embedding wood columns (posts) in soil. As a result, the established practice (which was not adhered to in this case) was to set the bottom of wood posts on pedestals raised 6 inches above the finished floor.

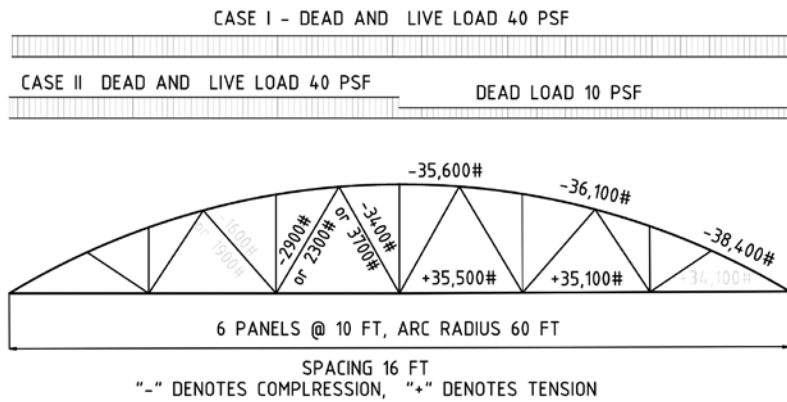
A review of a drawing of the Bowstring Roof Truss in the 1944 Timber Engineering Company's (TECO) *Typical Design* reference manual reveals, with some approximation, the level of noncompliance to the NYC code. TECO analyzed two loading combinations (*Figure 4*): (a) a total 40 psf dead and live load over the entire span, and (b) a 40 psf dead and live load for one half of the span and a 10 psf dead load for the balance of the span. As expected, the entire length of the bottom truss chord had to be designed for the same tension force. The TECO notes refer only to a minimum 1200 pounds per square inch (psi) extreme fiber bending stress. As an example, if the bottom truss chord used allowable stresses, say 50% of what we accept today, it would mean that, per code, the truss could carry a total load of about 20 psf. After subtracting the dead load, the remaining 10 psf represent the weight of about 5 to 6 inches of wet snow. The fact that many trusses still stand might be explained by the high factor of safety used for wood strength; since the 1920s, the factor of safety for wood has varied somewhere between 6 and 4, mainly because of the large variability in the strength of natural materials.

Figure 4. Reproduction of loading combinations from *TECO catalog* (circa 1944).

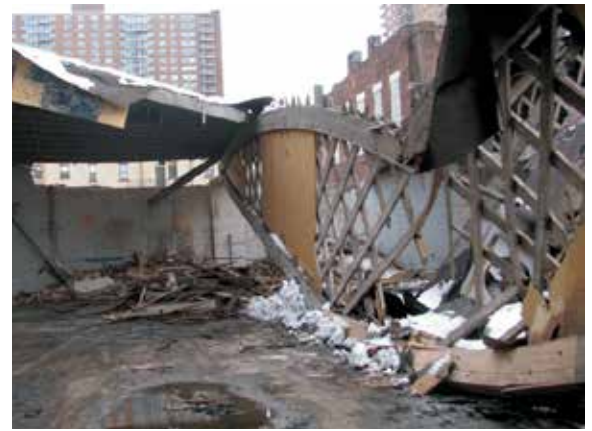
Figure 5. Collapsed “Belfast” bowstring truss. Wood failed at bottom chord mid-span. Note relatively small snow cover.

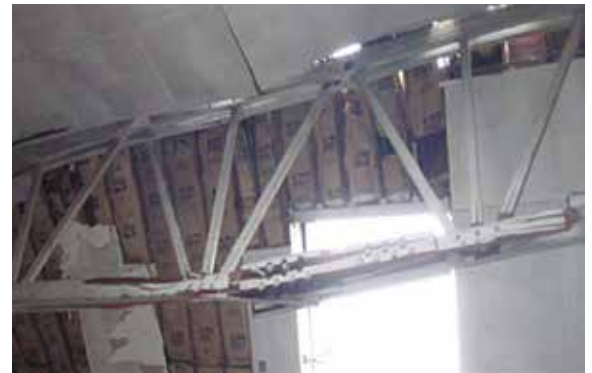
Figure 6. Bowstring truss failed at connection.
