Caltrans Highway Structures

By Mark Yashinsky

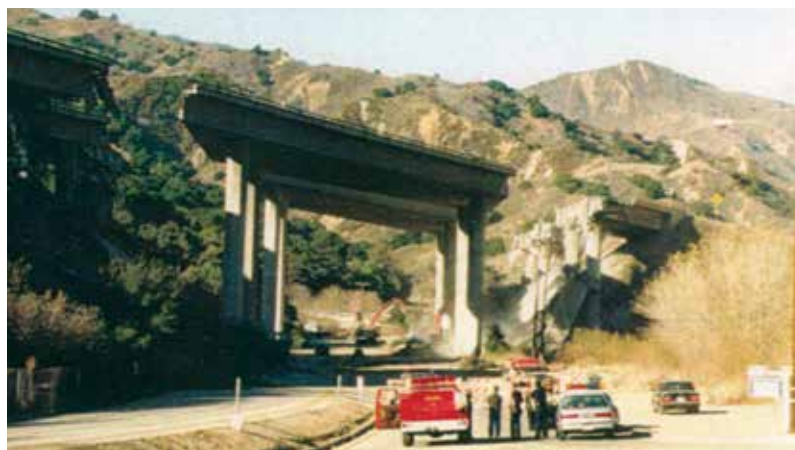
Figure 1. Gavin Canyon Bridges.

These two parallel 741-foot-long bridges (53 1797L/R) built in 1955, were designed with table-like center frames that supported the cantilevered spans of the four end frames on highly skewed, 8-inch-long hinge seats. A retrofit in 1974 added restrainers at the hinges. During the earthquake, the outer frames rotated, failing the restrainers, followed by unseating and collapse of the cantilevered spans. In *Figure 1*, the demolition crew has already started removing the bridge before the reconnaissance team could inspect the damage (the team started in Sacramento and were escorted by the California Highway Patrol down I-5 through various detours to a hotel in Pasadena). Among the lessons learned was that the fundamental mode during an earthquake for a bridge may be rotational, not translational; that long seats, not restrainers were needed to prevent unseating; that high skew makes it easier for bridges to become unseated by moving normal to the skew; and, that the anchorage for restrainers is often the location of failure. However, most of these lessons had been learned during previous earthquakes. After this earthquake, these bridges were replaced with single frame structures.

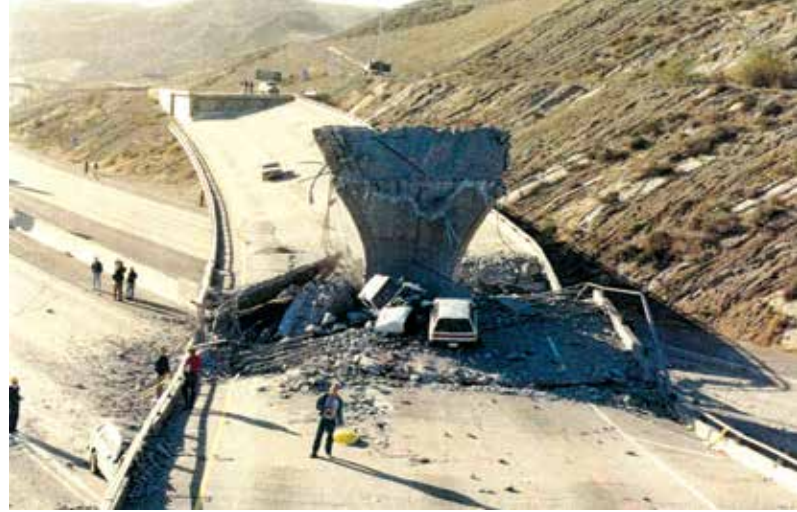
Figure 2. Route 14/5 separation and overhead.

This 1582-foot-long bridge (53 1960F) on single column piers was under construction (and was still on falsework) during the 1971 San Fernando Earthquake, but it collapsed during the Northridge

Earthquake (*Figure 2*). There was considerable speculation as to the cause of the failure, but it was eventually decided (and corroborated by analysis) that it was due to the shear damage to short, stiff Pier 2. Most long bridges have short bents near the ends and tall bents in the middle. As this bridge moved back and forth during the earthquake, the stiffer elements could not displace as much as their taller neighbors and broke. After Pier 2 broke, the superstructure sagged, broke around Pier 3, and slid off Abutment 1 (*Figure 2*) and Pier 4. After the earthquake, Caltrans instituted standards to ensure that the columns within a bent, bents within a frame, and frames in a bridge have similar stiffness or period.

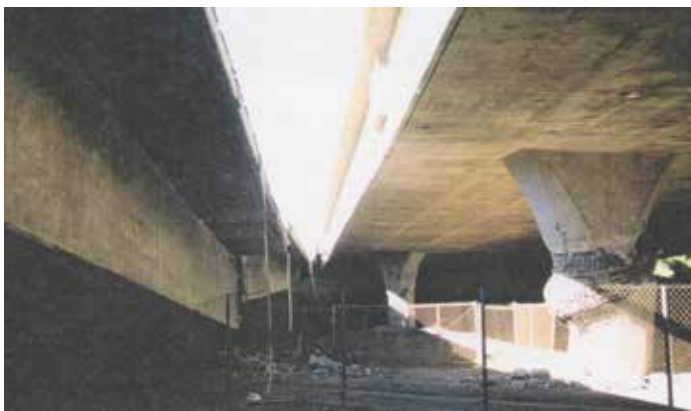
Figure 3. Route 118 Mission Gothic Undercrossing.

These parallel structures (53 2205L/R) included a 506-foot-long 3-span left bridge and a 566-foot-long 4-span right bridge on two-column bents and abutments with 4-foot-long seats. The bridges were 98 feet wide with prestressed bent caps (except for Bent 4 on the right bridge). The bridges were designed in 1973 and built in 1976. They crossed over an intersection and consequently had opposing skews at the two ends. The columns were fixed at the top and pinned at the base. A common detail used on these bridges was architectural flares on the columns, which were assumed to spall off during earthquakes. However, during the Northridge earthquake, the flares did not spall off and reduced the effective column height, resulting in a combination of shear and flexural damage. As can be seen in *Figure 3*, the bridges displaced transversely during the earthquake. The right bridge (the left side of *Figure 3*) collapsed while the left bridge settled approximately two feet. Typically, a bridge is locked in by the abutments, which act to limit the movement during earthquakes. It was concluded that having abutments at opposite skews allowed the bridges to move away from the abutments, which contributed to the collapse. After the earthquake, Caltrans funded research at the University of California San Diego, which confirmed the vulnerability of flared columns and a new detail was developed to isolate the flare from the superstructure on new bridges (existing bridges were retrofit with casings around the column and the flare).

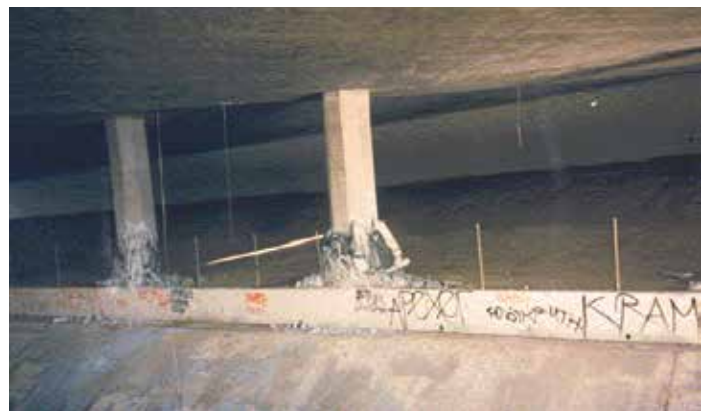
Figure 4. Route 118 Bull Creek Canyon Channel Bridge.

These parallel 3-span structures (53 2206L/R) were 256 feet long with a variable width (minimum of 200 feet) and a variable skew. Like their neighbor (Mission Gothic Undercrossing), they were designed in 1973 and built in 1976. The bridges were supported on 9 and 10 column bents and tall, end-diaphragm abutments. The columns had a modern design with spirals at a 3-inch pitch at the top and bottom

and a 12-inch pitch elsewhere. The bridges crossed over a channel, and the concrete for the channel walls was placed against the columns at Bent 3. The structure appeared to have rotated clockwise during the earthquake. Similar to Mission Gothic, the channel wall had the effect of shortening the columns and consequently attracted more seismic force. Also, the top of the channel wall was where the transverse column reinforcement was at a 12-inch pitch. All the columns at Bent 3 failed in shear (*Figure 4*). The top of some of the columns in Bent 2 formed plastic hinges, probably after the columns in Bent 3 were damaged.

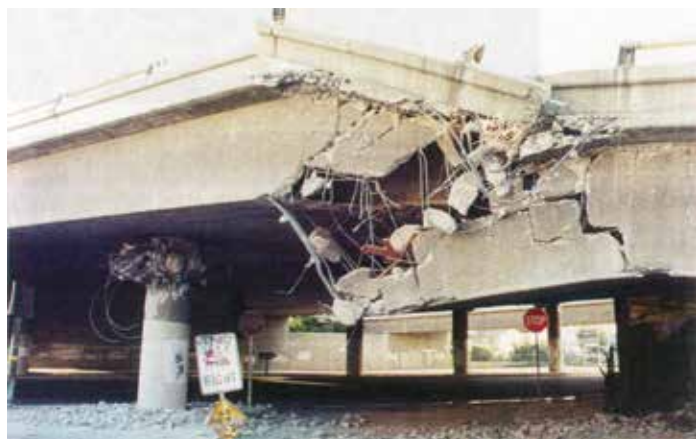
Figure 5. I-10 La Cienega-Venice Undercrossing.

These parallel, three-frame (7-span) 871-foot-long bridges (53 1609L/R) on 2 and 3 column bents and bin-type abutments were designed in 1962 and built in 1964. The frames were connected with 6-inch-long hinge seats. There was also a connector and an on-ramp on the right bridge. Columns had lapped hoop reinforcement at a 12-inch spacing and were pinned or fixed to pile caps without a top mat or any shear reinforcement. Most of the columns on the right bridge formed plastic hinges at the bottom, although a few columns had plastic hinges at the top (*Figure 5, page 20*). The column damage was thought to have caused Span 6 of the right bridge to become unseated. However, the superstructures were caught by a storage facility that had been built under the bridges. The foundations were excavated after the earthquake, but no damage was found. It was thought that the thick layer of asphalt and concrete pushed the column damage up to where the columns were more vulnerable (although there was a lap splice between the column reinforcement and the footing). An observation after the earthquake was that the columns with

42- #11 bar main reinforcing experienced more damage than the columns with less main reinforcement. This bridge was far to the south of the epicenter (which ruptured to the north), but it was felt that long period shaking was amplified by the soft soil (La Cienega is Spanish for “The Swamp”).
