Gasconade Bridge Failure 1855

By Frank Griggs, Jr., Dist. M.ASCE, D.Eng., P.E., P.L.S.

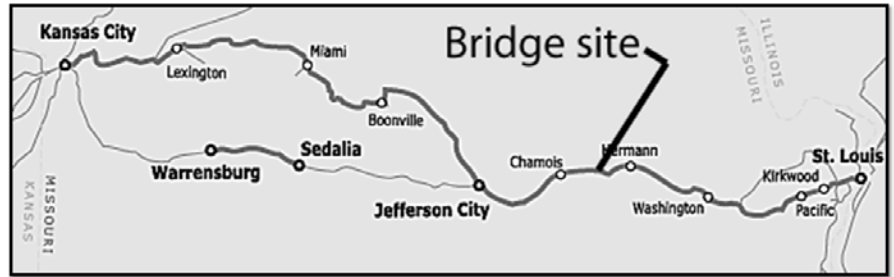
Gasconade bridge site.

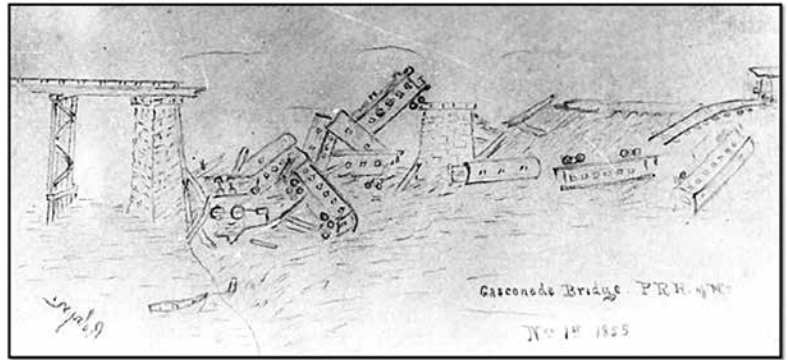
Sketch of disaster, note temporary bent for approach and masonry piers.

Now behold these support or bents, and keep in mind that they rise, twelve to 15 feet apart, rows of posts or rows of piles, to a height of twenty-five to thirty-five feet or more above the bed of the river – the piles standing in a yielding mud bed, both piles and posts standing out of plumb, and overhanging in different directions, with but a dowel pin connection between them!

The real cause of the accident was, and is, hard to determine. It appears to have been a result of excessive speed, a roadbed with varying support, and maybe even an undersizing of the trestlework with minimal falsework. The local newspapers were filled with people believing the railroad was guilty of poor and shoddy construction, and that traffic was permitted on the unsafe bridge as the Pacific Railroad was trying to impress the state government to provide funds for the construction of the line.
