## Desjardins Bridge Disaster of 1857

By Frank Griggs, Jr., Dist. M.ASCE, D.Eng., P.E., P.L.S.

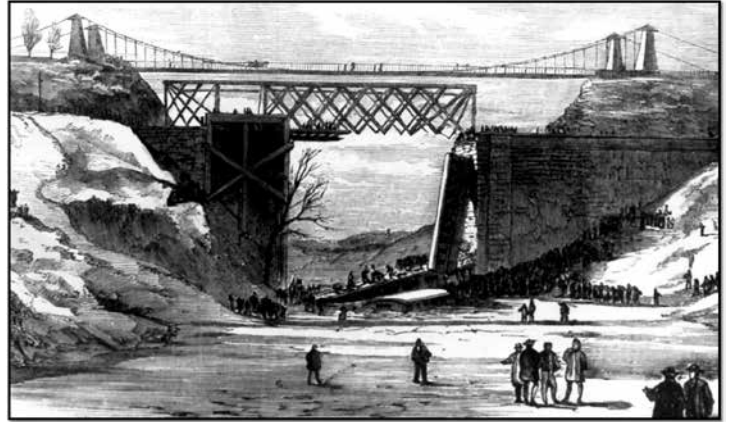
Failed swing bridge decking at Dundas. Illustrated London News, 1857.

*On that day, the Locomotive Oxford, drawing a passenger train eastward, with a broken axle, ran off the track upon the downgrade approaching the bridge and could not be stopped till it went crashing into the timber of the bridge; probably coming in collision with the light lattice timbers on the right hand side, cutting them off, and letting the engine and train down some 40 feet into the canal.*

The jurors aforesaid find that the immediate cause of the accident was owing to the breaking of the forward axle of the engine-truck close to the wheel on the right, at a point on the road not ascertained, in consequence of which the left forward wheel of the truck left the rail at or near the switch near the bridge, causing the locomotive when entering on the bridge to diverge to the right crushing and tearing away its supports, and precipitating the whole train into the canal, and resulting in the calamity which forms the subject of this melancholy inquiry...

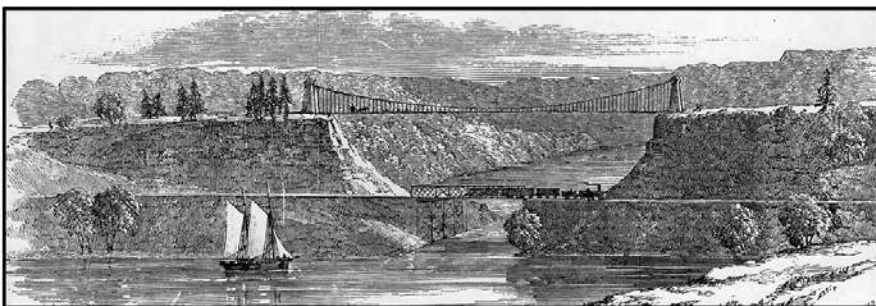
Swing bridge at Dundas on the Great Western Railway.

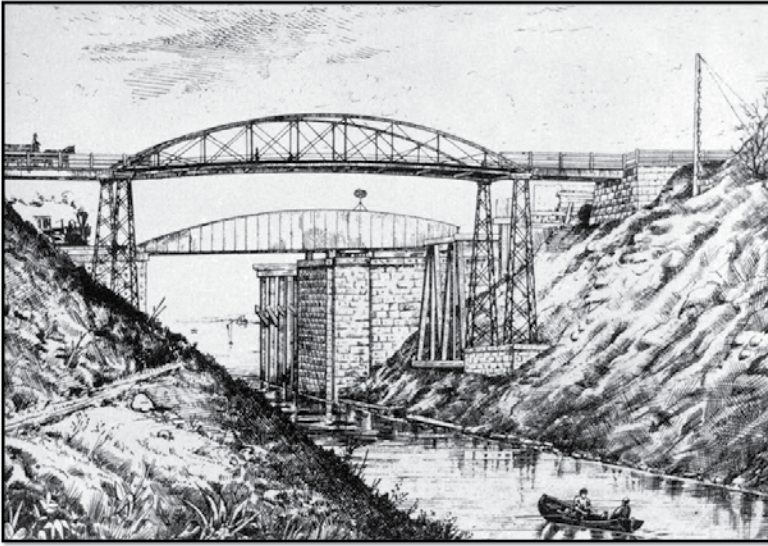
Later view of the site with iron swing span on the same abutments replacing Whipple's Bridge and a Whipple Truss on high piers replacing the suspension bridge.
