Napa County HISTORIC Courthouse

By Luke Wilson, S.E.,
Brett Shields, P.E.,
and Kevin Zucco, S.E.

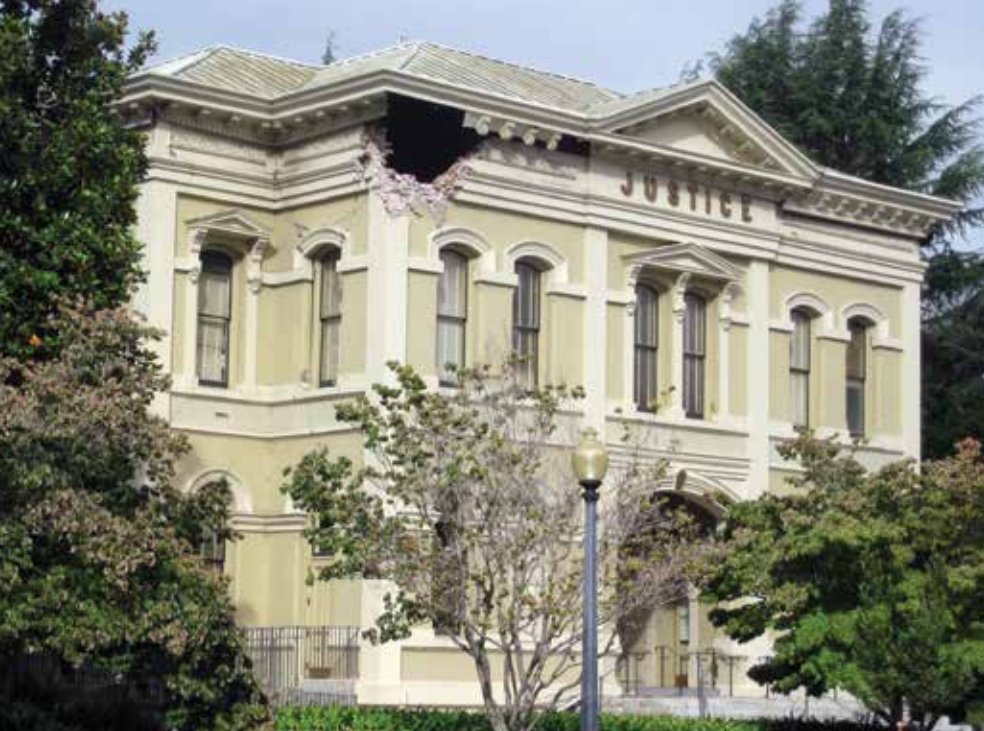
Figure 1. Entry showing damage; taken the morning of the Earthquake.

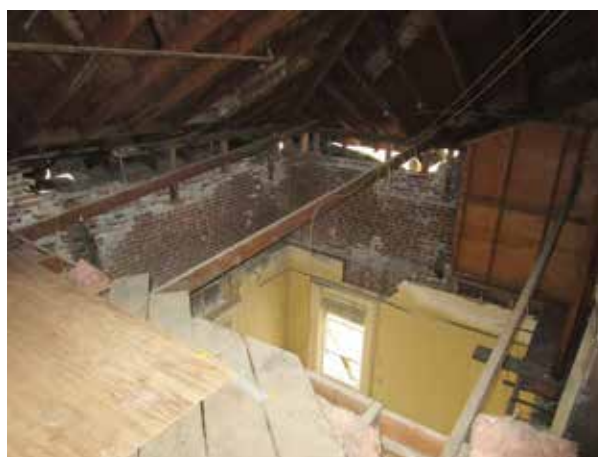
Figure 2. Courtroom view from the attic where brick partially collapsed the ceiling below.

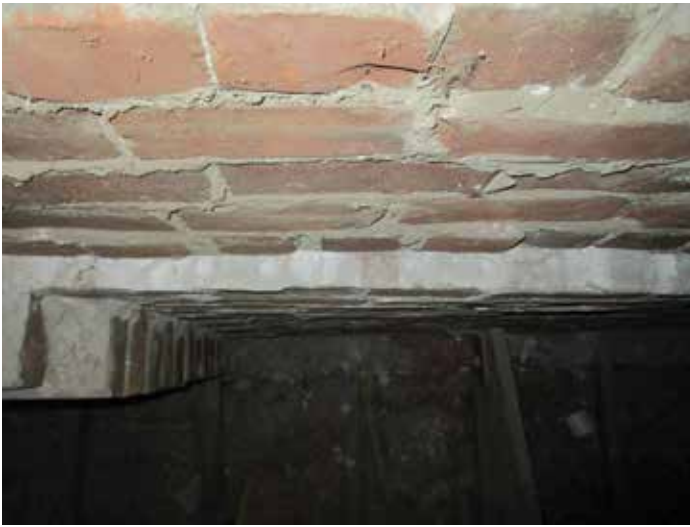
Figure 3. Horizontal offset of brick in the attic.

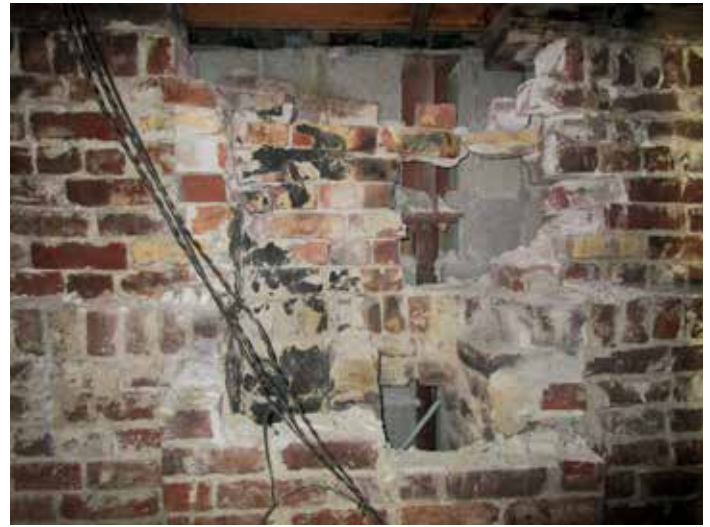
Figure 4. Partially collapse of URM wall due to adjacent Administrative Annex Framing.

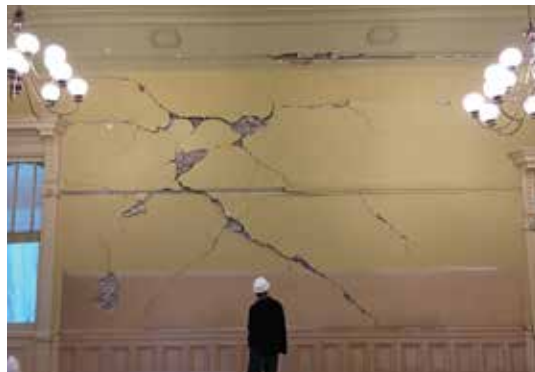
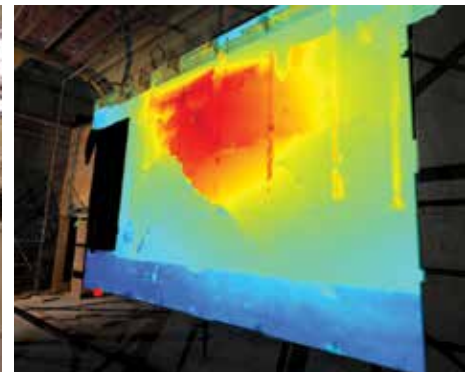
Figure 5. Site photo of damaged wall and heat map showing offset.

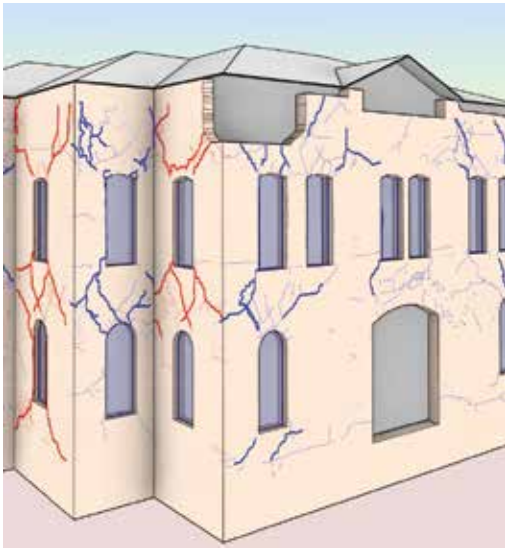
Figure 6. BIM Model showing entry damage (see Figure 1 for actual photo of area).

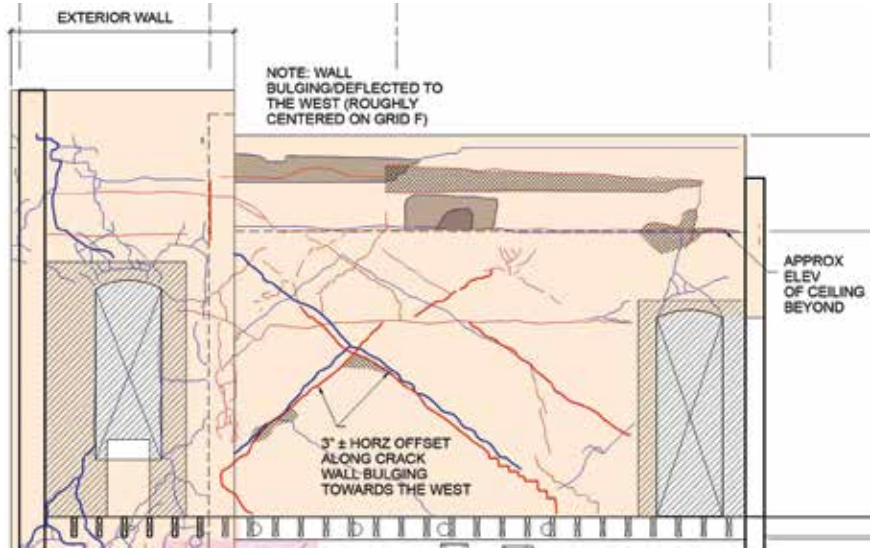
Figure 7. Example damage documentation drawings (see Figure 5 for an actual photo of the wall).

Using the damage documentation 3-D BIM model (Figure 6), two-story full-length wall elevations and 3-D views clearly illustrated crack patterns on both sides of walls (Figures 7 and 8). Using this whole-building approach to documenting the damage, significant two-story diagonal crack patterns were revealed that extended through wall faces, providing valuable insight into the global building behavior and resulting damage extent from the earthquake.

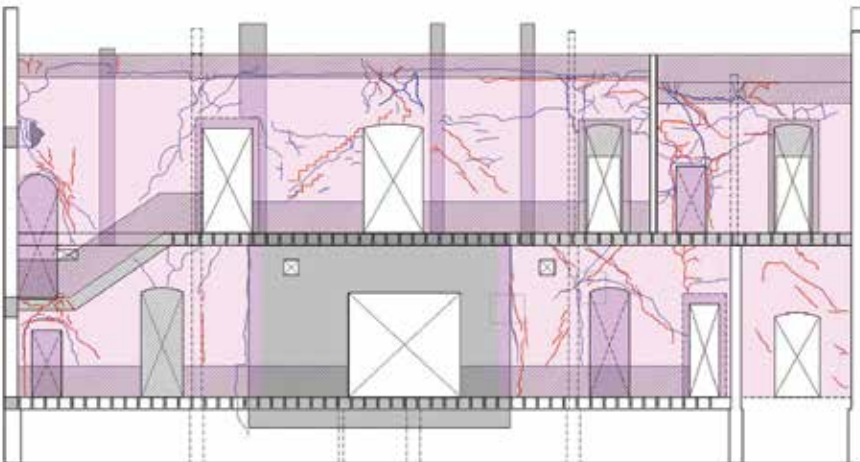
Figure 8. Twostory section through the main hallway showing damage documentation.
