## Novel Solution for Strengthening Handrail Anchorage

By Ali Abu-Yosef, Ph.D., P.E., S.E., Joseph Klein, P.E., Michael Ahern, P.E., and Randall Poston, Ph.D., P.E., S.E., NAE

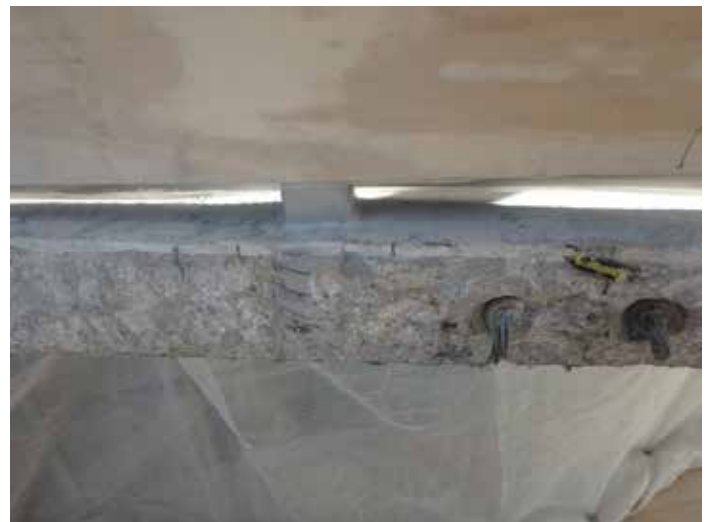
Figure 2. Concrete removal along a slab edge exposed grout pockets with missing hairpin anchor reinforcement.

During the early stages of repair construction, the contractor exposed railing post anchorages that did not have the No. 5 hairpin anchor reinforcement as specified in the original design (Figure 2). The issue of missing anchor reinforcement was only observed at the bottom four stories of the residential tower. A review of the original construction documents suggested that the culprit for the missing anchor reinforcement was likely miscommunication between the structural engineer, the railing system manufacturer, and the contractor.

As constructed, the railing anchorages with missing anchor reinforcement were structurally deficient and did not comply

with building code requirements. Due to the limited edge distance between the grout pocket and the slab edge, the post anchorages were susceptible to breakout if design-level, or even service-level, loads were applied. Hence, structural repairs to strengthen the deficient anchorages were necessary.

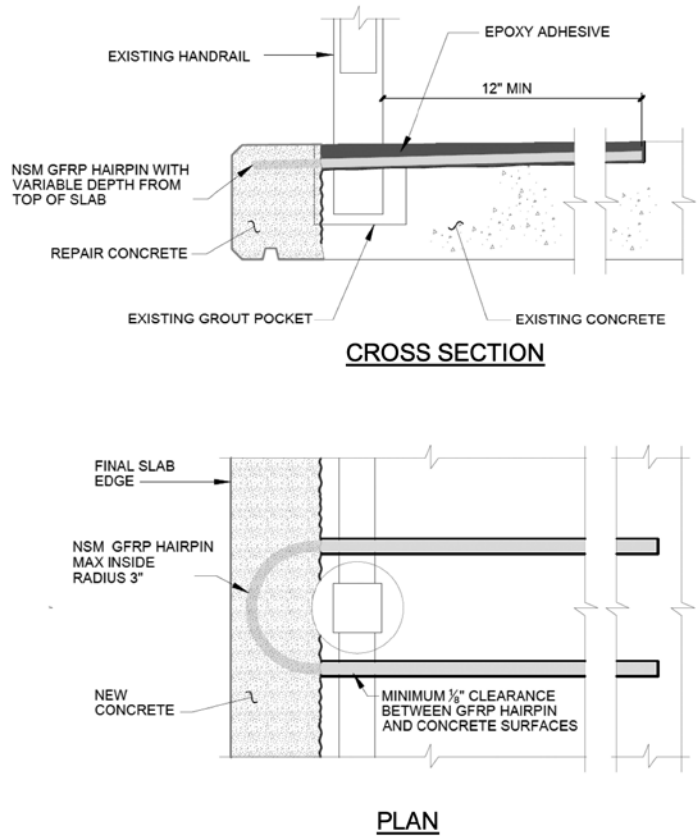
Figure 3. Details for typical NSM GFRP hairpin repair.

Based on the calculated demands, the analysis determined that a No. 3 GFRP hairpin was sufficient to provide anchor reinforcement for each handrail post. The length of the hairpin legs was determined based on the bond strength criteria provided in Section 13.3 of ACI 440.2R. For the selected bar dimensions and load demands, a development length of 12 inches was needed. The surface groove dimensions were detailed based on the ACI 440 guidelines. The minimum specified depth and width of the surface grooves ( $\frac{3}{4}$  inch) were greater than 1.5 times the GFRP bar diameter. Also, the groove surfaces had to be roughened and cleaned before installation of the epoxy adhesive and the GFRP bar.

If the NSM installation could be performed before the slab edge was cast, the contractor was allowed to embed the curved portion of the hairpin into the repair concrete. Because the thermal expansion properties of concrete and GFRP are different, the design specified an increased concrete cover over the portion of the GFRP hairpin embedded in concrete and not epoxy. Shallow concrete cover over GFRP bars can result in cracking due to a thermally-induced strain differential between the concrete and the GFRP material. As such, while a clear cover of 1/8 inch was sufficient for portions of the GFRP bars covered with epoxy, a more significant cover was needed for portions embedded in concrete. Per ACI 440 guidelines, the portions of the GFRP hairpin that were embedded in concrete had a vertical cover of at least 1/2 inch. This was achieved during construction by gradually increasing the depth of the NSM groove as the distance to the slab edge decreased. *Figure 3 (page 31)* schematically shows the repair details, and *Figure 4* shows a GFRP hairpin soon after installation.

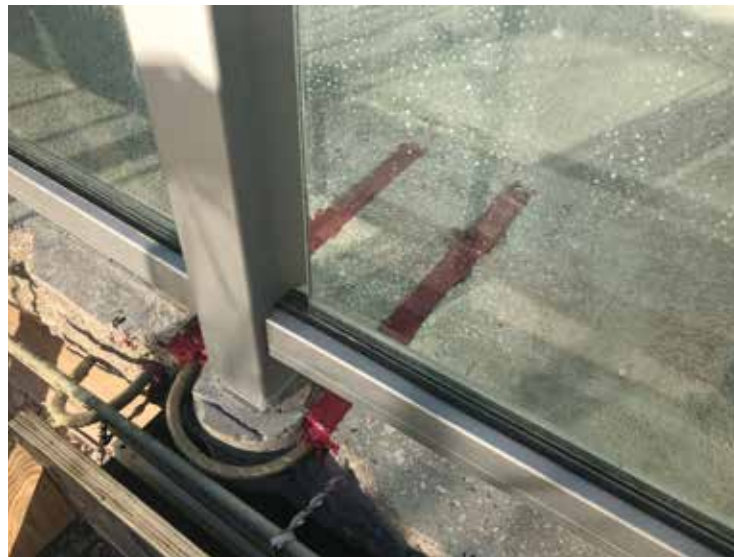
Figure 4. GFRP hairpin installed around a railing post grout pocket.

The repair contractor was able to perform the repairs without removing the railing components, which further reduced the cost of the repairs. The groove edges were created using shallow saw cuts, and then 15-pound chipping hammers were used to remove the concrete within the sawcut boundaries. The groove surfaces were roughened per ACI 440 requirements to improve the bond between the epoxy and concrete substrate. The epoxy adhesive selected for the NSM repair was chosen based on reported past performance and recommendations of the GFRP bar manufacturer. During NSM repair
