Napa County HISTORIC Courthouse PART 2

By Brett Shields, P.E., Luke Wilson, S.E.,
and Kevin Zucco, S.E.

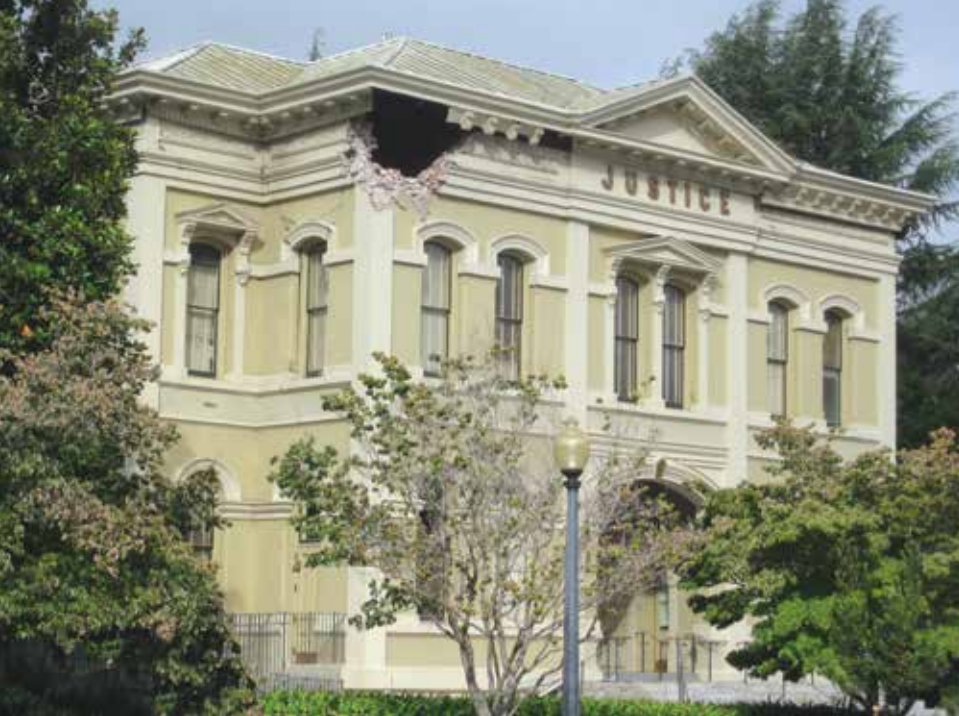
Figure 1. Entry showing damage taken the morning of the earthquake.

On August 24, 2014, the South Napa Earthquake left the Napa County Historic Courthouse heavily damaged with partially collapsed walls, ceilings, and extensive wall cracking (Figure 1). The City of Napa red-tagged the courthouse as un-occupiable, which began the extensive damage documentation effort outlined in the December 2019 edition of STRUCTURE. After documenting and assessing damage, the design team refocused efforts towards a solution to repair and preserve as much of the historic building as practical while providing improved detailing.

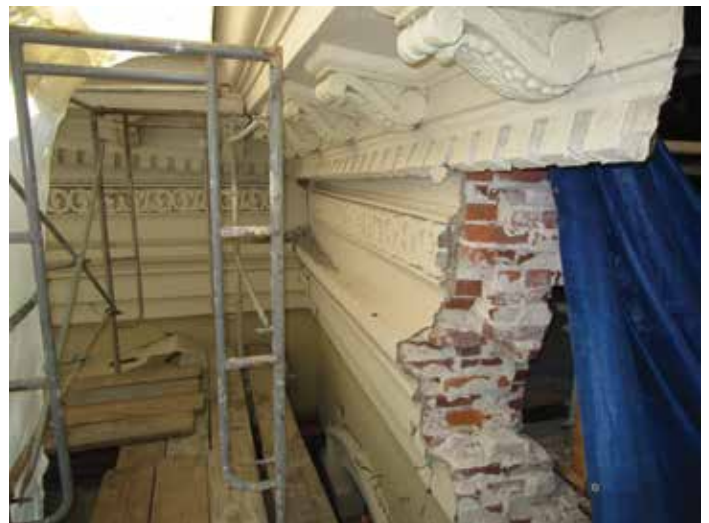
Figure 2. Historic exterior wall brick construction and dental cornice.

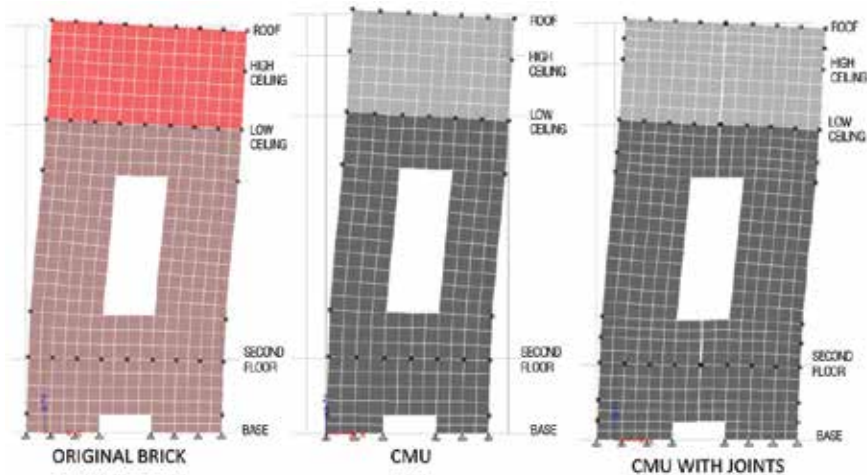
Figure 3. Analysis model showing original brick, CMU, and CMU with control joints.

These adjustments did not provide the desired reduction in stiffness; therefore, strategically located control joints were added to further reduce the stiffness of the areas rebuilt with CMU (Figure 3). The

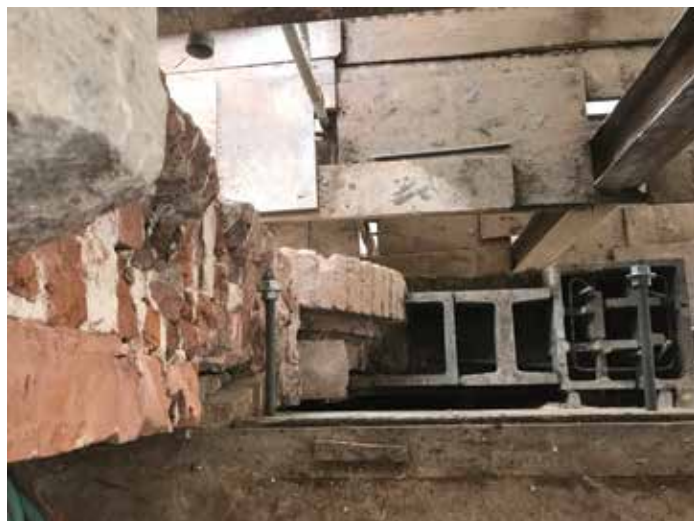
Figure 5. Detail of CMU interface with historic brick arch.

While CMU has some adjustability to accommodate small existing dimensional offsets, the number of intricate interface conditions to existing construction was a challenge. CMU had to interface with historic brick arches (Figure 5, page 23), existing floors and ceilings, adjacent precast concrete lintels (Figure 6, page 23), uneven base levels, wall anchorage, and existing penetrations while adjusting to match existing walls. The result was a number of details, both planned and unforeseen, requiring a level of mason care and ability beyond that of typical construction.

Combining the CMU rebuild with existing historic brick construction presented dimensional obstacles that were addressed in detailing. The brick arches at the 1st and 2nd-floor windows of rebuilt walls were recreated with precast concrete elements to adjoin rectangular CMU with curved historic windows. CMU was aligned at the exterior face of brick to minimize furring and plasterwork on the visible historic exterior and aid in providing a flush plaster joint with the existing plaster finish. At interior walls, CMU was detailed to be centered on the brick below to limit the dimensional offset from the brick below each side for installation of FRCM continuity laps. Transitions of CMU to unreinforced brick were dowelled with alternating embedment lengths to tie the walls together and avoid creating a defined weak plane in the brick similar to those observed at the 2003 concrete shear wall interface.

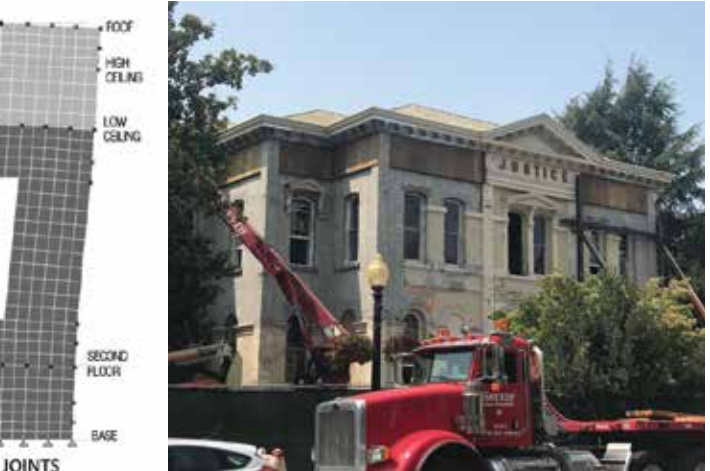
Figure 4. CMU reconstruction of damaged 2nd-floor walls.

rebuilding a new “straight” wall between two existing points (Figure 4, page 23) while still supporting the floor and ceiling. This condition was resolved through shimming of ledgers at small gaps and providing bearing angles at larger offsets.

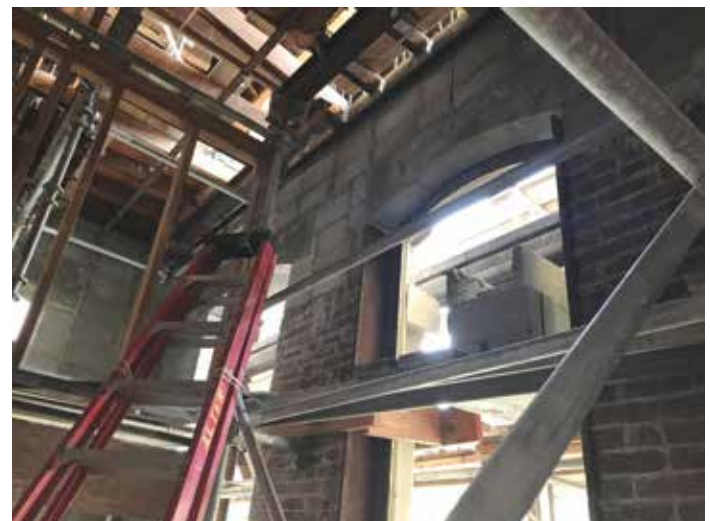
Figure 6. CMU and precast lintel construction above the original brick wall.

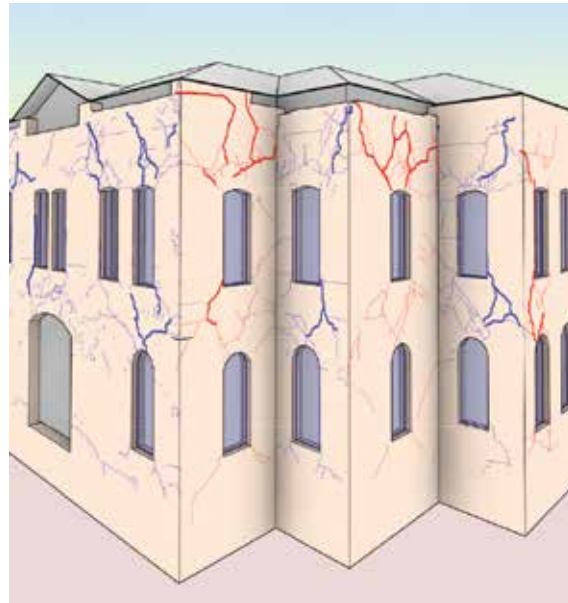
Damage documentation was largely completed by observing cracking in the finished plaster to assess overall damage before requiring expensive removal and reapplication of plaster. Localized areas were selected for removal to verify that plaster cracking correlated to a crack in the brick substrate. Removing plaster during construction often revealed that numerous small patterned cracks observed in the plaster typically resulted from fewer large cracks in the brick ultimately requiring grout injection. Even in areas receiving FRCM overlay, larger, open cracks were grout injected to provide a cohesive substrate for the FRCM. The process of injection uncovered a handful of unforeseen wall voids and chases that required grout filling before crack injection.

Figure 7. Example of damage documentation drawings.
