# RISING *Above*

## Addition, Renovation, and Rehabilitation at Hotel Julian

By David Nickell, S.E., Martin White, S.E., and Roger Reckers, S.E.

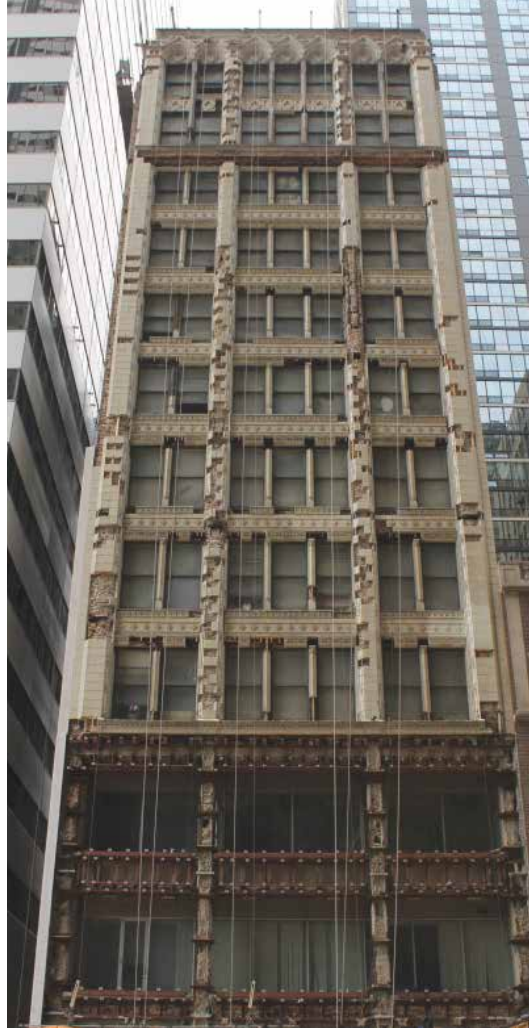
The condition of the building certainly did not match its high-profile location. For years, the existing 12-story building at 168 N. Michigan sat vacant on one of Chicago's busiest thoroughfares. With an address on Michigan Avenue near the northwest corner of Millennium Park, countless residents and tourists would pass by each day. This empty shell was a once-prominent structure that had fallen into disrepair due to previous renovation attempts that were abandoned in mid-construction. Pieces of the original terra cotta façade had been removed, openings had been created in exterior walls and left uncovered, and the interior was in a similarly poor condition (*Figure 1*). During the design team's walk-through at the beginning of the project, water that had penetrated the unsealed roof and traveled down 12 levels could be seen puddling on the basement slab.

Figure 1. The exterior façade facing Michigan Avenue at the outset of the project.

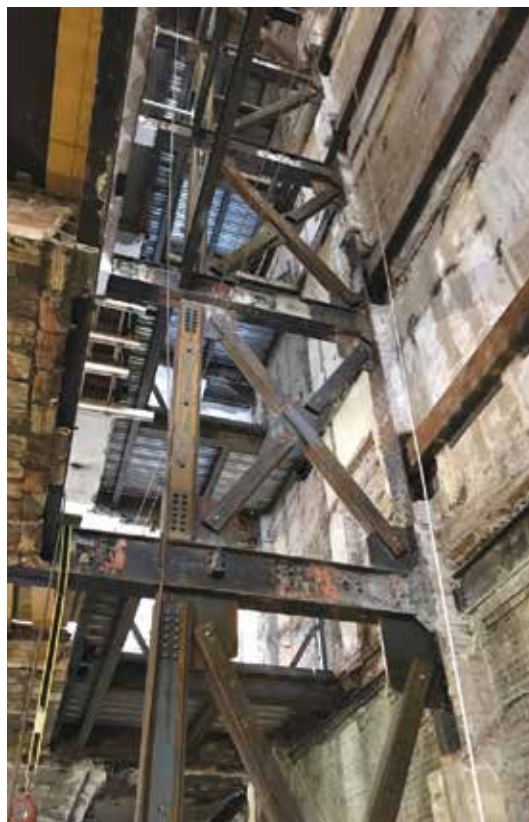
Unfortunately, it did not appear that the original designers accounted for the lateral load of a new addition. Although the 80-foot-tall addition increased the height by only 50 percent, it more than doubled the overall overturning moment on the building. The existing masonry shear walls (resisting loads against the short face of the building) were determined to be structurally adequate. However, the existing moment frames at the front and back of the building (resisting loads against the long face of the building) had no excess capacity to resist the new loads. A full-building 3-D analysis utilizing ETABS software revealed that all components of the moment frames were overstressed, from the bearing capacity of the existing caissons to the stress in the columns, plate girders, and riveted connections.

Additionally, deflections were determined to exceed the industry standard limits. This major shortcoming of the existing lateral system, but the adequacy of the gravity system, is most likely attributed to advances in lateral analysis and changes in code-required wind loads over the past century. Each moment frame would need to be wholly retrofitted or a new solution would need to be devised.

Figure 2. One of three new braced frames erected in the existing building.

- 1) Three new braced frames (Figure 2) adjacent to the elevator shafts were used for the main supplement to the existing lateral system. New columns were erected between the existing double I-beam girders and HSS braces were installed within the shaft walls at each level, extending down to the existing steel grade beams and up through the new addition. This allowed the new lateral component to fit seamlessly into the building while not impacting the architectural intent of the space.

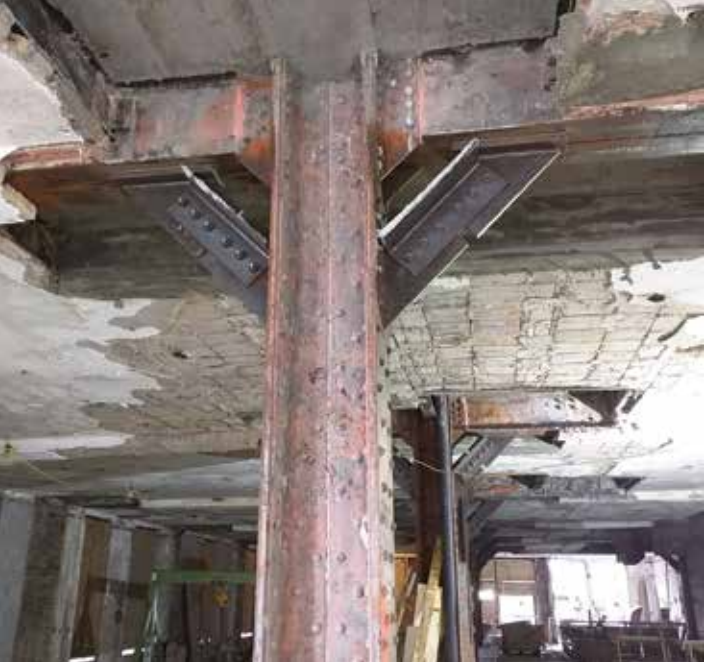
Figure 3. These double angle steel knee braces were installed at approximately 175 locations throughout the interior of the existing building.

- 2) The steel braced frames were coupled with double angle steel knee braces (Figure 3, page 24), installed at approximately 175 locations throughout the interior of the building. This turned the existing interior double I-beam girders into link beams between the steel brace frames and knee braces. This provided the additional lateral stiffness required to draw load away from the exterior moment frames. This approach required local reinforcement of the existing columns against prying effects on the riveted built-up steel columns, but maximized the excess axial and bending strength of the interior columns.

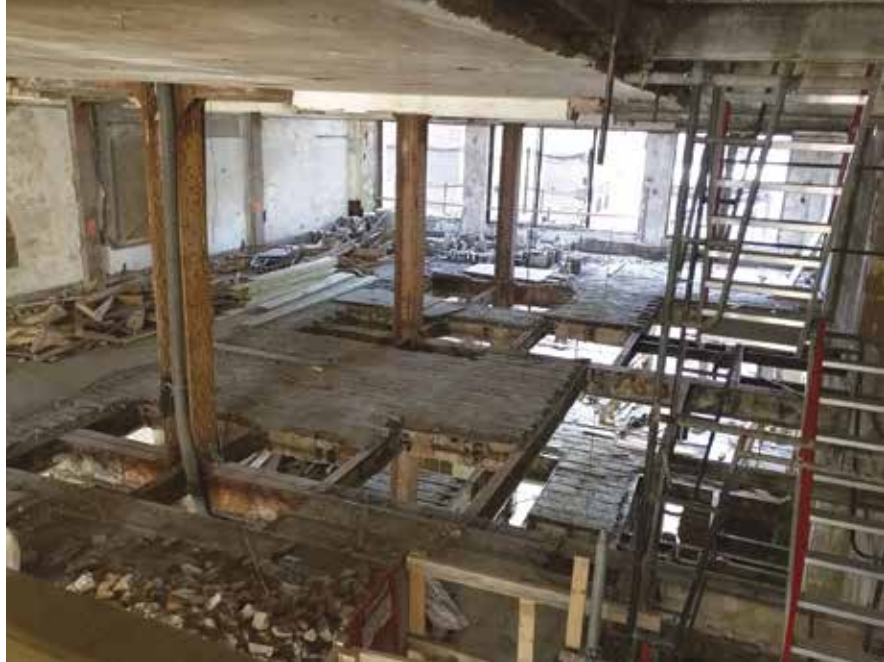
Figure 4. A typical level showing extensive demolition of the existing clay tile slab.

- Previously abandoned renovation attempts created openings in the existing clay tile slab around nearly every existing column (approximately 200 locations) (Figure 4). These areas, combined with new demolition due to programming requirements, were infilled using a cast-in-place concrete system developed to reduce construction time and costs compared to a slab-on-metal deck infill. This was achieved by eliminating the need for field welding new beams and metal deck to the existing painted steel I-beams, which would have required costly lead abatement before welding. Eliminating the need for new steel beams at the perimeter
