PRESERVING the Many Glacier Hotel

By Ian Glaser, P.E., and Christine Britton, P.E.

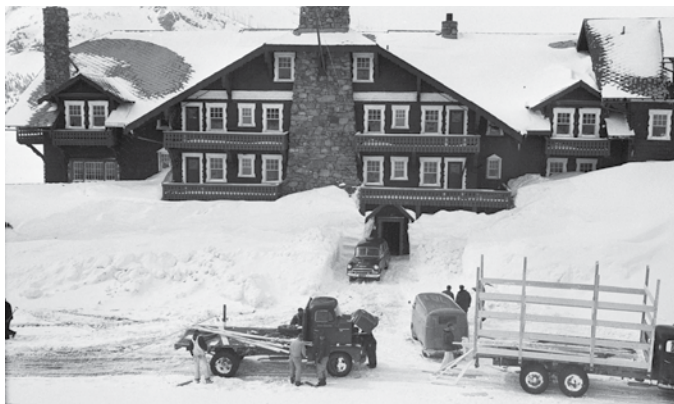
The Many Glacier Hotel in April 1956. Snow has reached the second floor of the lobby. Chimney at left was removed at an unknown date before the recent rehabilitation work. Courtesy of Glacier National Park Archives.

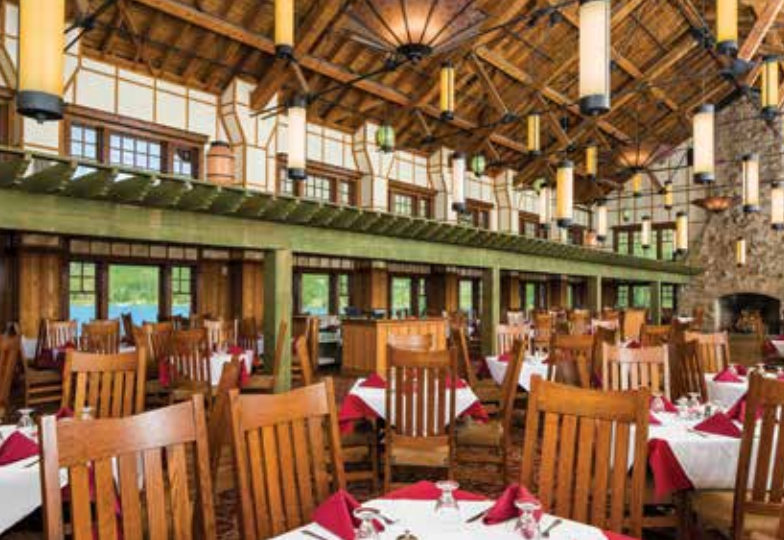
Interior of the dining room featuring the chimney and the original roof trusses. Courtesy of Mark Bryant Photographics.

The roof framing over the dining room had been concealed by a dropped ceiling installed in the 1930s. After selective strengthening of the purlins using lumber that matched the original lumber in appearance, the dropped ceiling was removed. The timber and steel-rod trusses were re-exposed, paying homage to the railroad engineers that designed and built them.

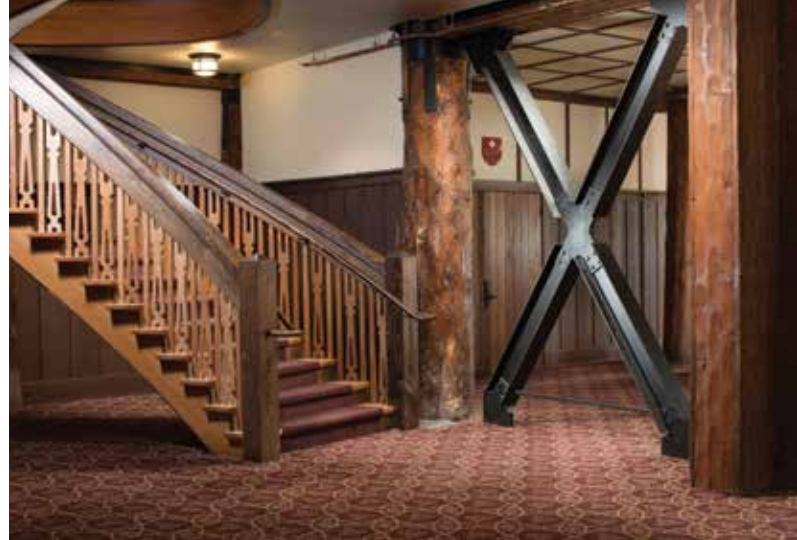
Braced frame in the basement level of the lobby. Courtesy of Mark Bryant Photographics.

The lobby wing features a ring of twenty 30-inch-diameter Douglas-Fir columns that extend from the basement to the roof and form the grand atrium space. The main level had very few walls that could be used as lateral force-resisting elements. Steel moment frames were ruled out since they would impact the aesthetic of the space. Instead, the log columns were mobilized as vertical collectors that receive upper-level shear forces and transfer them into the strengthened first-floor diaphragm and, in turn, into braced frames in the basement. The braced frames in the lobby's basement are some of the only structural retrofitting measures that are visible to the public.

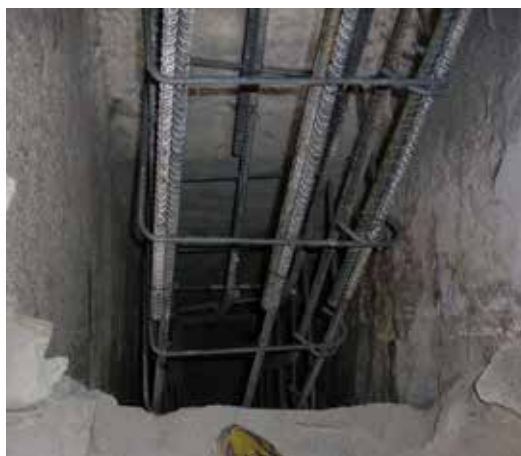
Reinforcing cage inserted into the full-height flue of the dining room chimney. Courtesy of Dan Cooke, JVA, Inc.

The dining room chimney has two flues. The flue that originally served the boiler in the basement was cleaned, reinforced, and grouted. The chimney's shoulder on the opposing side was removed, a reinforced concrete chord installed, and the shoulder was refaced with the original stones in their original positions. The dining room flue, which follows the reinforced shoulder, remains operational.
