## Fuzzy Wood and Coastal Piles

By Richard S. Barrow, P.E., S.I.

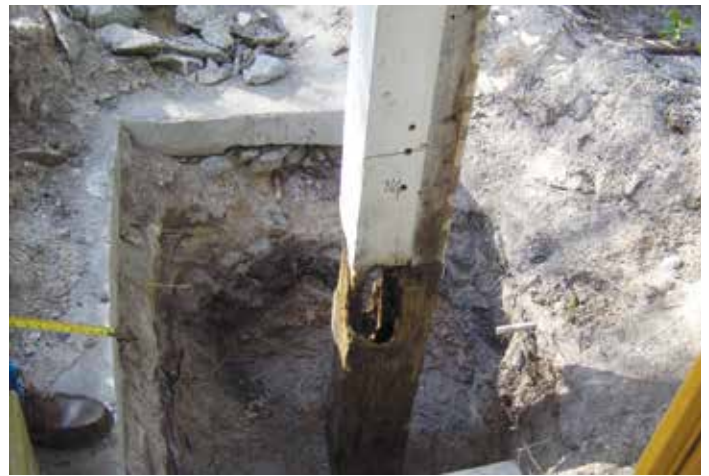
In high school biology class, we learned that all life requires air, food, water, and a sufficiently warm environment or habitat to survive. Naturally, the fungi, mold, insects, and marine life that inhabit and consume wood piles are no different. A wood pile driven into the soil will tend to degrade at or near the ground surface. At no more than a couple of feet below ground, oxygen levels become insufficient to support most life. At a couple feet above ground there may not be enough moisture to support life (*Figure 1*).

Figure 1. Wood pile deterioration near grade.

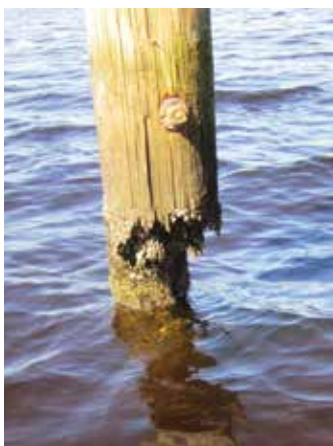
Similarly, piles driven into water will tend to degrade in the tidal zone or at just above the mean water elevation. In the continuously submerged zone, the low oxygen content is only sufficient to support some organisms (e.g. marine borers). Above the waterline, the amount of moisture is limited by drying of the pile (*Figure 2*).

Figure 2. Wood pile deterioration near waterline.

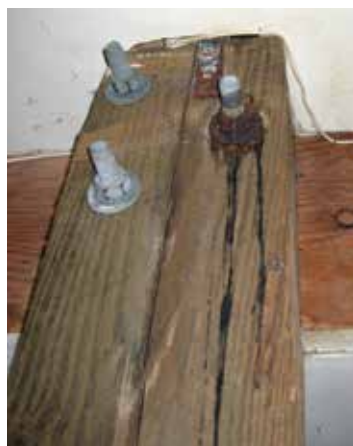
the piles would be on the portions of the pile that are exposed to the elements. Therefore, despite the lack of exposure to salt spray, it has been surprising to find that such sheltered piles often have severely corroded bolts connecting the top of the piles to the wood floor framing (*Figure 3*). Those piles may also have a furry or fuzzy appearance, which some fittingly refer to as “fuzzy wood” (*Figure 4*). Why would a wood pile, driven on land or near a body of saltwater, deteriorate at the protected top and not at the ground level or the waterline? To understand the cause of “fuzzy wood” and to provide an appropriate repair for that condition, we must examine the internal structure of wood and the response of that structure to saltwater.

Figure 3. Corrosion of bolt due to wicking at the top of an interior pile under a coastal home.

bearing points under beams are typically areas where a waterproof coating or an isolation material is needed to separate bolts and beams from the pile.

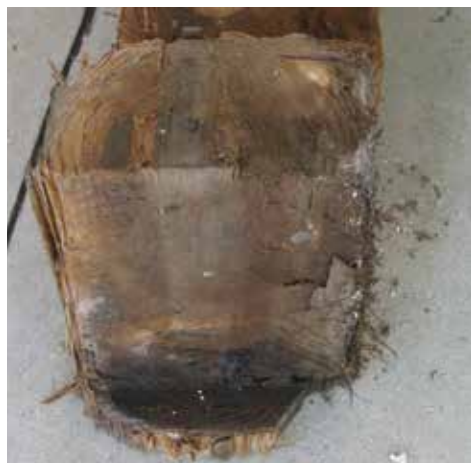
Figure 4. Fuzzy wood pulled from a jacketed dock pile.

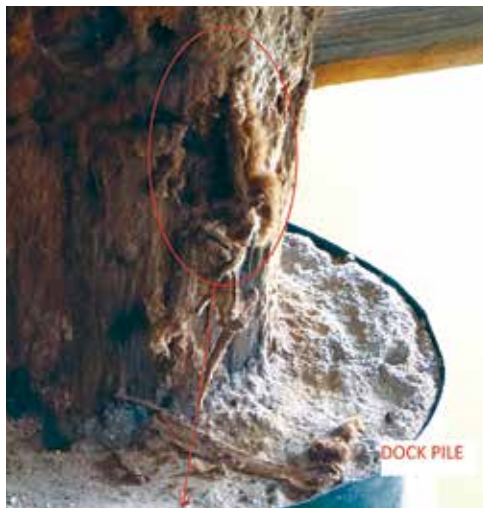
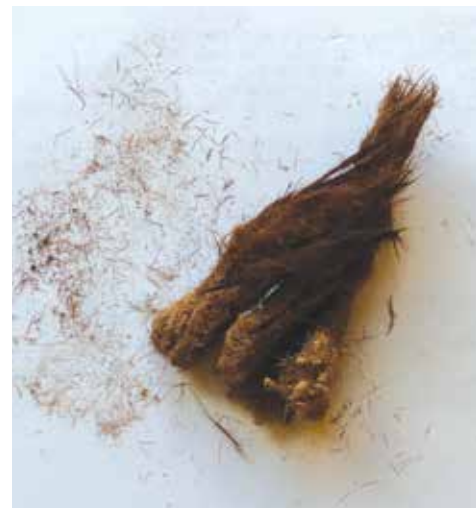
Figure 5. Left: Top of pile removed below a notch for floor beam bearing (note fuzzy wood on the right side). Right: "Fuzzy" wood and annular rings on the bottom portion of a coastal pile cut six inches below a degraded notch for floor beam. (photos are not of the same pile).

Piles with significant structural damage or loss of structural capacity are more challenging to repair. This is because it is expensive, if not impossible, to replace existing driven wood piles "in-kind" under an existing structure. Consequently, shoring and repairing only the degraded top portion of the damaged pile may be preferable to replacing the entire pile. Figure 5 shows a pile with significant damage at the top. However, when the pile was cut off, approximately six inches below the notch for bearing of the floor beams, the lower portion of the pile was found not to be significantly damaged. A splice can also be designed as a moisture barrier between the new top portion of the pile and the existing bottom portion.
