Why Did It Crack?

The Challenge of Determining the Root Cause of Cracking in Thick and Restrained Joints

By Elizabeth Mattfield, P.E.

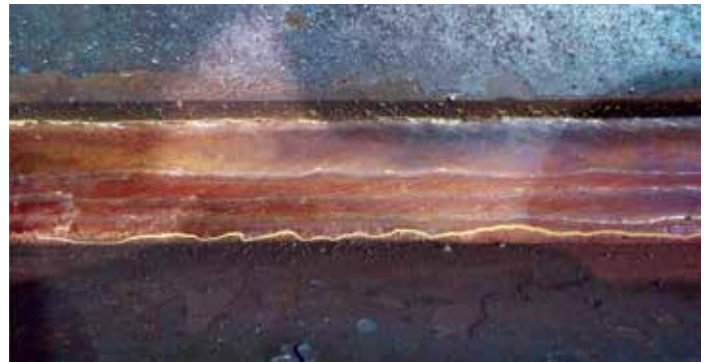
To confirm the extent and origin of the crack, magnetic particle testing (MT) of the welded joint and surrounding base metal was conducted by the shop's quality control inspector. It revealed the crack shown in the photos, with yellow powder accumulating in the cracked metal to distinguish the extent of cracking. It is clear from the powder's location that this fracture had originated in the heat affected zone (HAZ) at the weld's termination and propagated as a transverse crack into the base metal. Ultrasonic testing revealed that the crack extended 1-inch-deep in the ¾-inch-thick material.

Longitudinal crack at the weld toe.

Upon first inspection of mill test certificates of the steel received, it was evident that, while the WPS was perfectly acceptable for the designed ASTM A572 Grade 50 steel, it did not account for the properties of the steel that was actually received and being welded. In fact, the steel far surpassed the minimum yield and tensile strength specified for ASTM A572 Grade 50 steel, with yield values in the 62-63 ksi range and tensile values in the 91-93 ksi range. From a welding perspective, this steel would fall into Group III base metal, becoming undermatched by the 70 ksi filler metal being used to weld it. Undermatching of filler metal is favored where acceptable, such as in this case, where the design only demanded 50 ksi base metal. However, the extremely high tensile strength also pushed the base-filler metal combination into Category C, a category which requires a *minimum preheat of 300 degrees F*.

After determination of preheat via a hydrogen control method (Annex H of AWS D1.1:2015), it was verified that, indeed, this base metal should have been preheated to a minimum temperature somewhere between 300° and 320°F.

pieces of material, each 3/4-inch-thick. The volume of weld metal alone produces a joint of extremely high restraint, with stresses far exceeding the tensile strength of the steel during welding and cooling that occurred with each pass. The addition of stress relief holes at each end of the joint would provide a path for relief of heating and cooling stresses. Instead, the weld starts and stops abruptly at the ends of the tee joint, a perfect location for crack formation and subsequent propagation into the base metal.

control of at least some of the most common contributing factors can often be enough to preclude weld cracking. In this case, the contractor's determination of appropriate preheat and interpass temperatures for thicknesses over 2 inches and providing stress relief holes in the joint would likely have been sufficient to prevent the welds from cracking. ■

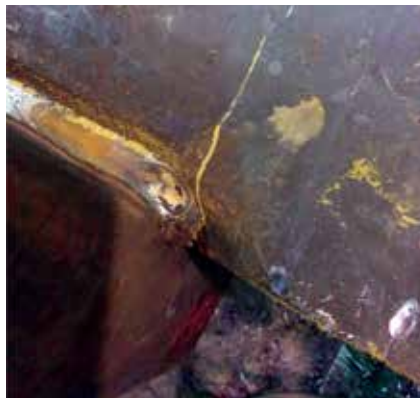
Transverse base metal crack at the end of the weld.

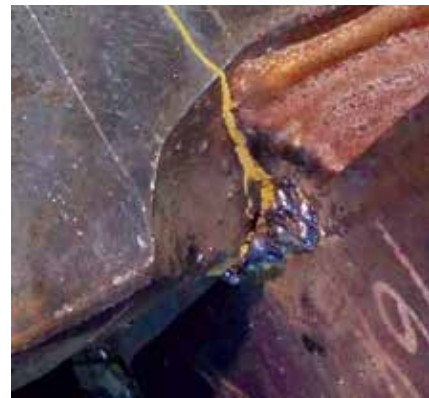
Transverse crack at the end of the weld, propagated from weld into the base metal.
