# Earthquake Effects on Temporary Wind Bracing

By James M. Williams, P.E., C.E., S.E., AIA, LEED AP

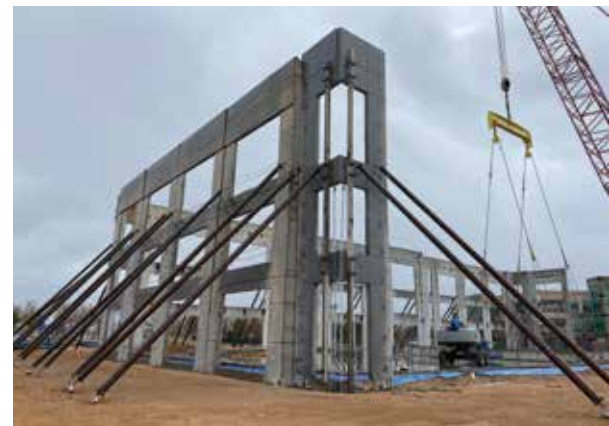
3-story tilt-up panel braced to the exterior using temporary helical piers.

At one particular building site (10 miles from the epicenter), a 3-story tilt-up building, with half of the wall panels erected and temporarily braced, was observed. The majority of the panels were braced to the exterior of the building using temporary helical piers to expedite construction. One corner of the building was braced to the interior floor slab due to its proximity to a drive lane. All of the tilt-up wall panels on this site remained standing after the earthquake, but there

was one localized bracing connection failure where the anchor pulled out from the panel. Another concern at this site was that the top of one of the helical piers appeared to have rotated. It was not clear if the earthquake caused this, or if the pier had been installed that way initially. Multiple wall panels moved several inches so that the spacing between panels was no longer uniform, and a couple of panels were no longer perfectly vertical or plumb. Wall panels had to be re-set, and the failed brace needed to be reattached. It should be noted that the 1-inch-diameter adjusting screws at each end of the braces were only partially extended, and the braces and connections were in good condition and quite robust.

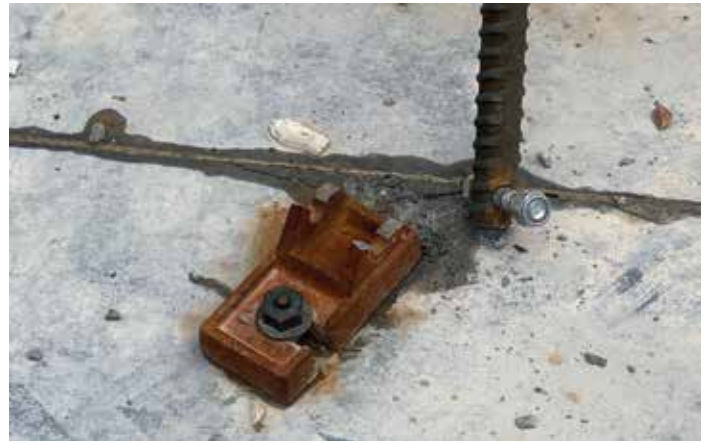
One of several failures of a footplate identified after the earthquake.

None of the wall braces buckled or showed any sign of damage except for the adjustable rod at the base of the brace and the footplate. The ¾-inch-diameter adjusting screws at the bottom of the braces were extended approximately 12 inches, and many had bent. The connections of the braces to the wall panels remained intact, but the connections of the braces to the floor slab had several modes of failure and appeared to be the weak link that resulted in the collapse of some of the wall panels. There were very few places where the slab showed cracking and or spalling at the brace anchor. The majority of the failures had to do with the brace footplate. There were several

locations where the anchor into the floor slab was intact, but the footplate of the brace had slipped off or away from the anchor. This was likely caused by the wave or rolling effect of the earthquake. There were many other locations where the anchor remained attached to the floor slab, but the foot plate itself sheared off, either at the slab anchor or at the bolted connection to the brace itself. All of the foot plate failures appeared to be a brittle shear failure.

The weak link in the temporary wind bracing is the brace footplate when braces are in tension from being subjected to the sudden impact of an earthquake force. The same failure mechanism (footplate fracture) most likely occurs at higher wind speeds as well. Increasing the adjusting screw diameter would also reduce or omit the bending that occurred. The argument still exists as to whether temporary bracing should be designed for any seismic force at all. Perhaps temporary bracing should be designed to withstand the forces associated with a moderate earthquake of magnitude 5.5 to 6.0, which results in slight property damage, since they occur approximately 500 times a year

All the temporary bracing was replaced as mandated by the bracing engineer and supplier as a result of the earthquake. Wall panels and spandrel beams that fell were also repoured. All the connections required additional special inspection, as did the structural steel and open web joists. Footings and floor slabs fared well and did not require repairs. Each project experienced considerable delays and increased costs due to the earthquake. Each building had to be assessed by a third-party engineer and architect for insurance claims. Earthquake damage remediation plans and processes also had to be generated.

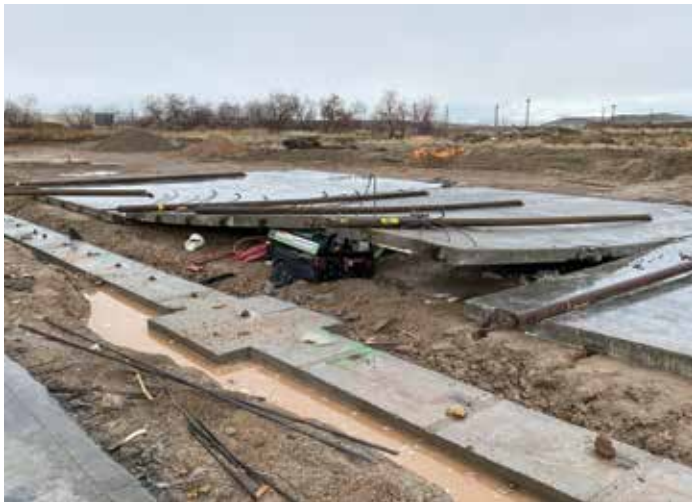
braces always prevented the wall panels from falling inward. All of the wall panels that fell were also thrown approximately 5 to 6 feet away from the building. This is important information for contractors to understand as they consider fall zones for future projects.

Toppled wall panels thrown approximately 5 to 6 feet.

All the wall panels that did fall had to be repoured. The embedment connections between panels appeared to be severely damaged, but the damage occurred from the panels falling and not from the earthquake forces themselves. When the panels fell, the connection angles between the footing and the wall panels failed in tension. The legs of the connection angles were still welded to the footing and the wall panel but were simply pulled in half due to the large moment at the base of the panels once the braces had failed. There were some decorative bump-outs in some of the walls that remained standing, which also helped to brace adjacent panels. The damage to the remaining buildings was identical to this second building.
