Adaptive Reuse of the Apex Hosiery Company Building

Part 4: Demolition Special Inspection and Post Demolition Assessment

By D. Matthew Stuart, P.E., S.E., P.Eng, F.ASCE, F.SEI, A.NAFE, SECB

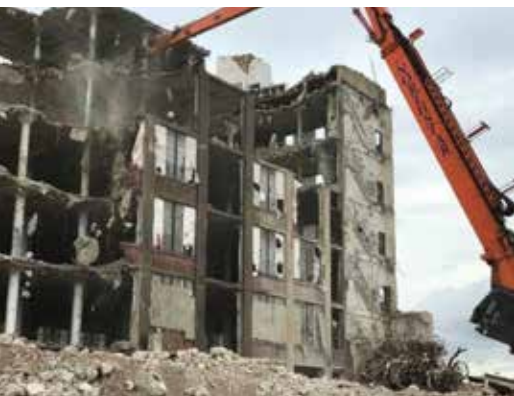
The second incident involved a localized progressive collapse of an SMI framed bay down to the foundation, in an area of the building that was scheduled for complete demolition. The collapse began on the 4th floor as a result of overloading the affected floor framing with an excessively large debris pile. The collapse then progressed through the floors below until

Figure 19. A progressive collapse to the ground floor began on the 4th floor as a result of overloading the floor framing with an excessively large debris pile.

coming to rest at the ground floor slab, as shown in *Figure 19*. No injuries occurred as a result of the localized structural failure, and the demolition contractor was instructed to avoid similar overloading going forward.

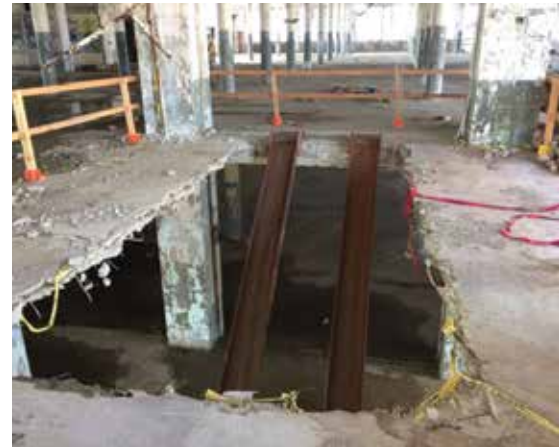
The first incident involved the demolition contractor cutting a large, unapproved opening in the SMI slab, as shown in *Figure 18*, to enable equipment to be driven between the floor levels scheduled for demolition. Subsequent assessment and engineering evaluation indicated that the opening had compromised the structural integrity of several top and bottom reinforcing hoops within the bay containing the opening. As a result, the load-carrying capacity of the immediately adjacent surrounding bays was reduced. The solution submitted by Pennoni to correct the temporary structural deficiency involved the installation of shoring posts in the surrounding compromised bays.

Figure 18. Vehicle access opening cut in the slab during demolition required the installation of shoring posts in the surrounding compromised bays.

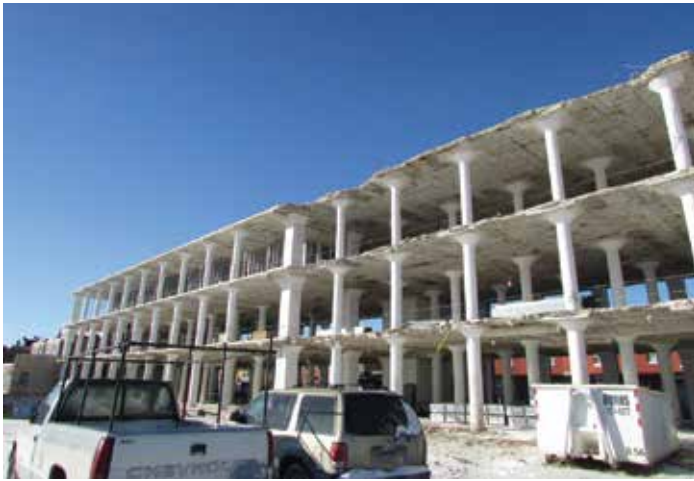
However, along a majority of the eastern line of demolition at the northern SMI slab, the demolition contractor did not take adequate precautions to ensure a uniform vertical face of demolition across the depth of the slab, as shown in *Figure 20*. As a result, a number of top and bottom reinforcing hoops that were intended to remain were destroyed or damaged, as shown in *Figure 21*. As a result, and similar to that described at the large equipment access opening during the demolition Special Inspection, the load-carrying capacity of the remaining, immediately adjacent bays to the west of the line of demolition was reduced.

Figure 20. The demolition contractor did not take adequate precautions to ensure a uniform vertical demolition face along most of the eastern line of demolition.

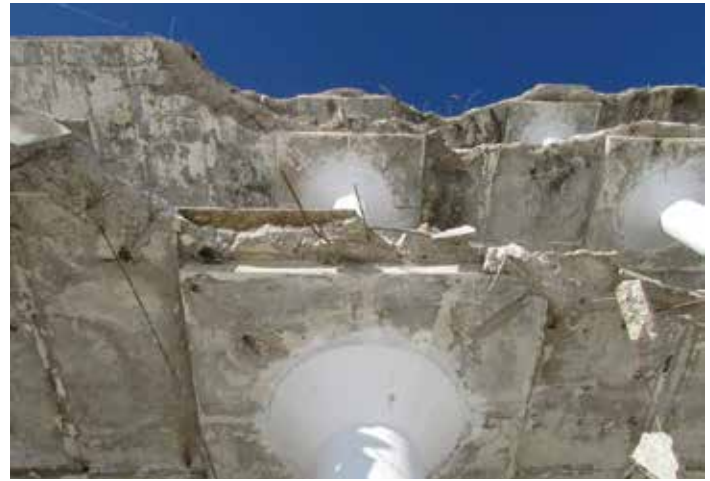
This reduction in load-carrying capacity occurred because once a hoop is no longer embedded in a significant portion of concrete anywhere along its circumference, or severed, it can no longer function to resist the radial flexural bending forces in the slab. Therefore, in an SMI slab when a top hoop is no longer able to function properly in response to negative cantilever flexural action induced by the supported adjacent simple span slabs, the undamaged diagonal and damaged orthogonal (i.e., north-south) positive moment span hoops must resist forces associated with a longer span

Figure 21. Several top and bottom reinforcing hoops that were intended to remain were destroyed or damaged, resulting in reduced load-carrying capacity of the remaining bays adjacent to the demolition line.

While the existing affected bottom hoops of the controlling diagonal span did appear to have enough reserve capacity to allow the slab to span the longer distance under its own dead load adequately, whether or not the slab had enough adequate reserve capacity to provide the required new adaptive reuse minimum live load of 40 psf and dead load of 15 psf for partitions, could not be confirmed. In addition, the load-carrying deficiency at the north-south orthogonal positive moment slab span was further adversely impacted by the loss of embedment or damage at some of the bottom hoops along the erratic line of demolition.

A proposed solution to the damaged conditions along the eastern line of demolition was submitted to Pennoni for review by another engineer engaged by the developer. The proposed solution involved attaching reinforcing bar dowels via mechanical couplers to all of the damaged reinforcing projecting from the line of demolition and encasing the same supplemental reinforcing in a newly formed and poured slab edge along the affected eastern edge of the northern section of the remaining building.

A review of the proposed repairs indicated that, for the framed SMI slab to be restored to its original capacity, the slab in the first bay west of the line of demolition would need to be jacked up to relieve all self-weight stresses from the remaining undamaged orthogonal and diagonal bottom and cantilever top hoops. Relieving the existing dead load from the remaining undamaged hoops would allow for the proper redistribution of the existing dead load to both the undamaged and repaired hoops, as well as ensure proper sharing of the proposed future loads by both the remaining and repaired hoops.

A plan of the required location of the temporary jack shoring was provided by Pennoni, which indicated that jacking of the slab to relieve the dead load must be sequential, starting at the ground level and then proceeding up to the next level above. The slab was to remain jacked up and shored until the repairs had been completed, and the new concrete slab edge had achieved full strength. Once the shoring was in place, the proposed couplers and bar extensions could then be added to the projecting remains of the top and bottom hoops so the same hoops could function again as initially intended.

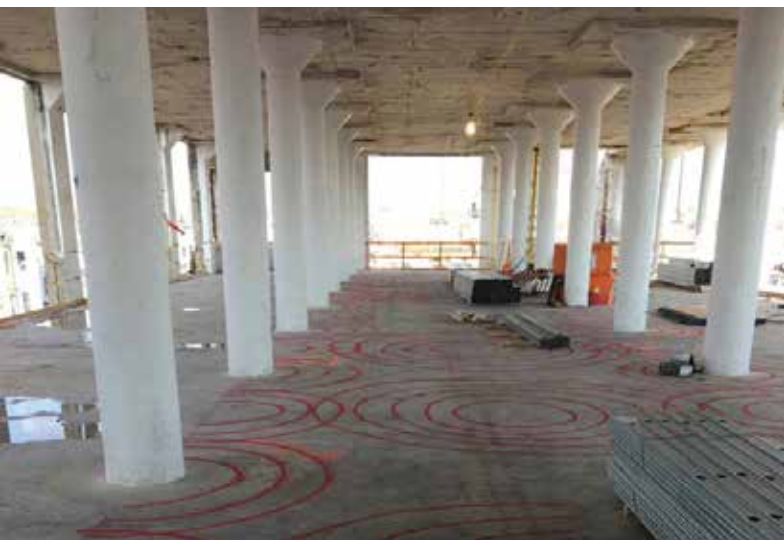
Figure 22. GPR equipment was used to locate the embedded SMI hoops, and their locations were painted on top of the concrete slab surfaces to prevent further damage.

After the completion of the demolition operation that involved drilling and coring new mechanical and utility penetrations, it was recommended that the location of the hoops be identified to prevent additional damage to all of the embedded and concealed SMI hoops during the renovation work. This was accomplished using ground-penetrating radar (GPR) equipment, which allowed for the location of the hoops to be painted on the surface of the concrete slabs, as shown in Figure 22.
