DEADLY MIAMI PEDESTRIAN BRIDGE COLLAPSE

Why and How the Structure Failed

By Ran Cao, Ph.D., A.M.ASCE, Sherif El-Tawil, Ph.D., P.E., F.ASCE, F.SEI, and Anil Kumar Agrawal, Ph.D., P.E., M.ASCE, F.ACI

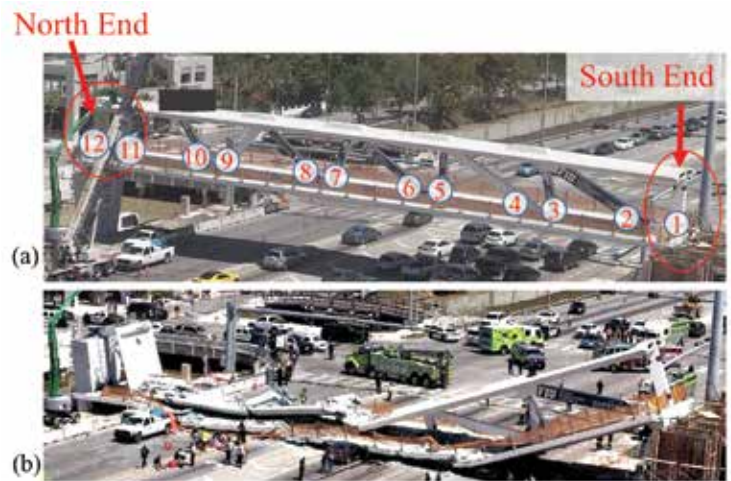
Figure 1. Main span of the bridge: a) before collapse; b) after collapse. Courtesy of NTSB.

On March 15, 2018, a pedestrian concrete truss bridge in Miami, FL, collapsed during construction. The span that collapsed had been designed as a concrete truss bridge with prestressed members. Figure 1 shows the bridge site before and after the collapse of the main span. The collapse caused multiple fatalities and raised serious concerns regarding the design and construction of the bridge, including the emerging concept of Accelerated Bridge Construction (ABC). ABC usually involves innovative planning, design, and construction methods to reduce the onsite construction time that occurs when building new bridges or replacing existing bridges. In this project, the main span of the bridge was constructed offsite, then transported and placed onto its piers overnight. The bridge collapsed five days later with the roadway underneath it open to traffic. According to the preliminary report from NTSB, workers were re-tensioning tendons in diagonal member 11 (Figure 1) at the time when the bridge collapsed.

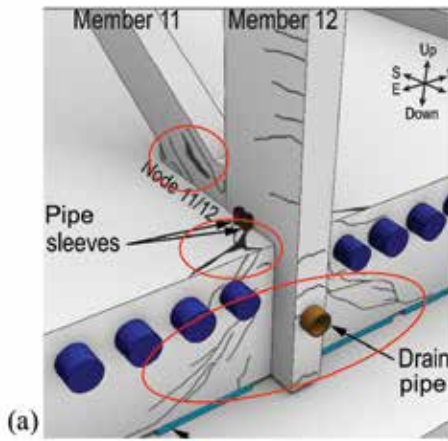
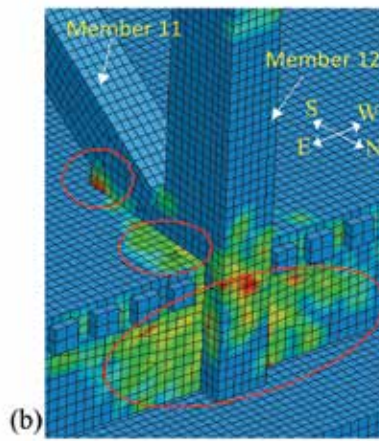
Figure 3. Cracks in the joint area of Member 11 after relocation: a) actual bridge, courtesy of NTSB; b) simulation.

Extensive cracking appeared around the joint at the north end of the bridge after the main span was placed on the piers. Figure 3 shows the concrete cracking observed in the real bridge and computed from the simulation model. There is a reasonable correlation between the observation and the simulation, providing confidence in the simulation model's fidelity. The east side of the joint experienced severe cracking damage in the heel of member 11 (Figure 3a) due to excessive sliding along the cold joint between members 11 and 12 and the deck. Other cracks extended into the deck, creating a pattern consistent with punch-out failure distress associated with the excessive force demand imposed by diagonal member 11 onto the deck. The simulation model suggests that the bridge was on the verge of two different types of failure modes: sliding along the cold joint and punch-out failure in the deck region.

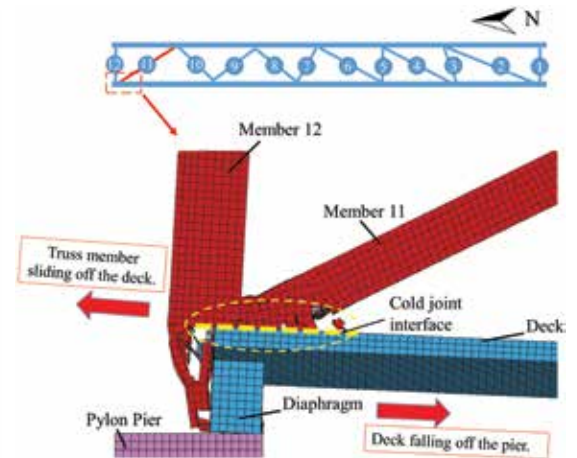
Figure 4. Sliding action triggered by re-tensioning member 11.

After observing the cracked condition of the bridge at the north end joint, bridge engineers decided to re-tension diagonal member 11 in an attempt to close the cracks in the joint region. During this operation, the bridge collapsed. The simulation model suggests that collapse occurred due to sliding on the cold joint between members 11, 12, and the deck (Figure 4). In essence, the north end joint was pushed out, causing the bridge to fall off its support. Instead of

- 3) Re-tensioning diagonal truss members should not have been considered as an appropriate solution to remedy the cracks in the cold joint area since it promoted more sliding across the cold-joint, making the bridge more vulnerable to collapse. Cracks in the cold joint area should be viewed as a meaningful warning sign of impending collapse, and immediate action should be taken to ensure the stability of the structure after detailed calculations or modeling.

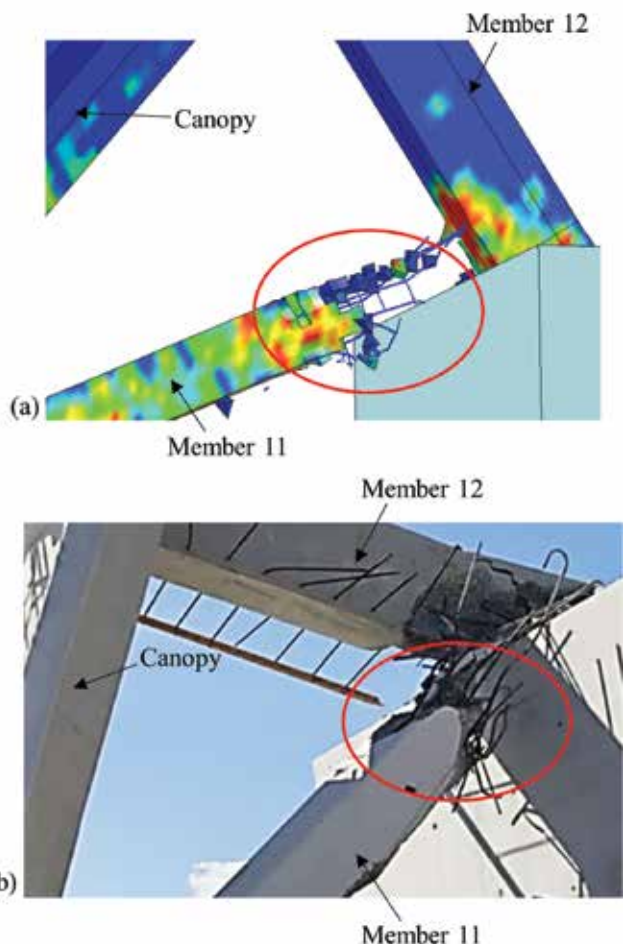
remedying the cracking symptoms as intended, re-tensioning member 11 aggravated the situation and precipitated the progressive collapse process. Figures 5 and 6, page 32, show the collapse process, the final configuration of the actual bridge, and as-computed from the simulation model. The simulation results captured the collapse mode of the bridge reasonably well.

Figure 6. Close up of failure of member 11 during the collapse: a) simulation; b) accident photo. Courtesy of NTSB.

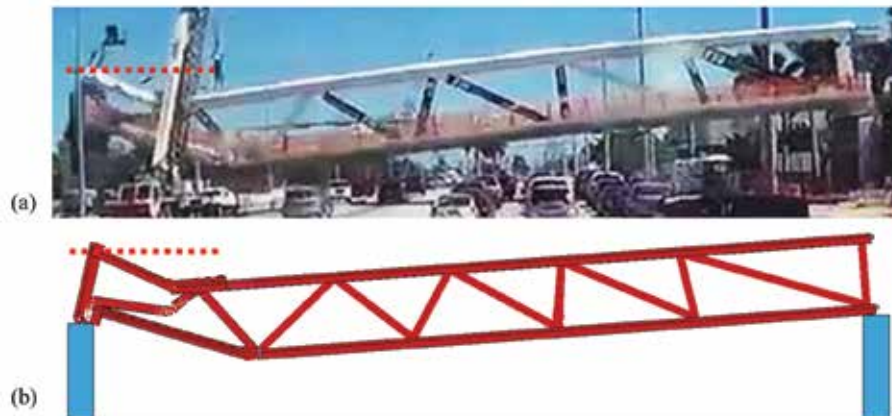
Figure 5. Failure mode of the bridge from a) accident video frame, courtesy of Instagram/@o2webdev; and b) computer simulation.
