# SHORING THE UNSHORABLE

## Challenges in Repairing a Severely Corroded Rooftop Cooling Tower Support Structure

By Roya A. Abyaneh, P.E., and Edward S. Breeze, P.E.

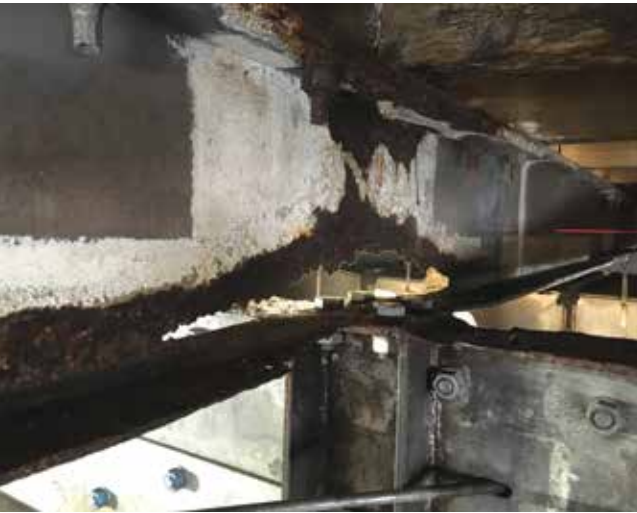
Figure 1. Corrosion of steel beams below the cooling tower.

The existing structure's assessment revealed that the steel girders had experienced up to 50% section loss in some of the webs and flanges. In some locations, personnel could poke their fingers through the web (*Figure 1*). The most severe corrosion was observed directly over a central concrete pedestal. Each of the 12 concrete pedestals was built with four encased steel pipes, which had also been damaged by corrosion.

The corrosion across the web and flanges of some sections was so significant that it would be necessary to cut out the deteriorated length and to splice in new pieces. Adding steel plate reinforcing was also considered; however, several areas exhibited insufficient “healthy” steel for suitable welding or composite shear flow through the beam. Further, the repair steel would have covered most of the existing steel, impeding the ability to monitor for future corrosion.

Substitution of the damaged beam section appeared more practical. Shoring would need to redirect the cooling tower loads while the corroded steel was cut out, and a new section was spliced in. Unloading the members nearest to one pedestal by shoring would result in a change in the loading of the other pedestals. The roof framing was analyzed as a system to understand the unintended effects of shoring.

After stabilizing the shores, the contractor cut out the deteriorated beam section, and a new piece was spliced with welded full-moment connections. The placement of welded splices was designed around the wood beam locations with appropriate fire watches. Bent splice plates were used to join the new and old steel. These plate bends were necessary because of the mismatch between the historic steel shape heights and the new steel shapes.

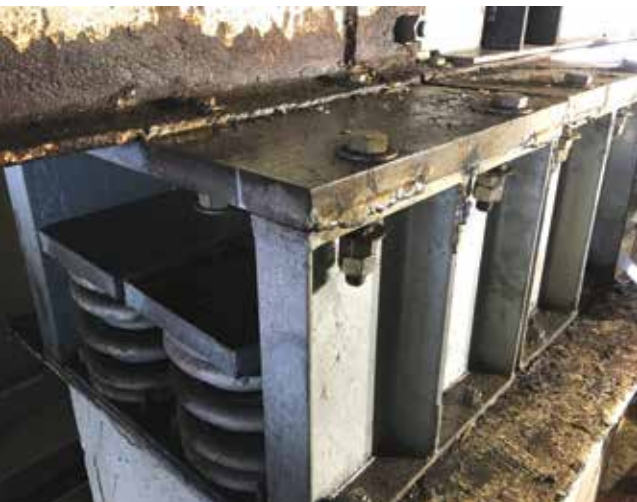
Figure 2. The base isolator bearing plate was temporarily welded.

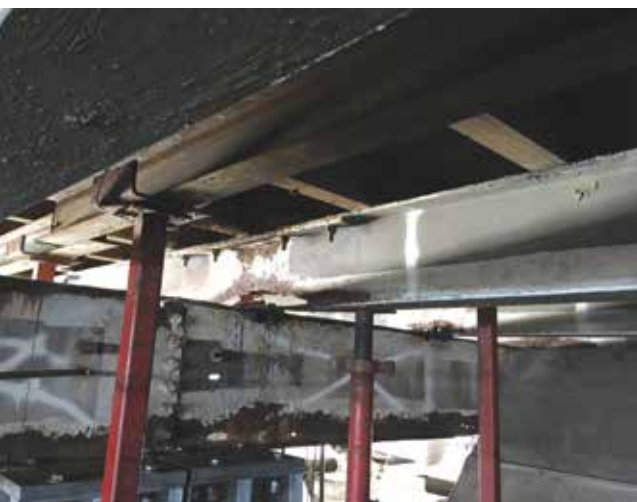
Figure 3. Post shores and horizontal shoring beam.

Before the shoring process began, the as-built construction of the roof framing was verified by accessing the roof’s underside. Temporary lateral braces were installed at shoring points and at locations where bracing members were disconnected. Although the lifting process was intended to unload the steel beams, it would also decompress the isolator springs supporting them. This decompression would push the beams upwards and prevent the intended clearance gap between the steel beams and the cooling tower. The base isolator’s top bearing plate was temporarily welded to lock its position (*Figure 2*). Shoring beams placed on each side of the repair lifted the wood beams from the top of the subject steel (*Figure 3*). A laser level was used to monitor the displacement progress.

The post shores operate based on a screw jack system. Once the shores were each snug-tight against the structure, the lifting team would advance all shores in a row by half a turn, alternating between rows. Lifting the wood  $\frac{3}{16}$  inch proved adequate to install the new steel beam sections.

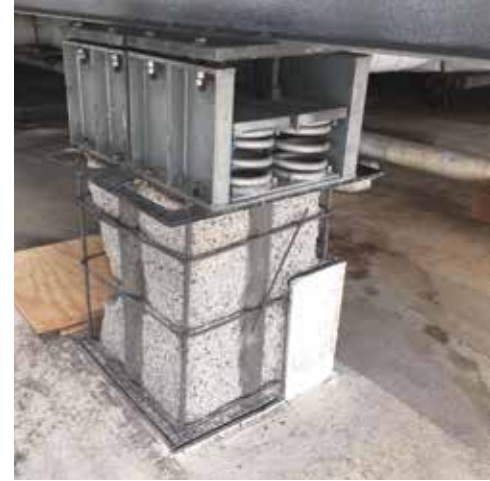
The concrete pedestals also revealed more significant distress than initially evident. The contractor removed loose concrete up to 8 inches deep, revealing encased steel pipes (*Figure 4*). Ultrasonic testing was used to confirm that the pipe thickness was adequate to remain in place. The steel was cleaned, new mild steel reinforcement was installed, and concrete patching was placed.

Figure 4. Repair of the concrete pedestals revealed the encased steel pipes.
