Falling Through the Cracks

Unexpected and Unfortunate Events Leading to Structural Failures

By Ross J. Smith, P.E., LEED AP BD+C, CDT

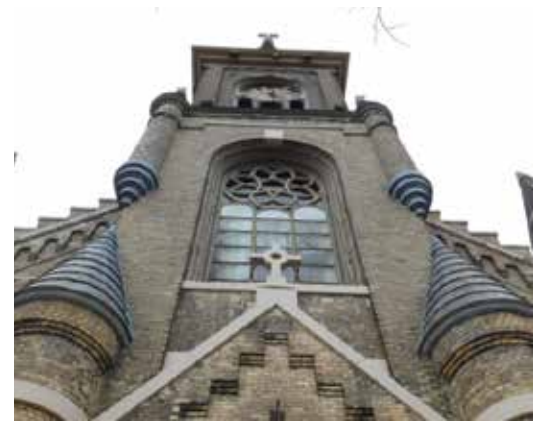
In hopes of saving the building, concerned staff and community members sought an independent technical opinion from a structural design professional. Grade-level exterior inspections revealed a series of cracks that existed in the exterior brick masonry at windows, doors, and near building corners. Presenting at areas of expected stress concentration throughout the building, these cracks were common in masonry of this vintage and not related solely to structural behaviors of the tower.

Significant gaps between the exterior masonry wall of the tower and the perpendicular flying buttresses of the adjacent side aisles were observed from windows of adjacent structures. Previous reports and assumptions asserted these gaps were specifically attributable to the usage of the carillon bells.

Figure 1. Front elevation view of 1888 church bell tower in Northern Michigan.

Fortunately, in this case, the involvement of a structural professional furnished the church with a fact-based assessment and detailed explanations regarding typical exposure-related masonry cracking and separations due to long-term differential building movements. Armed with renewed insight, a phased masonry restoration program was initiated, the carillon restrictions lifted, and the community gathered around the spire once again to hear the bells ring.

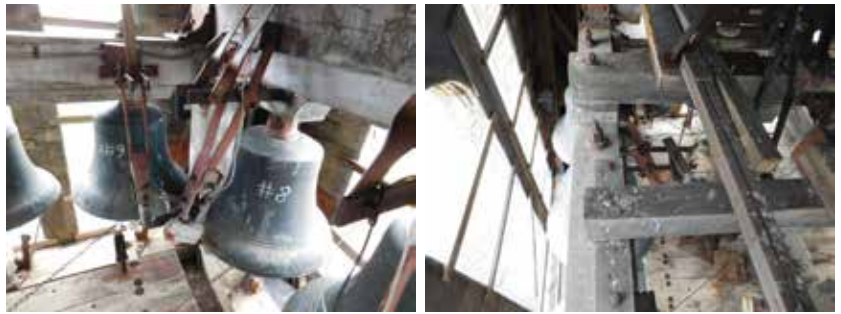
the ringing of each bell is activated by a side-mounted, electronically-activated hammer (*Figure 2*). Since they are stationary, the bells do not create any significant dynamic forces within the tower. Further, whatever minimal forces are initiated are not transferred to the masonry walls due to the as-designed structural isolation. Combined, these two realities painted the originally voiced concerns as potentially costly misconceptions.

Figure 2. Left: View from the belfry where bells are observed to be permanently affixed and stationary. Right: View from the belfry revealing the bell support framing is structurally isolated from the tower

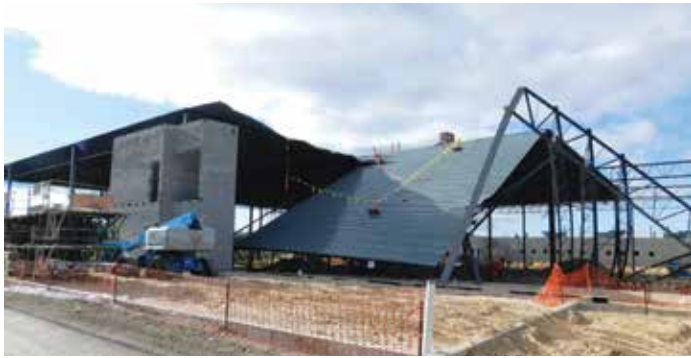
Figure 5. Partial view of framing and roof collapse.

A plastic molding and electrostatic plating company touting 50 years of manufacturing success and experience decided to support continued growth by adding a new manufacturing facility in Western Michigan. A 40-foot-tall high-bay structure comprised of steel columns, connecting girders, and panelized joist assemblies was selected, designed, and rapidly constructed to expedite the opening, usage, and profitability of the expanded facility. With over half of the structure and roof deck in place, a construction failure occurred. The collapse damaged two 50- x 60-foot bays of steel framing and one completed bay of roof joists and decking (Figure 5). During post-event interviews, the steel erector admirably accepted responsibility and provided insight on some contributing causes leading to the collapse.

After erecting two new columns and girders spanning from the existing frame to the new columns, the bay frame was not completed with a tie joist linking the two columns. Instead, since it was nearing evening and raining, the work was stopped early for the day, leaving the two girders and their end columns unbraced. Rain evolved into a storm with high winds causing the unbraced girders and columns to enter a dynamic cycle of out-of-plane displacements, eventually culminating in failure at the column baseplate connections. Felled columns pulled down their respective girders, which pulled additional columns and a progressive, multi-bay failure ensued. "All because of the rain," as reported.

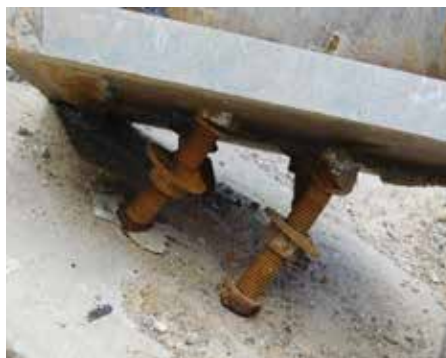
Closer inspections of the debris field found oversized double holes in the column baseplates and cupped round washers. Some washers

and nuts had completely pulled through their baseplates (Figure 6). Other anchor bolt assemblies where columns were not yet placed were found with brand new square plate washers installed and corroded round washers discarded nearby. Clearly, material selection and field implementation had suffered and contributed to the event. A detailed review of the joists revealed numerous failed welds at the bearing seat angles as well as misplaced, oversized holes. Poor weld quality allowed shearing failures between joist webbing and the seat angle (Figure 7), leaving the entire seat angle perched on top of the column. Fabrication of the joists, particularly the quality of the welds, was now in question as well.

Figure 6. Close-up view of anchor bolt washers and nuts that pulled through oversized baseplate holes.

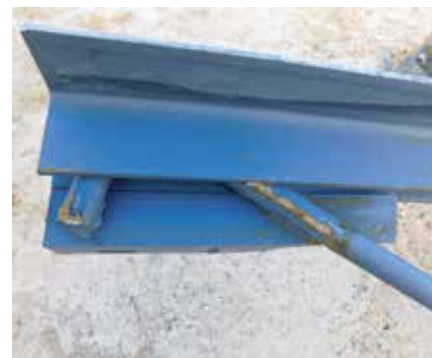
Figure 7. Close-up view of joist seat, which has sheared off at suspect quality weld locations.

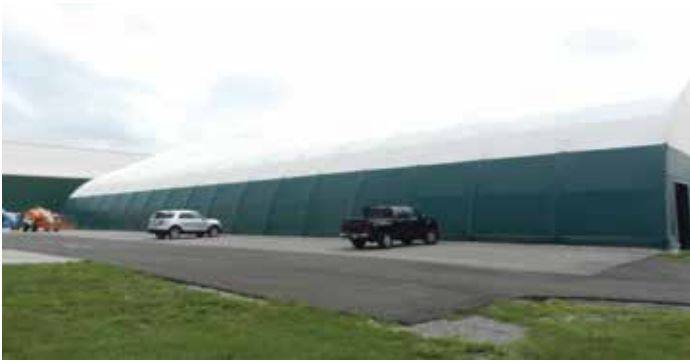
An indoor tennis facility on the western fringe of lower Michigan suffered snow-related damage during the unusually heavy winter of 2013-2014 (*Figure 3, online*). Averaging 76 inches of snow annually, the region recorded over 132 inches of snow and fewer warming/thawing cycles during this season, thereby leading to more significant overall snow accumulations. The pre-engineered structure was comprised of a fabric shell stretched over a series of structural steel arches, and was installed ten years prior. The shell reportedly exhibited visible deflections in several of the arches, causing the owners to close the facility and engage snow removal services. During the following spring, a structural engineering professional was engaged to document the extent of damage and provide a causation analysis.

Figure 3. Overall view of the fabric shell structure.

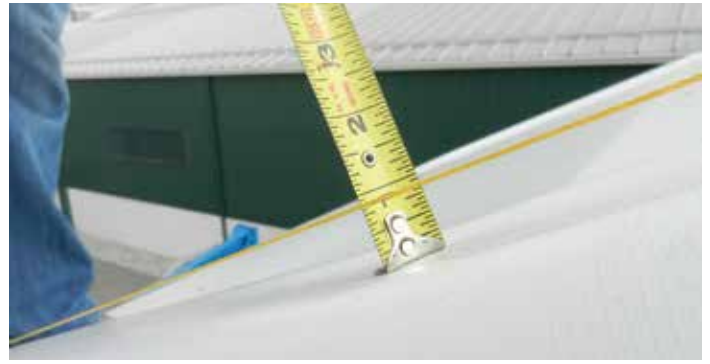
Field investigation and deflection measurements along the length of the frame segments found plastic deformation in six of the nine arches, ranging from less than 1/8 inch to as large as 5 inches. A review of available proprietary information, followed up with lengthy phone conversations with the pre-engineered system provider, revealed the designer, manufacturer, original installer, and the presumptive repair contractor were all the same entity. The manufacturer’s published deflection criteria provided more stringent deflection criteria than the governing codes. The technical representative explained the arches were not intended *ever* to hold snow, and the restrictive deflection criteria were intended to ensure snow accumulations on the fabric did not occur. That

statement of assumption was both enlightening and concerning, considering the structure is within two miles of Lake Michigan, a historically documented heavy snow zone. The designer contended that the fabric surface, structure’s slope, and arch stiffness collectively prevent snow from accumulating. Actual events and structure performance suggested otherwise. Simply, snow accumulated on the roof caused expected deflection, which ironically allowed for additional accumulation and additional deflection (*Figure 4, online*).

Figure 4. Steel deflection measurements collected along the length of the arch frames.

As structural design professionals, it is imperative to revisit assumptions regularly, especially those used repetitively. Different locations and situations always require renewed attention and verification of previous expectations. In the end, this site narrowly avoided a collapse and instead only suffered the arch deformations. All arches with permanent deflections out of manufacturer's strict tolerances were replaced, operational heating recommendations were refined, and the building management implemented removal instructions for any future snow accumulations.
