Tariffville Bridge Disaster

By Frank Griggs, Jr., Dist. M.ASCE, D.Eng., P.E., P.L.S.

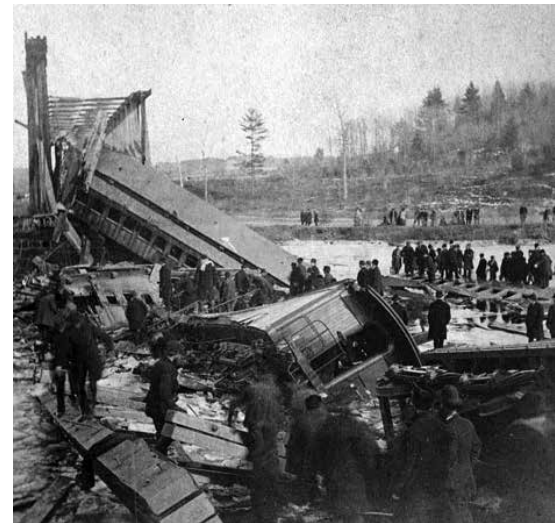
The Annual Report of the Railroad Commissioners of Connecticut described the crash as, “Both the trusses of the west span, with the two locomotives and baggage car thereon, immediately fell together towards the south, the forward locomotive being overturned and leaving its ashpan on the abutment, the second locomotive landing on the ground just

Tariffville Bridge disaster.

behind it, and the baggage car still further back in the river. The three passenger cars on the east span were also forced into the opening by the momentum of the train behind them, the first one being turned to a position nearly at right angles with the bridge, and the second and third left with their forward ends in the river and their rear platforms against the center pier. The remaining six cars of the train were uninjured.”

5) We are of the opinion that if the materials of the bridge at the time of its construction were of suitable quality, quantity, and proportion to fulfill all of its requirements, they had at the time of the disaster become deteriorated; that the iron suspension rods, from being overstrained or from some other cause, had lost their tension and sustaining power; that the timber of the chords from many years exposure to the action of the elements without covering or paint, had become weakened by decay to such an extent as to render the bridge unsafe and unfit for the purpose for which it was constructed; and that the disaster was occasioned by the heavy train passing over a bridge thus rendered dangerously weak and defective.

"The principal lesson, therefore, taught by the Tariffville disaster is the necessity of larger suspension rods than those heretofore used in most of the wooden railroad bridges of the State. If, in that bridge, the broken rods had been one-quarter inch larger in diameter with upset ends, their area and efficiency would have been nearly doubled, their liability to breakage correspondingly diminished, and their strength nearer the standard recommended by the best engineers. They were, however, fully equal in size and strength to the general average of rods used on other similar bridges in the State. At the time of the accident, this Board was not empowered by law to order any changes of construction to increase the safety of bridges or other railroad structures, but simply "to recommend from time to time the adoption of such measures and regulations as they may deem conducive to the public safety and interest."

Despite this failure, the Howe Truss was still used on many railroads and roadways around the country well into the 20th century. Like the iron bridge builders, the builders of most of the Howe Trusses adopted the upsetting of threaded tension bars such that the cross-sectional area of the bars at the root of the threads was equal to or greater than the cross-section of the main bar.
