## West Hartford (Woodstock) Bridge Disaster

By Frank Griggs, Jr., Dist. M.ASCE, D.Eng., P.E., P.L.S.

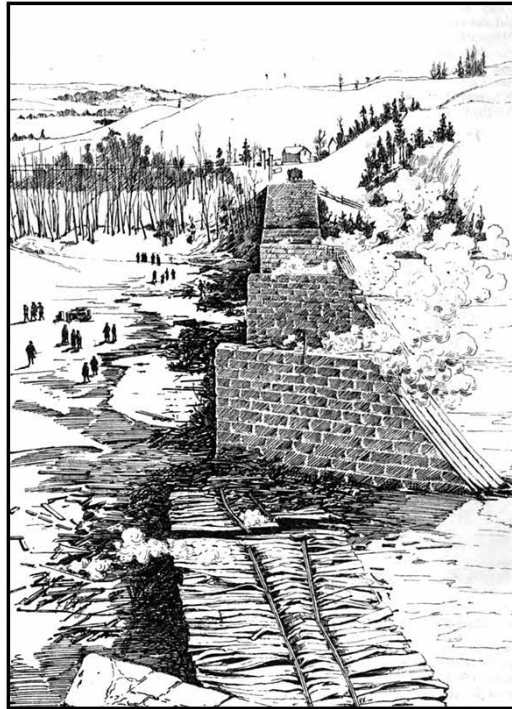
Bridge in the White River; note iron rails and wrought iron sheet intact.

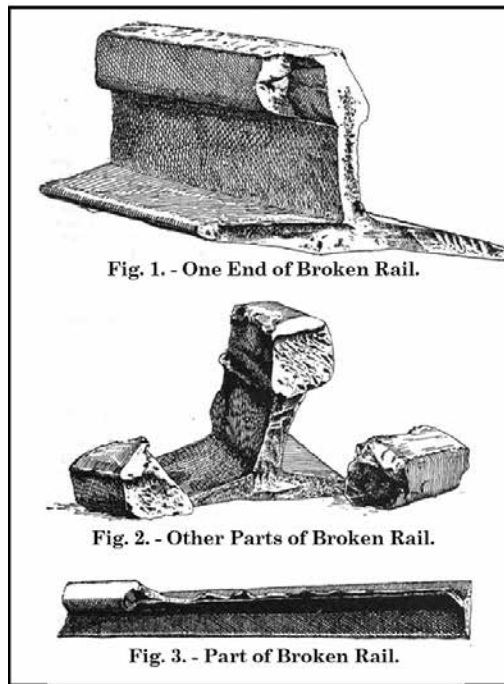
These are the principal facts relevant to the case...However, in the opinion of your correspondent, the evidence seems to point to the failure of a rail about 450 feet from the end of the bridge as the beginning. Whether this failed partly under the locomotive or under one of the forward cars, we can only guess, but the battered condition of the ends of some of the fragments indicates that they had been struck by two or more trucks or wheels, which may have succeeded in mounting and passing over them."

Broken rail by Fletcher.
