Virginia State Capitol Building Dome

WDP & Associates Consulting Engineers, Inc was an Outstanding Award Winner for the West Virginia State Capitol Building project in the 2020 Annual Excellence in Structural Engineering Awards Program in the Category – Forensic/Renovation/Retrofit/Rehabilitation Structures under \$20M.

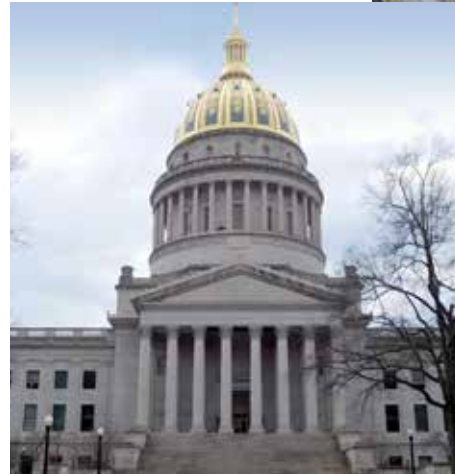
In some locations, the coconut fiber wads had begun to fail. There was also cracking observed within the lower portions of the inner shell. The clay tile walls beneath the inner dome that were intended to serve as furring for the interior plaster had displaced outward and upward through irreversible moisture expansion and had been laid in various orientations that compromised their structural integrity. Much of the inner shell's weight was bearing on cracked clay tile walls, and the hangers for the dome had buckled.

Through structural modeling, the stresses within the existing dome were correlated to crack patterns and other failures. Laboratory testing of plaster samples containing coconut fiber reinforced gypsum from the interior rotunda was performed to determine key material properties for the analysis. At the inner shell, locations identified to have high stresses were retrofitted with glass fiber reinforced polymer (GFRP). This GFRP retrofit was also tested in a laboratory setting to evaluate the performance and increased strength of the composite system.

Stainless steel plates connected with wire ties were also installed as supplemental supports to connect the inner shell to the outer shell to compliment the coconut fiber reinforced wadding used during the original construction. The GFRP system was

coated with a cementitious coating to offer fire resistance and mimic the appearance of plaster. A stand-alone mockup of the inner dome was constructed to work through constructability challenges before installing the components on the dome itself.

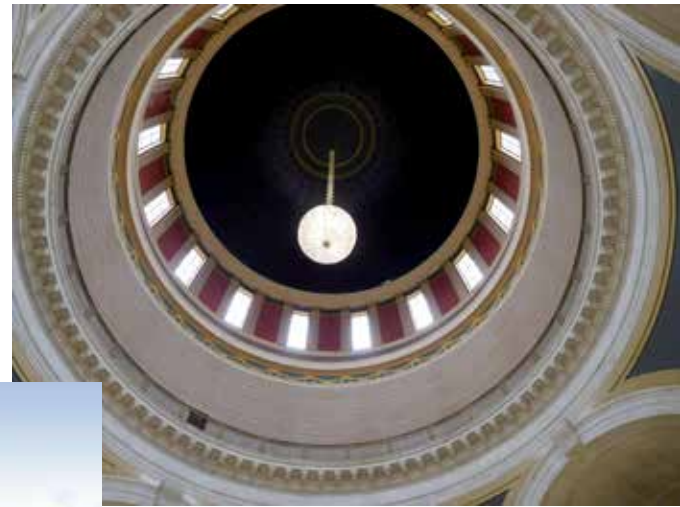
Many of the flat straphangers for the hanger system supporting the outer shell were buckled, and several of the concrete deck attachments were deficient. The repair design incorporated turnbuckles into each hanger such that the tension could be adjusted for each individual hanger. In-line data-logging load cells were installed at key locations such that the tension could be monitored during and after the retrofit process to ensure the loads within the hangers were properly distributed. This monitoring system will remain in place to provide a warning system if any of the loads become disproportionate.

Much of the inner shell's dead load was bearing on the clay tile walls, which prevented them from simply being removed and replaced. A creative solution was developed to turn the cracked non-structural clay tile units into a reinforced horizontal bond beam element. The top two courses of existing clay tile would be grouted and reinforced to form a continuous beam around the base of the dome that would then be supported by new steel brackets connected to the main structural

framing of the building. A detailed sequencing plan was developed that created redundancy in the support of the dome as the walls were completely removed from beneath the dome. First, slotted openings were made within the existing clay tile to insert the reinforcement and fully grout the outer cell of the existing clay tile. Once the bond beam was complete, discrete openings were made at each column to install the steel brackets; the reinforced clay tile beam was utilized to transfer the weight of the dome to the portions of the wall that remained. Finally, sections of clay tile were removed between brackets to install tube steel and angles to provide supplemental support below the clay tile bond beam. Flexibility was incorporated into the connections to the brackets using slotted holes and field welding to account for variations in the elevation of the bond beam and brackets. Once the steel framing was in place, all remaining clay tile was then removed.
