Bussey Bridge Disaster, aka Forest Hills Bridge, 1887

By Frank Griggs, Jr., Dist. M.ASCE, D.Eng., P.E., P.L.S.

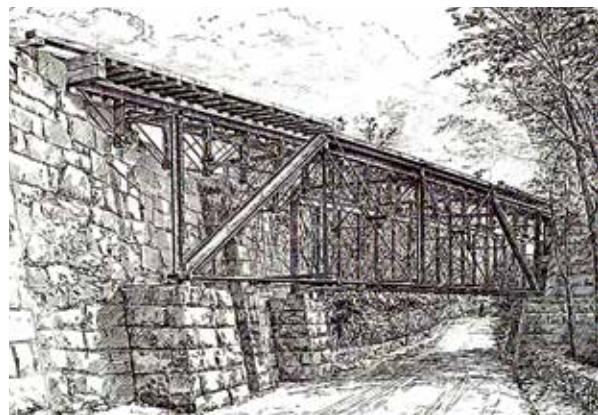
Bussey Bridge – Truss A in foreground, Whipple in background.

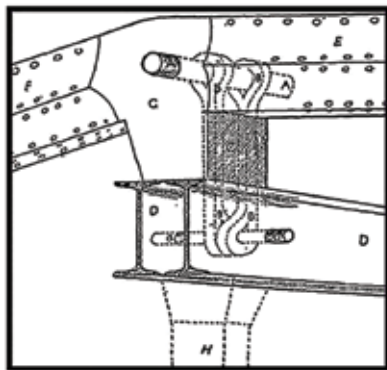
Cast Iron Junction Box, hangers and cross beams, trussing rods under beams, and diagonals dropping down from the top pin not shown.

"In looking at one of these hangers, where one floor beam was hung at the end joint of the upper chord, I found that the hangers were defective and had been largely rusted off. These hangers were made with a weld, and the weld seemed to be in some places imperfect, and it seemed to me extremely probable that at this joint where the hangers were broken, the original rupture might have occurred..."

Nothing in the catastrophe tends to show that the trusses themselves were too weak, and there has been no time for making the necessary computations. But the badness of their design in many details, we may almost say in every detail, will be at once evident...The hangers...were so boxed in with cast-iron that a real inspection must have been difficult or impossible after erection, but the badness of the fragments now in our office, at least, must have been obtrusively evident during erection."
