Up FROM THE Ashes

Rebuilding the Sperry Chalet: Part 2

By Ian Glaser, P.E., Jeffrey Schalk, P.E., S.E., and Michael Schuller, P.E.

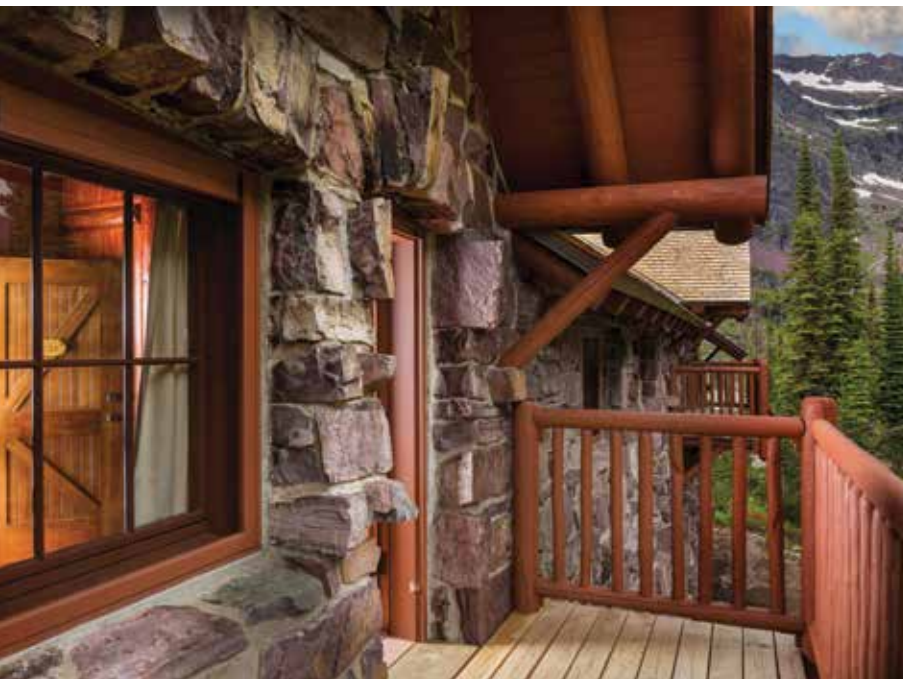
Figure 6. Completed roof and balcony framing as well as rehabilitated masonry. Note unremovable soot stain over door. Courtesy of Mark Bryant Photographics.

The masonry walls' inside faces were first descaled of unbonded material from top to bottom. Mortar joints were raked back to match the new inner wall plane. Jamb stones that were exposed to the fire on three sides and consequently suffered through-unit cracks were replaced. The tops of the walls were reconstructed where the setting mortar between the smaller stone units had severely degraded in the fire. Replacement stones were transported by helicopter from the original quarry to the masons.

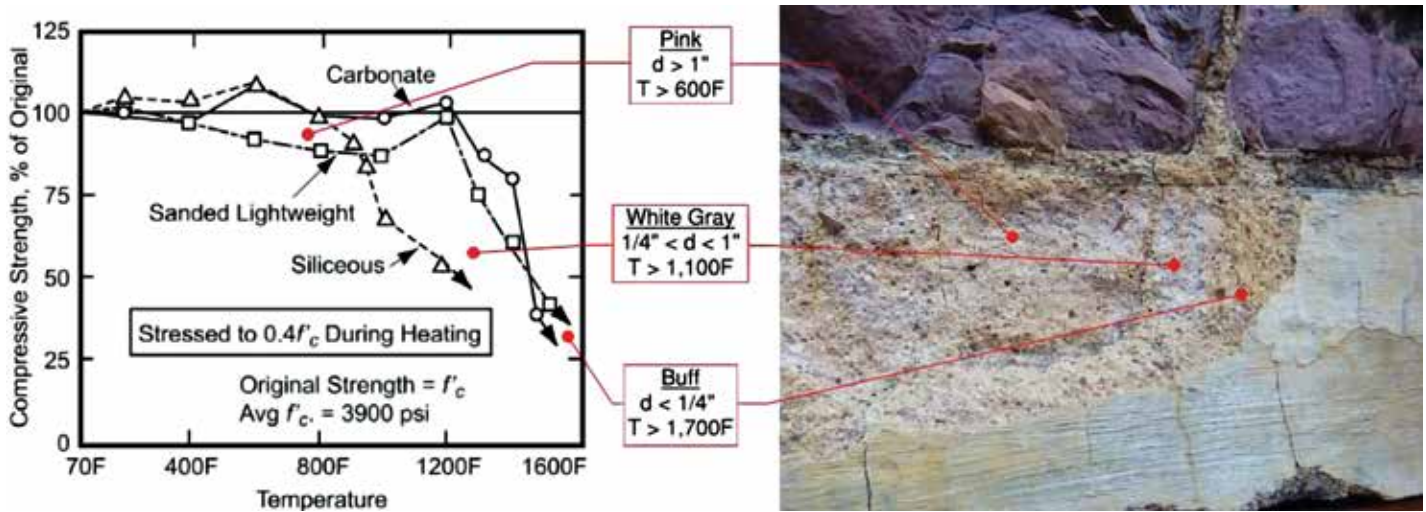
Figure 7. Color changes through the cross-section of spalled concrete lintel provides clues on the intensity and duration of fire. Effect of temperature on concrete strength keyed to observations (Chart: Bilow, S., Kamara, M. "Fire and Concrete Structures." Structures 2008: Crossing Borders, ASCE.)

Another component of the investigation was understanding the fire's effect on the concrete lintels. Concrete, mortar, and other cementitious materials undergo color changes when subjected to high temperatures. Color changes progressively from gray to a subtle pink color, white-gray, and finally to buff as the temperature rises. After the fire, the concrete lintels' faces were observed to be a buff color, suggesting that maximum fire temperatures exceeded 1700°F. In one location, the concrete spalled to reveal a multicolored cross-section that provided more clues. For concrete with siliceous aggregate, the observed depths of color gradation suggested a high-temperature duration of 1½ to 2 hours and an approximate halving of concrete compressive strength in the outer 1 inch of material (Figure 7).

The fire-weakened concrete lintels were retrofitted with galvanized steel lintels. WT webs were fit into vertical slots cut into the underside of concrete lintels, and the flanges bear on galvanized plate steel at

the jambs concealed by window trim. Spalled sections of concrete were patched with repair mortar.

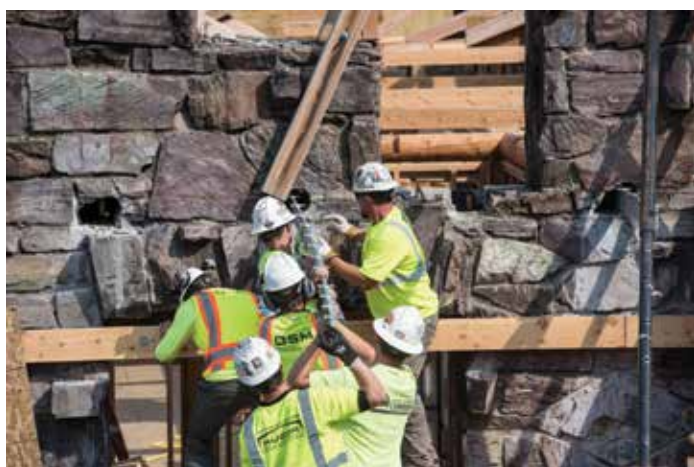
Figure 8. Construction crew fishes second-floor balcony's joist fitch through wall pocket. Courtesy of A Boring Photo.

When the reconstruction was designed, it was assumed that the original log floor joists at the second floor cantilevered through the exterior masonry walls to form the balconies. It was discovered during the initial site visit that the original balcony framing was separate from the interior framing. The balcony joists were simple-spanning, supported only by the wall pockets and diagonal log knee braces. Without positive anchorage of the balconies through the wall into the interior floor, the original design lacked seismic connectivity. The knee braces exerted lateral thrust mid-height on the stone walls, and the framing was extremely prone to decay in the harsh environment. Formerly, the balcony framing was actively maintained and periodically rebuilt by the park to address decay conditions. A part of the design challenge was to increase the longevity of the balconies and integrate life safety.

Since the wall pockets did not align from exterior to interior, interior log joist framing was respaced to facilitate the new cantilevered joist design. The interior joists were located to exit the building in alignment with the original balcony joists to favor the historic exterior appearance. The new continuous joists are fitted with galvanized steel plate flitches (Figure 8). The flitches were designed to take the full cantilevered outer-span load, allowing the logs to stop short of the masonry where they would otherwise be prone to decay. The balcony logs act essentially as jackets that can be periodically replaced. The balcony knee braces are not relied upon for strength but are incorporated into the design to limit deflection and recreate

the exterior appearance. The flitches are grouted solid into the walls, with logs tight to masonry on either side and serve as seismic wall ties that transmit masonry anchorage into the floor diaphragm.

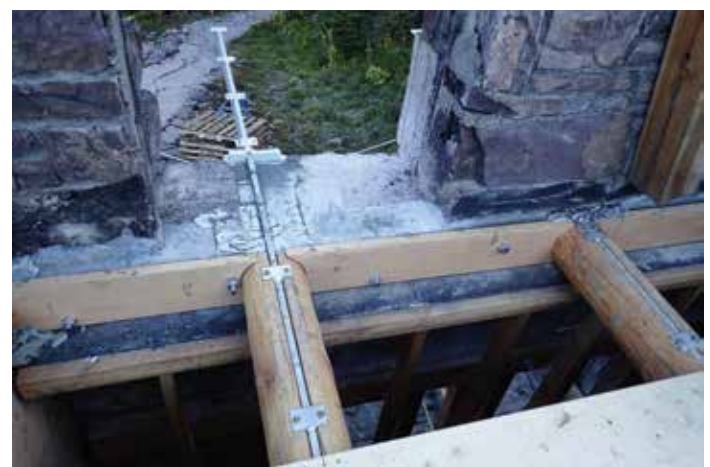
Figure 9. Second-floor balcony joist fitch grouted in wall pocket. Joists are supported on inside face of wall by a steel angle ledger.

Interior log floor joists that are not part of the balconies were sized without flitches and were held short of the wall pockets to avoid decay susceptibility, bearing instead on a ledger angle. The abandoned interior pockets were grouted solid, and the steel angle was designed to double as a continuous diaphragm chord and seismic collector (Figure 9).

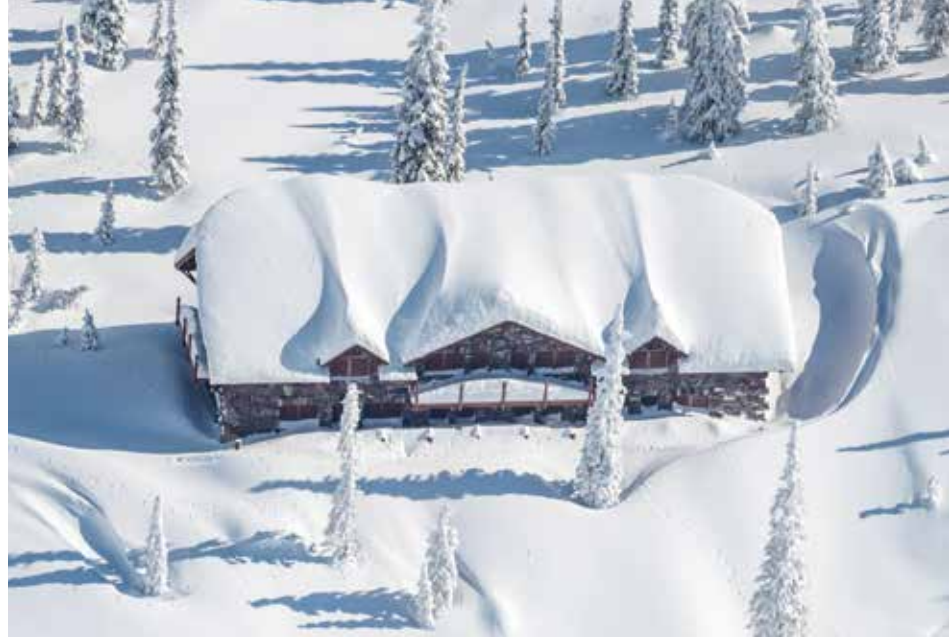
Figure 10. The roof endures its first load test after the first construction season. Courtesy of Gravityshots.com.

One of the most obvious structural challenges was the roof design, as the chalet is almost entirely buried by snow during the winter months (Figure 10). Stakeholders were clear in their desire to reframe the roof with exposed logs having the same proportionality as the original ones. The original roof framing was certainly undersized. It was later learned that the original roof survived the winter months via internal props installed during the end-of-season shutdown. The roof framing also relied on a set of interior knee braces along the heavily loaded purlin lines that induced horizontal point loads on the masonry end walls and interior posts.

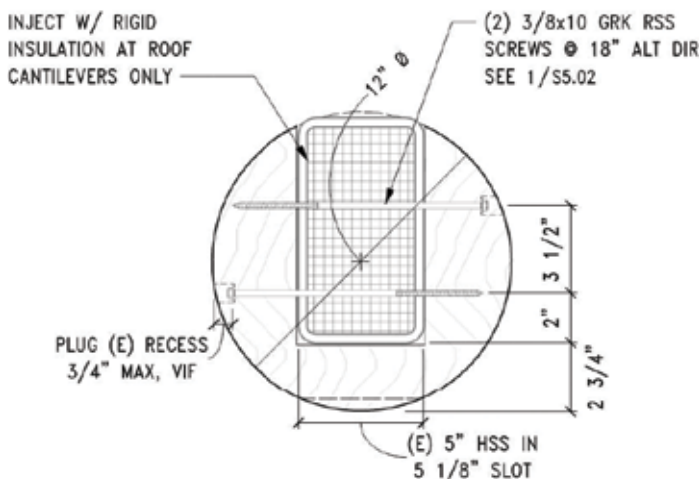
Figure 11. Tube steel purlin with log wrap.

The interior knee braces were eliminated in favor of clear-spanning HSS tube steel purlins wrapped in log jackets to create a cleaner roof framing load path. Like the balcony framing design, the purlins were designed to cantilever to the rake edges without structural reliance on the exterior knee braces. The log jacketing is omitted through the plane of the wall to avoid decay and allow for periodic replacement of the outboard ends. The purlin ends are foam-insulated to lessen the potential for condensation inside the building envelope (Figure 11). The long-span log rafters and valley beams were outfitted with galvanized steel plate flitches. Unlike the balcony logs and roof purlins, the rafters are better protected by the roof, and they run uninterrupted over the top of the walls wrapped in a vapor barrier in stone saddles.
