Blackshear Bridge Failure

By Frank Griggs, Jr., Dist. M.ASCE, D.Eng, P.E., P.L.S.

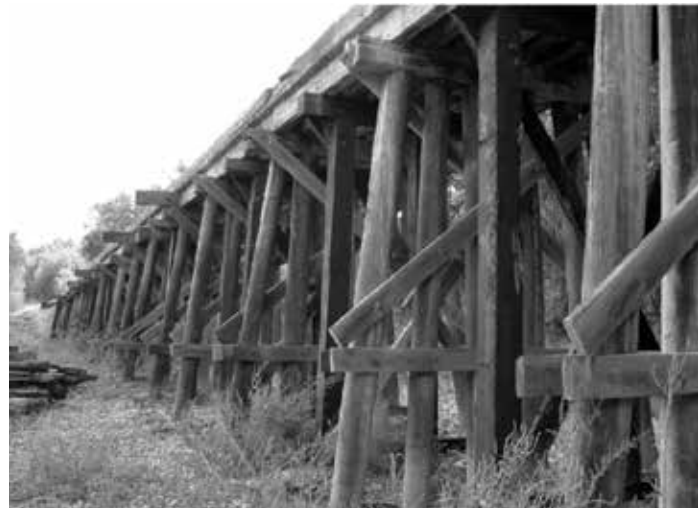
Inverted W wooden trestle with piles, similar to Blackshear.

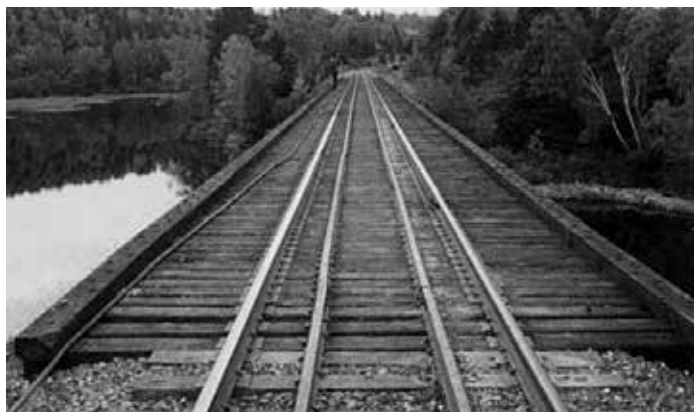
Wooden trestle with the recommended steel guardrails, closely spaced ties, and wooden outer rails.

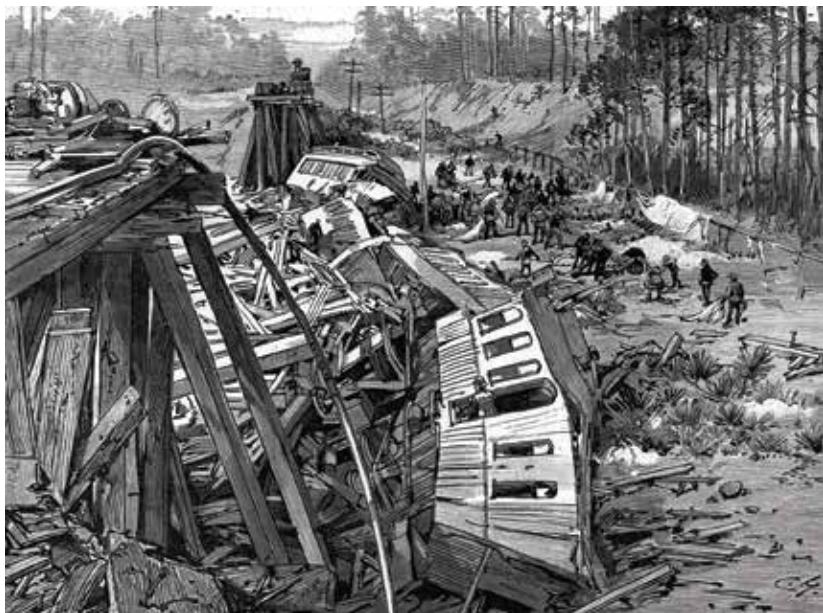
Harper's Weekly image.

The failure was, therefore, due to a derailment and, in the eyes of the *Engineering News*, a poorly designed trestle with ties too short, too widely spaced, and with no curb to keep trains on the structure. ■
