## The Point Ellice Bridge Failure

By Frank Griggs, Jr., Dist. M.ASCE, D.Eng, P.E., P.L.S.

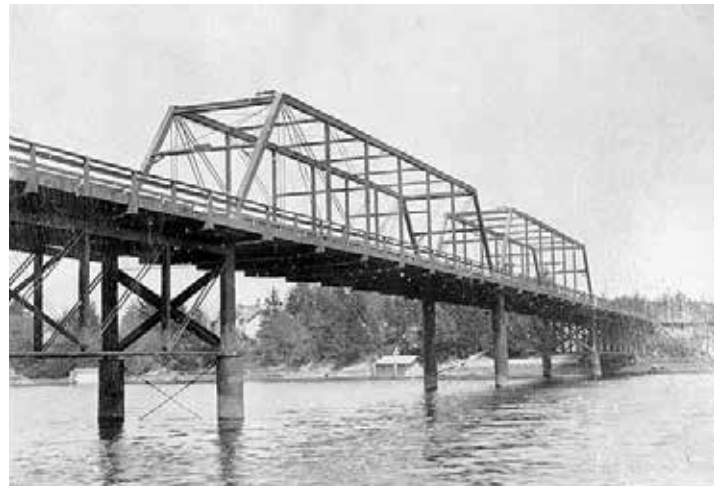
Point Ellice Bridge.

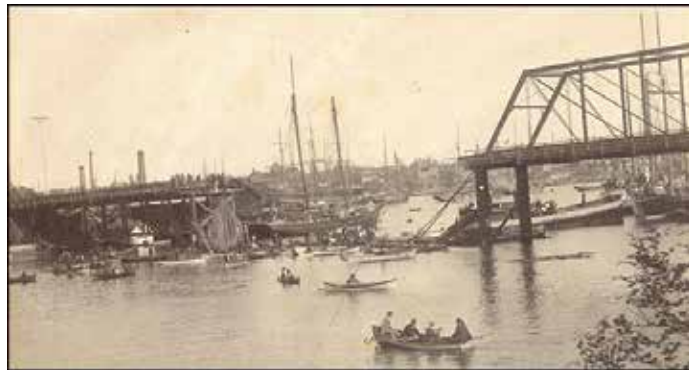
It is quite evident from the evidence produced before us that the primary cause of the accident was the breaking of one certain hanger, shown as number 5 on the diagram produced in evidence, resulting finally in the collapse of the bridge; said hanger being part of the original construction.

Failed 150-foot span, search for bodies underway.

In summary, the cause of the failure was likely the compounding of bad design, bad construction, lax inspection, and inadequate oversight of the electric railway operation. ■
