## **Eden Train Wreck**

Dry Creek Bridge Failure
By Frank Griggs, Jr., Dist. M.ASCE, D.Eng, P.E., P.L.S.

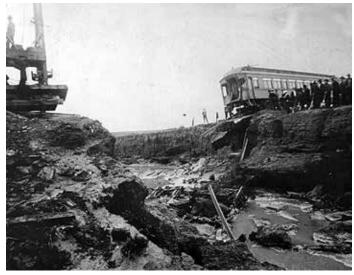
Dry Gulch with Pullman cars on the edge of bank and water subsided.
