# In-Situ Evaluation of Old Pan-Girder Bridges

By Nur Yazdani, Ph.D., P.E., F. ASCE, F.SEI, F.ACI,  
and Eynosias Beneberu, Ph.D., P.E.

For the study discussed here, an in-situ evaluation was conducted of the East Bound (EB) US 80 pan-girder bridge (Figure 2) over a frontage road in Forney, Texas, through visual inspection and condition assessment. TxDOT recommended the inspections to catalog the current bridge condition in order to

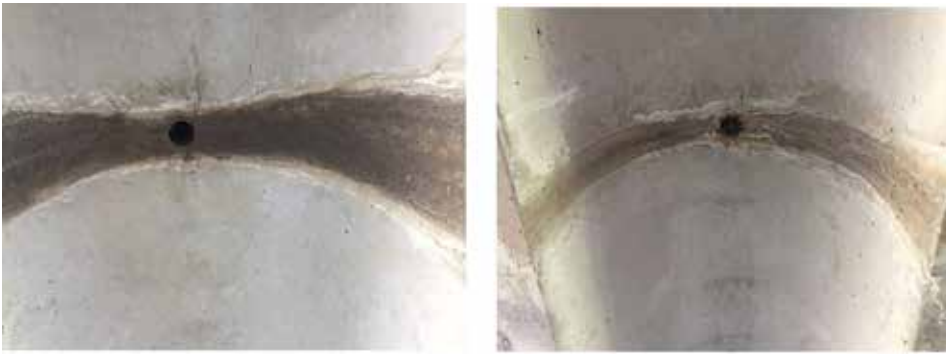
A detailed visual inspection plan was prepared, and the structural elements were evaluated for visible signs of distress, damage, and deterioration. Various types and levels of damage that could jeopardize the overall health and serviceability of the bridge's structural elements were located and cataloged. Deteriorations included, but were not limited to, hairline cracks, concrete crushing and spalling, and water damage. Observed damages are summarized in the *Table*. Beam numbers are progressive from north to south. Identical beams in various spans showed similar levels and types of damage, and these repetitive damaged numbers of beams are shown in parenthesis after the corresponding beam numbers. For example, 3(2) indicates that beam number three in two spans showed an identical type of damage. In addition, it is apparent that most beams sustained some form of water damage at mid-span, as shown in *Figure 4* (page 44).

The presence of form lowering holes at the crest of the pan girders at quarter-span and mid-span of the girders could be the reason for water damage, as the water seeped through the holes. Efflorescence was visible in the form of white and gray residue, which occurs when the calcium salts from concrete react with water and air to form insoluble calcium carbonate. This phenomenon is harmful to concrete as salt can increase concrete permeability and induce corrosion of steel rebars. Corrosion propagated from the drainage areas in most of the girders, and a few beams had exposed rebars. Rebars were exposed and corroded in some of the beams around the form lowering holes. Such corrosion could occur due to the water

Figure 4. Water damage at mid-span.

seepage from the holes, which caused concrete scaling and spalling. However, no corrosion was observed in the primary longitudinal reinforcement, located at the bottom of the stem. If present, corrosion in the rebar could potentially affect the load-carrying capacity of the beams.

- 1) A PVC pipe can be glued on the form lowering holes extending beyond the concrete surface of the arch. This will prevent water seepage through the holes and minimize water damage, spalling, and scaling of concrete.

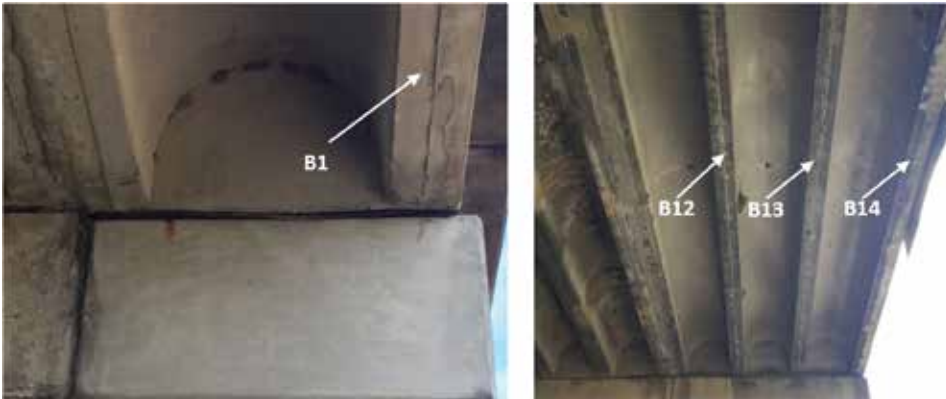
Figure 5. Condition in newer beams.

It may be noted that beams 1, 12, 13, and 14 displayed little or no water damage. These beams were added in 1978 during the bridge expansion, while the other beams were in service for about 23 additional years. The four newer beams were in much better shape and did not show any extensive visible deterioration and/or water damage (Figure 5). The new bent caps used for the widening were connected to the existing bent caps with dowel bars for continuity.

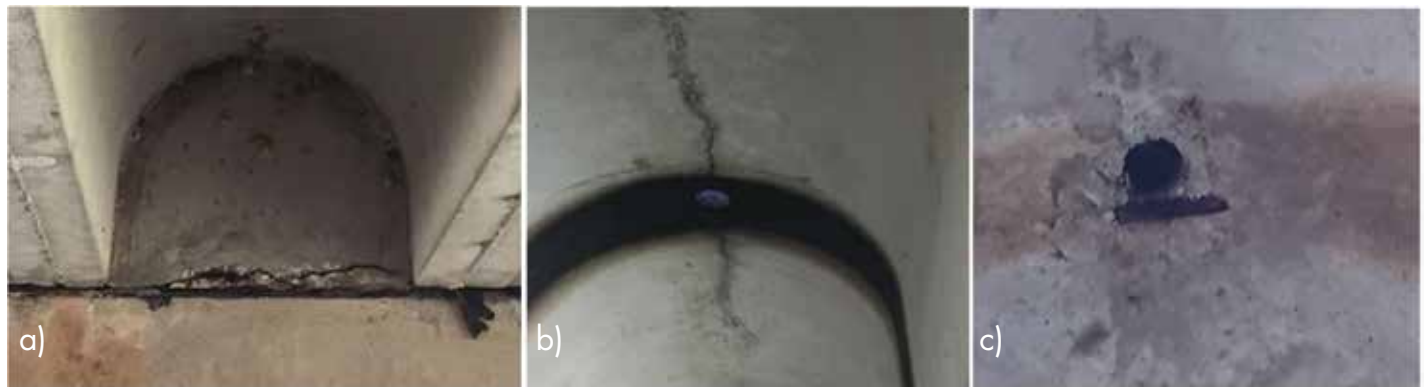
Beam 11 was the most severely damaged in all spans, with practically all the deterioration mentioned in the Table. Water damage was visible in this beam at every quarter-span location in all spans. Samples of deterioration are shown in Figure 6. This could be caused by the fact that Beam 11 was on the exterior side before the bridge widening; after widening, it became an interior beam that increased the load it carried and aided in the damage process.

Figure 6. Deterioration in beam 11. a) Crushing of concrete; b) Longitudinal crack; c) Exposed and corroded reinforcement.

- 3) Appropriate retrofitting and repair techniques may be used to upgrade deficient pan-girder bridges with extensive deterioration. For example, experience has shown that externally bonded Carbon Fiber Reinforced Polymer (CFRP) laminate is a viable method for strengthening concrete bridges in general (Mohanamurthy and Yazdani, 2015; Pallemapati et al., 2016) and also for under-capacity pan-girder bridges. Thus, such rehabilitation methods may be suitable to upgrade deficient pan-girder bridges.
