# historic STRUCTURES

## Quebec Bridge, The First Failure, 1907

By Frank Griggs, Jr., Dist. M.ASCE, D.Eng, P.E., P.L.S.

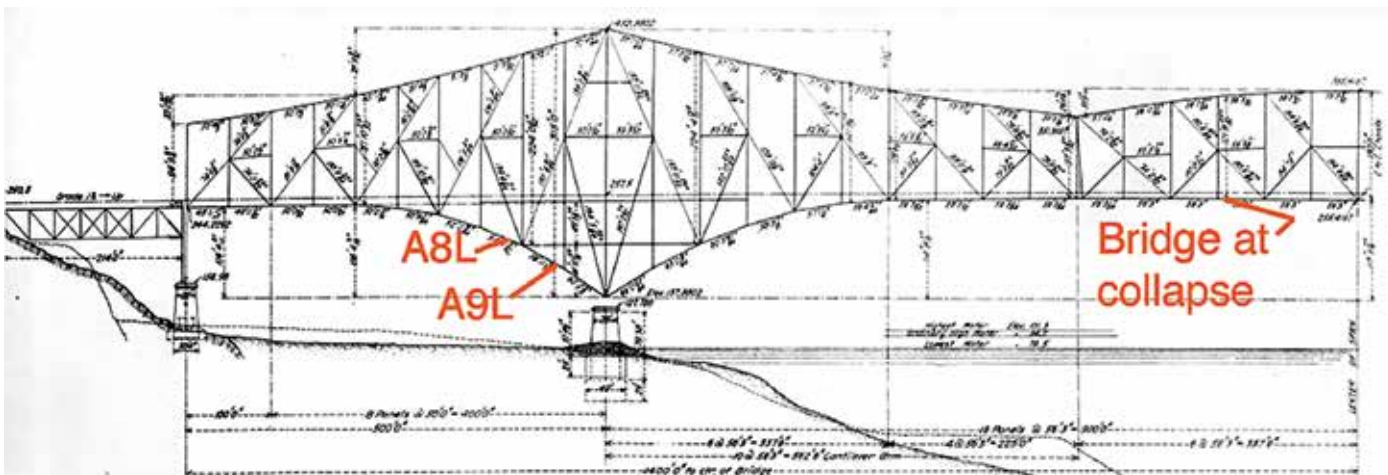
Plan of bridge showing failed member A9L and planned suspended truss to mid-span.

- a) The collapse of the Quebec Bridge resulted from the failure of the lower chords in the anchor arm near the main pier. The failure of these chords was due to their defective design...

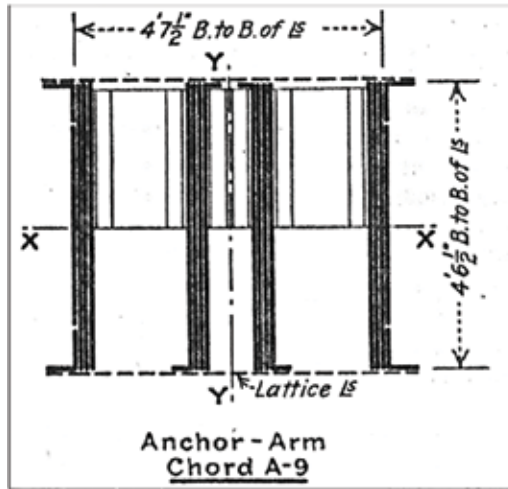
The outside ribs on A9L were each built up of 3 plates – 54 inches ×  $\frac{15}{16}$  inch and one  $37\frac{3}{4}$  inches ×  $\frac{15}{16}$  inch combined with stich rivets. The interior ribs were built up with 2 plates – 54 inches ×  $\frac{15}{16}$  inch and two 46 inches ×  $\frac{15}{16}$  inch also connected with stich rivets. The ribs were separated by latticing top and bottom and diaphragms near the top. The ends of the plates were milled, and the compressive load between the members of the lower chord was to be transferred from member to member by bearing. However, during erection, they encountered many problems bringing the members into full bearing over the entire joint.

Bottom chord cross-section A9L.

to time, it is only very recently that these have been in this condition, and their present shape is undoubtedly due to the stress they are now receiving. Only a little over a week ago, I measured one rib of the 9-L chord of the anchor arm here shown, and it was only  $\frac{3}{4}$  inch out of line. Now it is  $2\frac{1}{4}$  inches."

“Since, however, the lower chord members of the Quebec bridge are butt-jointed, they are neither continuous nor pin connected, and it is impossible to make the whole section bear uniformly under the various conditions of loading...

However, there is a deficiency in many of the compression members, as their connections, such as the latticing, are not sufficient to make the parts composing them act as a unit. The most pronounced defect in this respect exists in the lower chord members of the cantilever and anchor.”

While not emphasized in his report, in the opinion of many, these were the cause of the buckling and failure of members A9L and A9R.

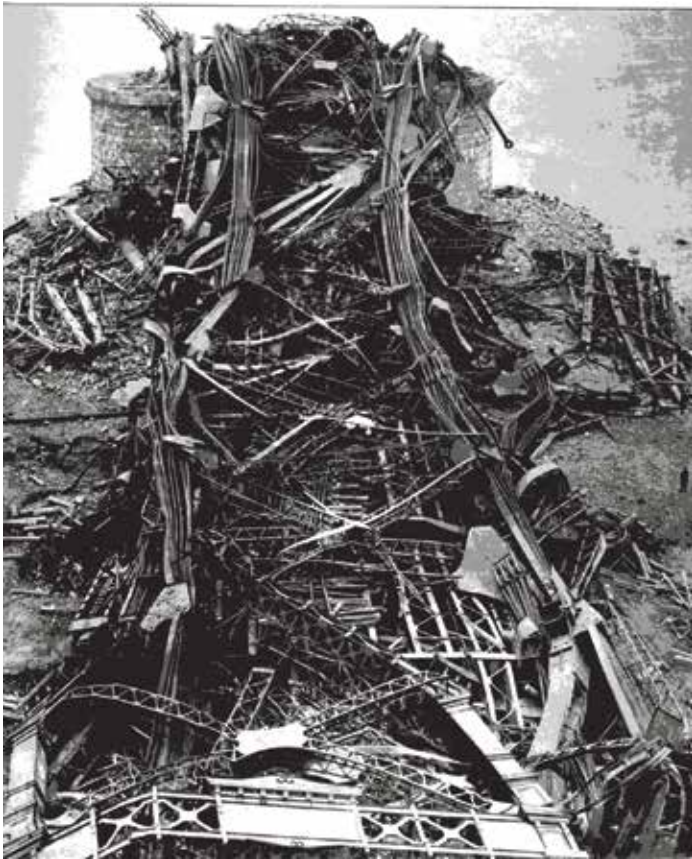
at 1:15 PM. McLure would not arrive at Phoenixville until 5:30 PM. At that time, the bridge collapsed into the St. Lawrence River, killing 75 men.

Bridge in the river.
