# Adaptive Reuse OF THE HISTORIC WITHERSPOON BUILDING

## Part 3: Structural Investigations

By D. Matthew Stuart, P.E., S.E., P.Eng, F.ASCE, F.SEI, A.NAFE, SECB

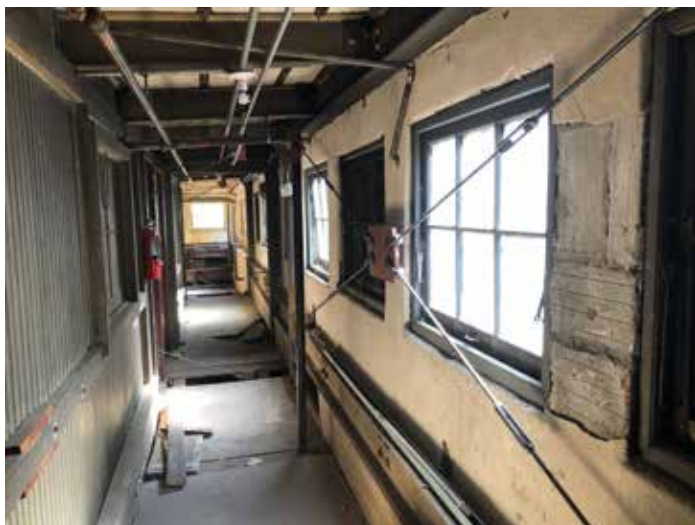
Results of the main roof and original mechanical penthouse investigation indicated that the high penthouse roof had sufficient reserve load-carrying capacity to support proposed new mechanical rooftop units (RTUs) that serve the residential units. However, it was necessary to design steel beam support dunnage that clear spanned between the penthouse columns to prevent imposing any load directly on the book tiles and bulb tees (*Figure K, online*). The increased lateral load on the penthouse due to the raised RTUs also required additional vertical X-bracing (*Figure 11*) to be installed inside the penthouse

between the existing cast-iron columns and below the high roof beams. In addition, the installation of the X-brace connections was designed to avoid welding to the cast-iron columns by only connecting to the existing beams.

Figure 11. New vertical X-bracing at mechanical penthouse.

During the project's construction phase, direct tension testing of the penthouse X-brace rods was conducted. This was to ensure correct rod pre-tensioning via turn-buckle rotation was performed without yielding the ½-inch-diameter rods. In addition, during the high roof dunnage construction, it was necessary to remove some of the brick masonry façade wall at the northeast corner of the passenger elevator machine room penthouse to access the existing column so that it could support the southwest corner of the dunnage. After removal of the brick, it was discovered that the steel wide flange column that supported the penthouse roof had been spliced on top of an existing Gray column (*Figure 12*).

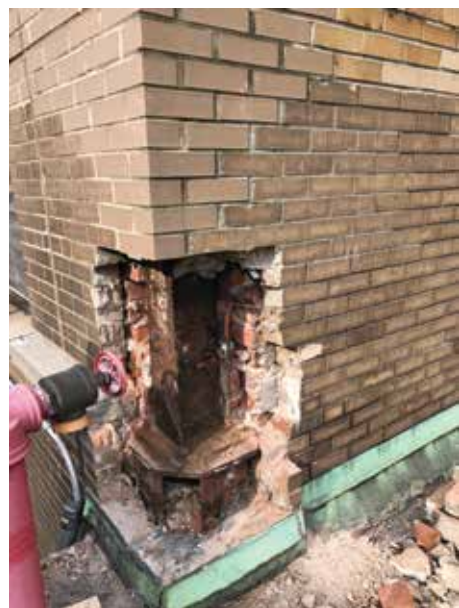
In addition, corrosion of both the wide flange column and Gray column had occurred due to moisture infiltration from a failed penthouse parapet coping above. The damage was corrected by cleaning the steel of all corrosion by-products to determine the extent of section loss, adding welded headed studs to the column sections, then encasing the members in a reinforced concrete pilaster that recreated the masonry corner of the penthouse. Encasing the steel columns in concrete strengthened them to offset the loss of section and protected the steel from further corrosion.

Figure 12. Northeast corner of passenger elevator penthouse at southwest corner of new RTU dunnage.

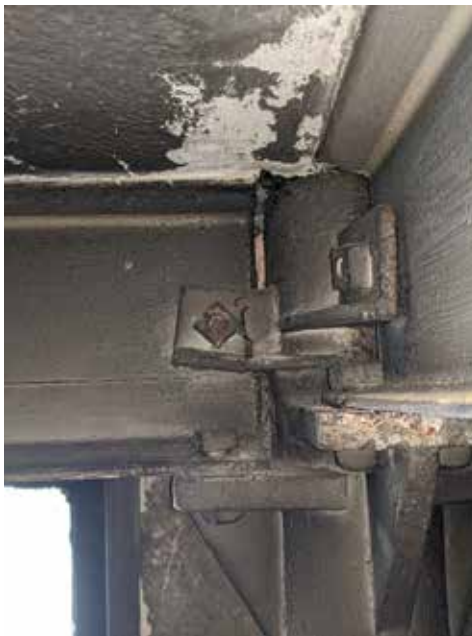
beam web connection clip extensions that had been cast with the original pipe section (Figure 13). The source of the cracking was unclear; however, it was assumed that the cracks occurred during the original handling and erection of the columns due to the brittle nature of cast iron. It also appeared that the clips were intended for lateral support of the beams during erection only and served no actual structural function in the as-built condition. Nevertheless, new bracing angles were added between the affected beams and adjacent orthogonally framed beams at the same column.

Figure 13. Cracked beam-web connection clip at a penthouse cast-iron column.

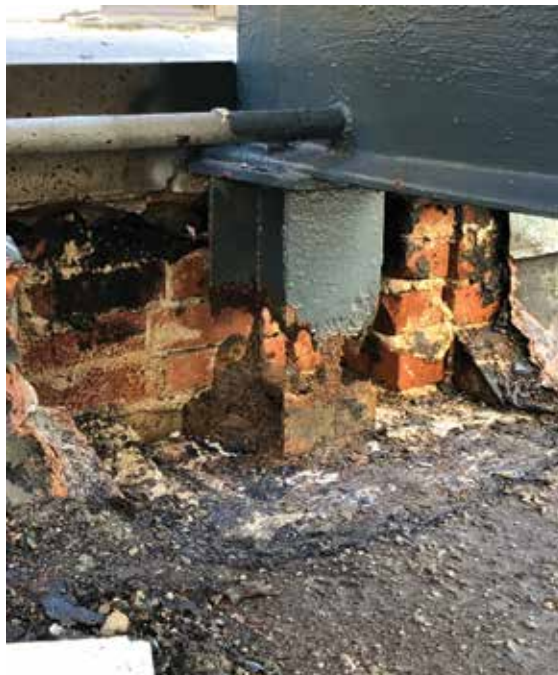
proposed new chillers indicated that, in general, the existing exposed framing could support the new equipment once the existing cooling towers were removed and the existing steel was cleaned and repainted to prevent further corrosion. However, unsafe structural conditions were observed at the two easternmost column post supports, immediately adjacent to the building's edge, due to excessive steel corrosion and almost complete section loss (Figure 14).

Figure 14. Corrosion and excessive section loss at an existing cooling tower steel dunnage column support.

The building owner was immediately notified of the unsafe conditions; however, the conditions were not corrected until much later in the project when similar corrosion was observed at all other dunnage column supports. In the interim, the existing cooling tower equipment was removed from the dunnage. Damaged columns were either replaced with new steel HSS columns or, if the corrosion was not too severe, encased in a reinforced concrete plinth that included headed studs welded to the original steel column.

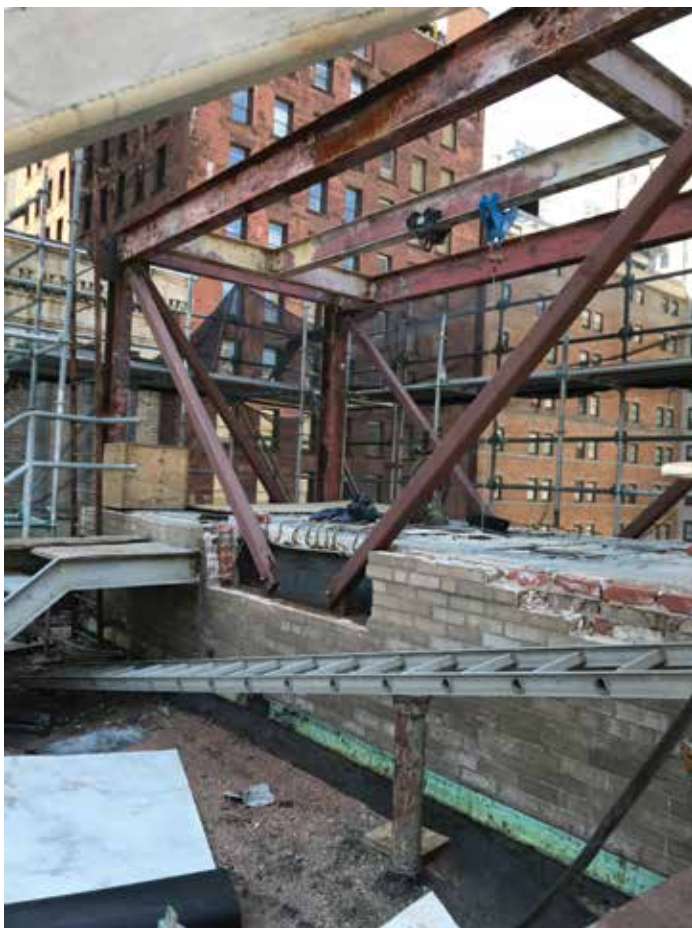
Figure 15. Partially erected strengthening of the existing freight elevator penthouse.

Based on ASME A17.1 Section 2.9.5, allowable deflections of elevator equipment support beams must be less than  $\text{span}/1666$ . While the calculated deflections of the blocking beams and W14 beams were less than this same amount due to the proposed new equipment, deflection of the W16 beams and W24 girders would be more than the same allowable deflection and were therefore not capable of safely supporting the proposed new loads. As a result, structural reinforcing was developed for the W16s and W24s.

Strengthening the W16 and W24 beams involved installing vertical steel members diagonally between the floor beams and the roof beams above to create story-high trusses (*Figure 15*). In addition, due to the increase in the minimum-code roof snow load requirements since the existing Otis elevator was installed, the roof truss that supported the W24 penthouse floor girder had to be re-supported with an additional column between the top of an interior 11<sup>th</sup> floor column and the bottom chord of the existing truss to reduce the span.

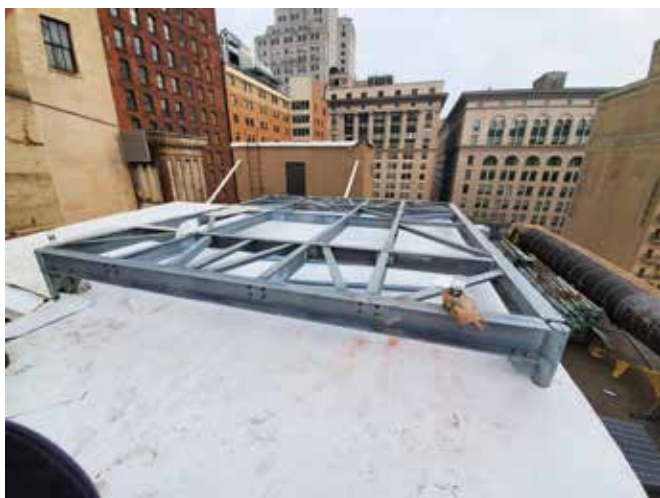
Figure K. Mechanical penthouse high roof RTU support steel dunnage frame.

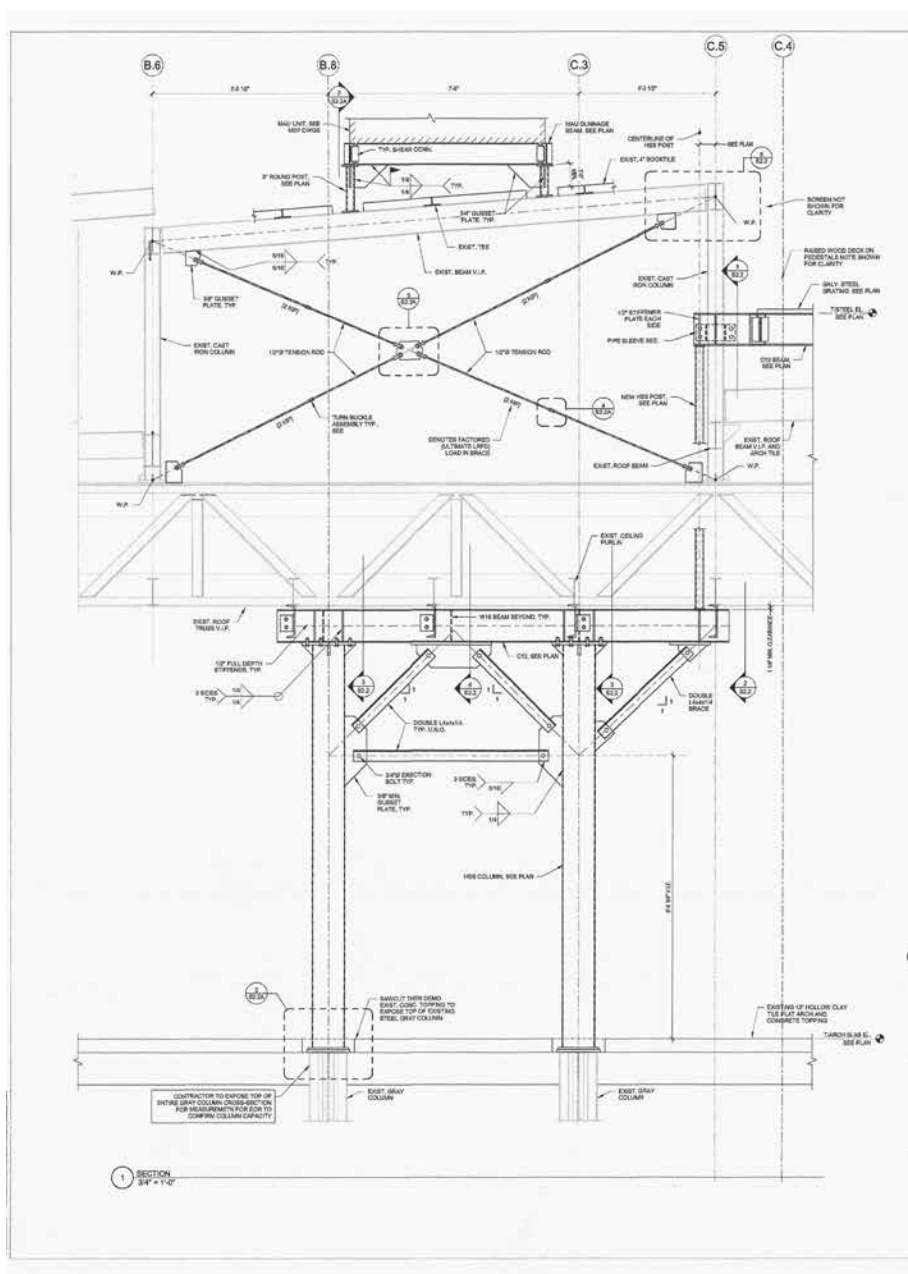
Figure I. Unused support detail at the exterior assembly space dunnage at the mechanical penthouse.

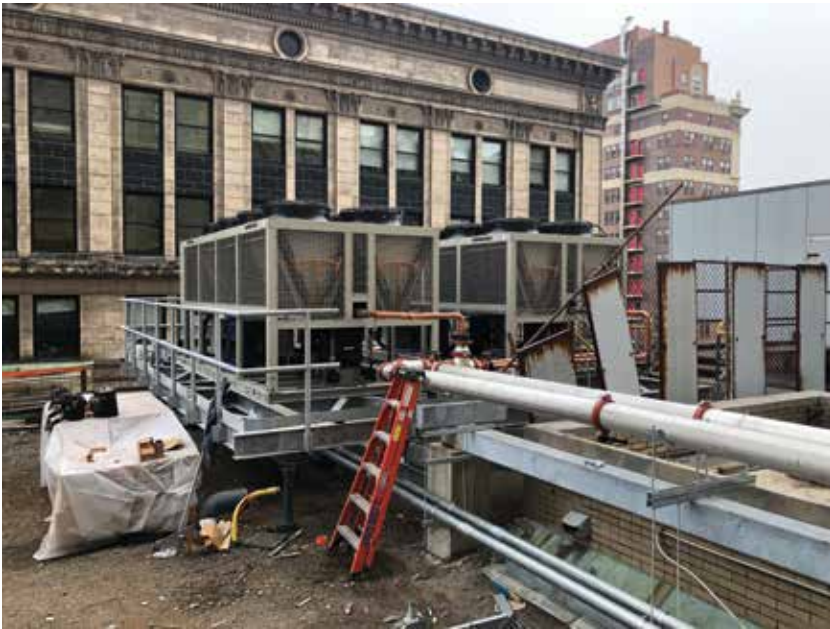
Figure M. Completed chiller dunnage framing (not including grating) and pipe support frame.

After the equipment was removed, the steel dunnage was cleaned and assessed. This resulted in the discovery that section loss due to corrosion exceeded 5% of the original area; therefore, it was necessary to weld reinforcing plates to the wide flange members to offset cross-sectional area loss. It was also necessary to design new steel grillage framing on top of the existing dunnage to marry the new chiller equipment to the existing framing footprint. New open steel grating catwalks were also provided, along with new support framing for the chiller piping between the existing dunnage and mechanical penthouse as required to avoid placing excessive pipe loads on the main roof framing below. The completed chiller dunnage and pipe support framing is shown in Figure M (online).

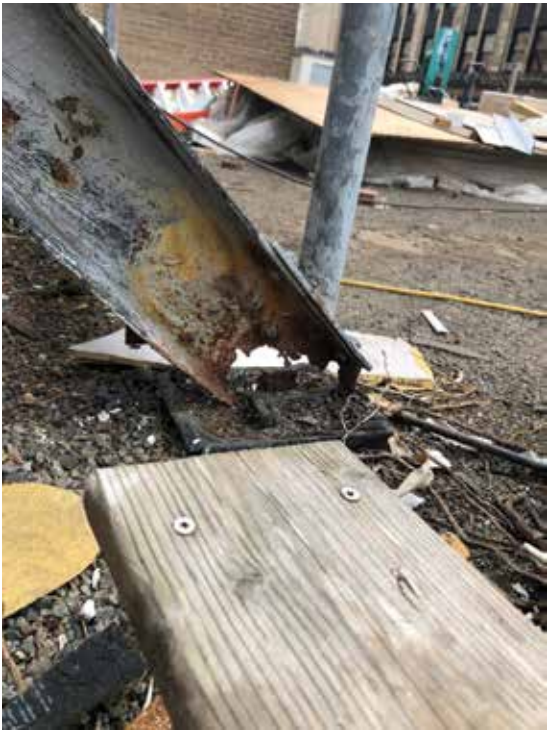
In general, the condition of the existing penthouse structure was fair; however, isolated cracking of the perimeter concrete base wall and moderate corrosion of the interior floor and roof framing were observed. Further, severe corrosion at the exterior steel stair stringers (Figure N, online) between the penthouse and main roof, which had resulted in complete loss of section in some areas, required that the damaged area of the stringer be demolished and replaced. In addition, isolated spalling of the floor slab soffit was also observed.

Figure N. Corrosion and excessive section loss at the additional mechanical penthouse exterior stair stringer.

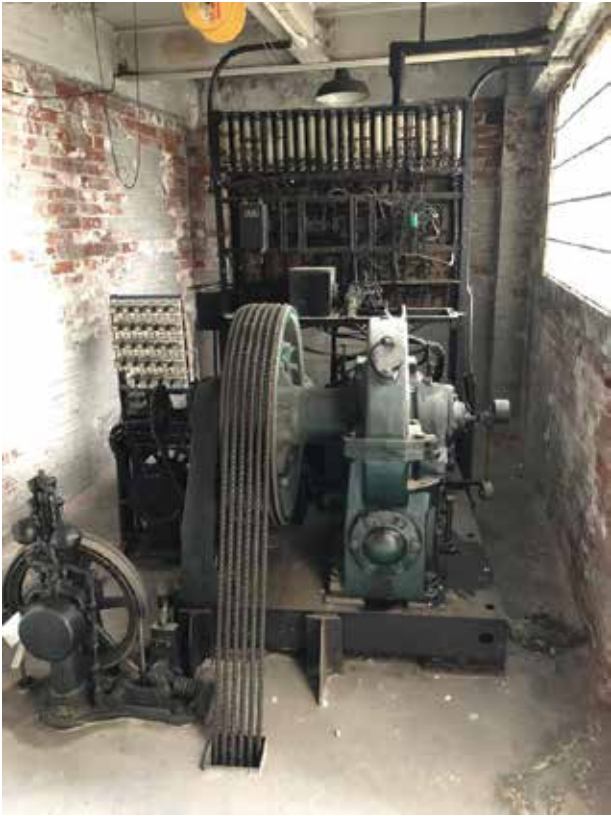
Figure O. Existing Otis freight elevator machinery.
